To Inspect Vehicle No: SJQ 7053T

Make: SUZUKI SWIFT 1.5XE A CO 1490

NOTICE TO INSURER TO CONDUCT PRE-REPAIR INSPECTION
CLAIMANT: CHEW ZI HANG
TRAFFIC ACCIDENT ON 23 JANUARY 2019 AT 17:50 HRS ALONG TOWNER ROAD
(HONG WEN PRIMARY EXIT) INVOLVING VEHICLES NO. SJQ7053T & SMF1126D

VEHICLE DAMAGE INSPECTION REPORT

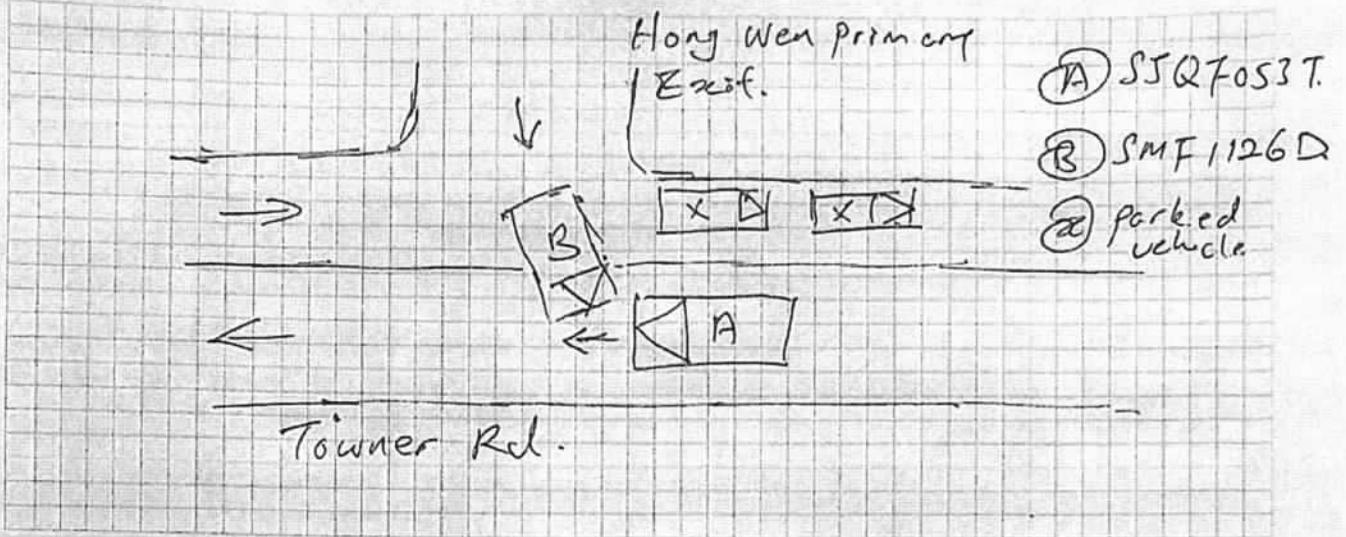
SKETCH PLAN

On mentioned date and time, I was travelling along Towner Rd outside Hong Wen Primary. Suddenly veh B drove out from Hong Wen primary exit and collided onto my vehicle right front portion.
