SHD 8865C - CS / A71150114084 / RJ10352

INITIAL INSPECTION REPORT OF VEHICLE NO. SHD 8865C.

ADJUSTMENT ON REPAIR COST FOR VEHICLE NO. SHD 8865C

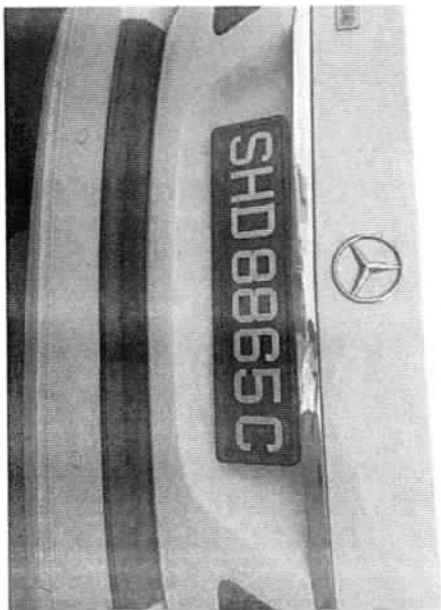
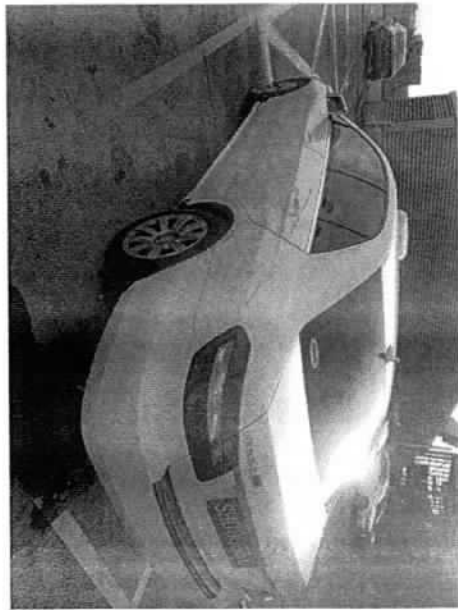
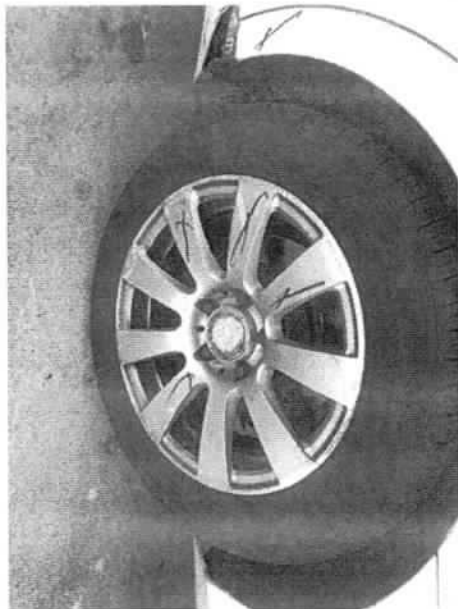
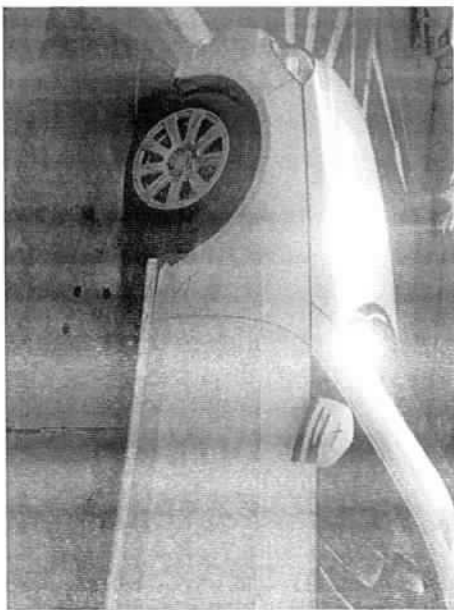
The vehicle sustained damages at the n/s portion.

4. Description of Damages			
THE VEHICLE SUSTAINED DAMAGES AT THE N/S BODY. DAMAGES SEE DETAILS.			
5. General Information			
	Accident Date	26/01/2019	Inspection Date
			28/01/2019
	Survey held at	COMFORTDELGRO ENGINEERING PTE LTD	
		59 LOYANG DRIVE	
		SINGAPORE 508969	
5a. Remarks			
A)THE INSPECTION WAS CONDUCTED ON A"WITHOUT PREJUDICE" BASIS. B)IN ACCORDANCE TO YOUR INSTRUCTIONS, WE HAVE NOT AUTHORISED REPAIRS.			
5b. Estimate Days of Repair			
	ESTIMATED NORMAL PERIOD FOR REPAIR:		4 Working Days

RECOMMENDED COST OF LUMP SUM REPAIRS (TO ITS PRE-ACCIDENT CONDITION)			5,400.00
---	--	--	----------
