1. Policy Particulars :- THIRD PARTY CLAIM				
Insured Veh.	SLM 8509L	Veh. Inspected	SMB 42P	
Policy No.	5099697038	Coverage (\$)	0.00	
Claim No.	MT/1016992-002	Excess (\$)	0.00	
Assign From		Assign Date	29/01/2019

4. Description of Damages				
THE VEHICLE SUSTAINED DAMAGES AT THE FRONT PORTION. DAMAGES SEE DETAILS.				
5. General Information				
Accident Date	11/10/2018	Inspection Date	29/01/2019	
Survey held at	SMRT AUTOMOTIVE SERVICES PTE LTD 60 WOODLANDS INDUSTRIAL PARK E4 SINGAPORE 757705			
5a. Remarks				
A)THE INSPECTION WAS CONDUCTED ON A"WITHOUT PREJUDICE" BASIS. B)IN ACCORDANCE TO YOUR INSTRUCTIONS, WE HAVE NOT AUTHORISED REPAIRS.				
5b. Estimate Days of Repair				
ESTIMATED NORMAL PERIOD FOR REPAIR:		2 Working Days

ADJUSTMENT ON REPAIR COST FOR VEHICLE NO. SMB 42P

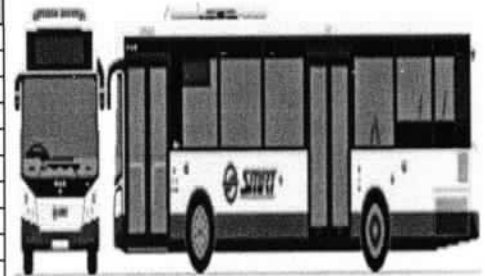
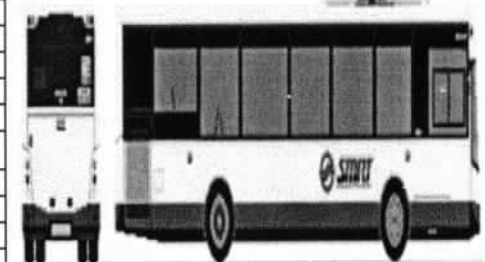
Qty	Description of Parts	Condition	Estimate By Workshop (\$)	Our Adjusted (\$)
1	REPLACEMENT OF PARTS	CRACKED		
	LAMP, BLINKER;FRONT, LEFT, FOR MB OC 500 LE		155.30	155.30
	LESS 10% DISCOUNT		-	-15.53
			155.30	139.77
	LABOUR			
	TO REMOVE & INSTALL ALL ABOVE ITEMS AND REPAIR OTHERS DAMAGED AFFECTED AREAS.		530.00	265.00
	TO PUTTY & RESPRAY.		616.00	446.00
			1,146.00	711.00
GRAND TOTAL			1,301.30	850.77

RECOMMENDED COST OF LUMP SUM REPAIRS (TO ITS PRE-ACCIDENT CONDITION) (CONFIRMED)			700.00
---	--	--	---------------
