Your Ref: Toyota Engine  
(number 2AZF026872)  
Our Ref : CI/TP19002149/D

### **INSPECTION REPORT OF A TOYOTA ENGINE WITH NUMBER 2AZF026872**

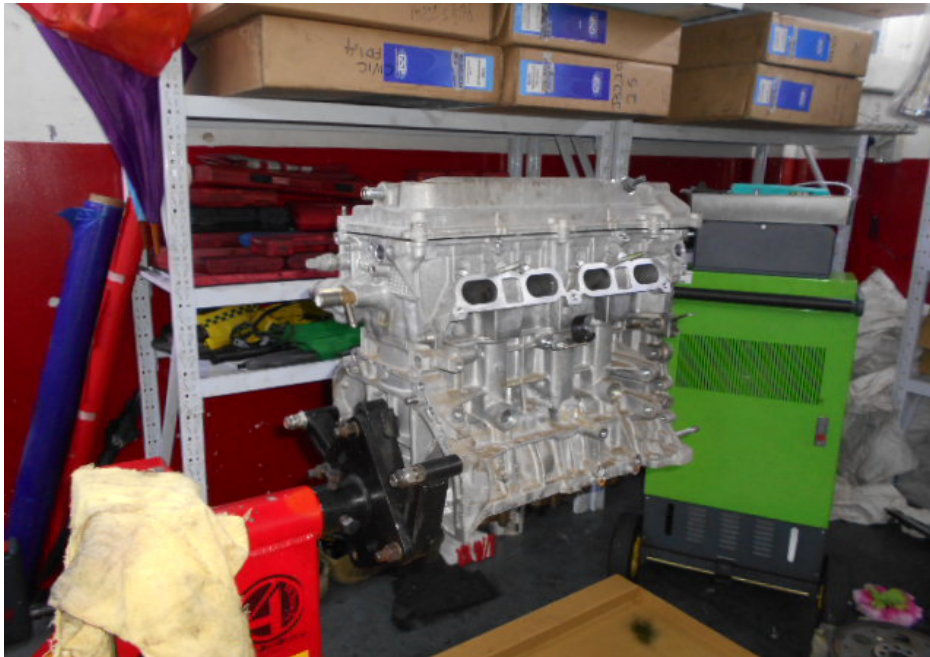
**Photo 1** shows a general view of the Toyota engine that I had inspected. The Toyota engine was observed to be a used engine and was not fitted on any motor car. It was also observed to be a complete assembly with all mechanical parts still intact, within the engine housing.

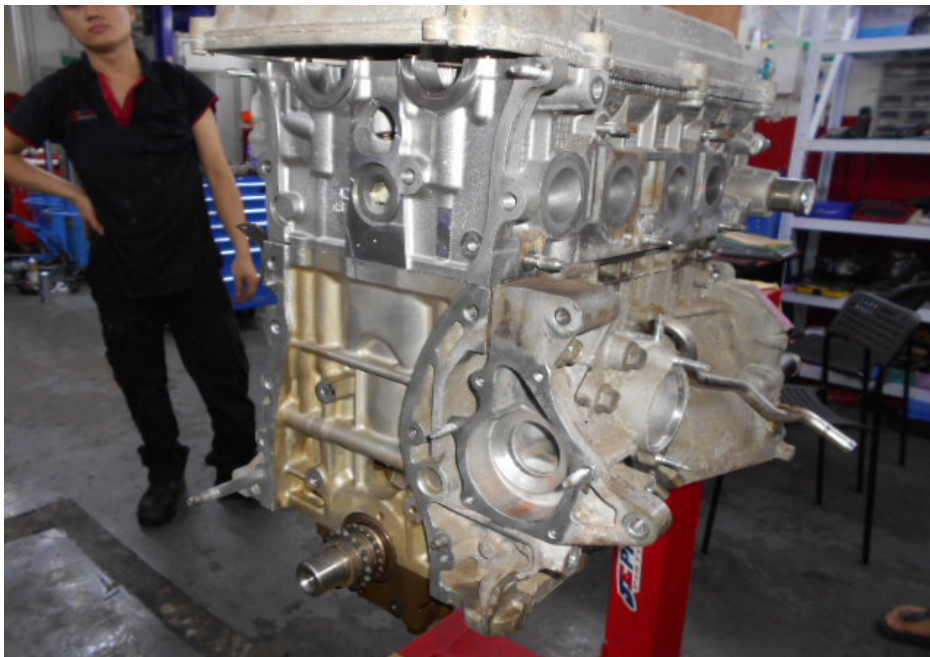
**Photo 2** shows a general view of the Toyota engine that I had inspected. My visual examination of the engine housing revealed the housing to be of serviceable/satisfactory condition. There was no crack and/or hole observed on the engine housing.

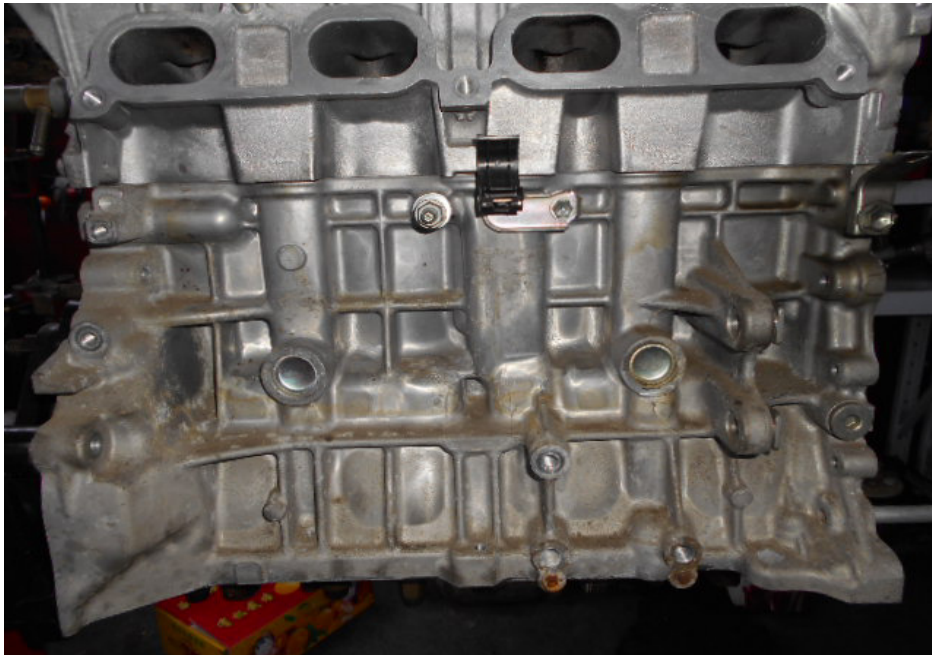
**Photo 3** shows a general view of the Toyota engine that I had inspected. My visual examination of the engine housing revealed the housing to be of serviceable/satisfactory condition. There was no crack and/or hole observed on the engine housing.

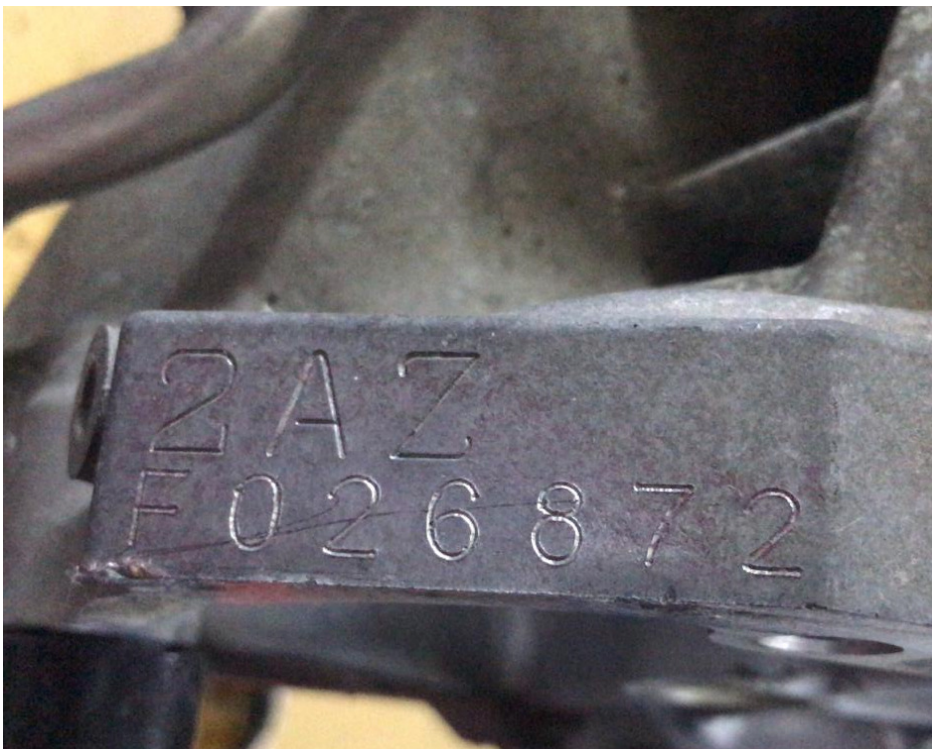
**Photo 4** shows the engine number engraved on the housing of the Toyota engine that I had inspected. The engine number was 2AZF026872.

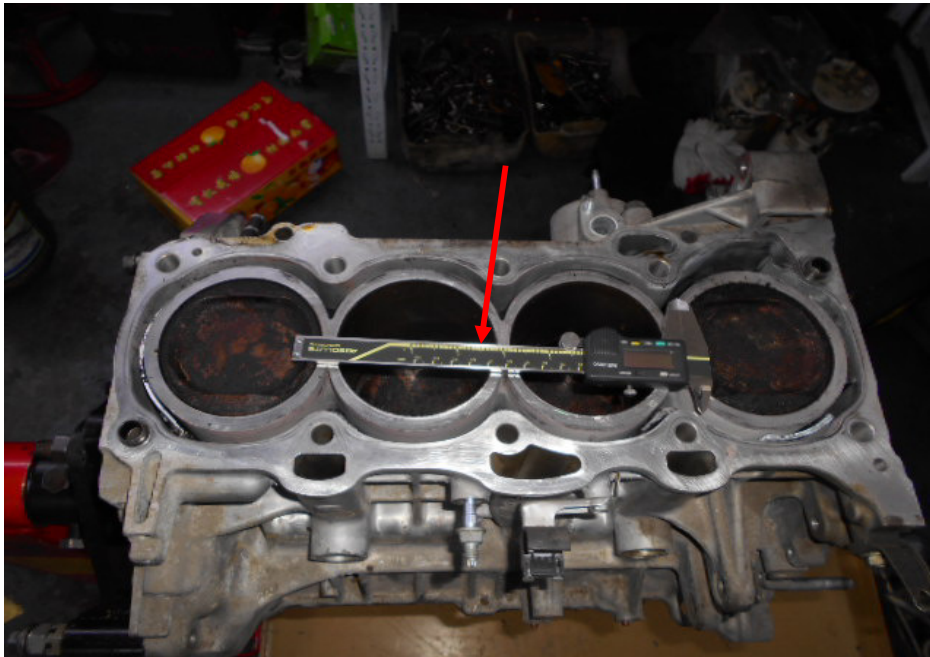
**Photo 5** shows the bottom block of the Toyota engine. The top block of the Toyota engine was separated from its bottom block to enable me to carry out measurements of its cylinders, in particular the bore and stroke measurements of each cylinder, which typically can be used to determine the engine displacement or more commonly referred to as engine cc. A digital Vernier Caliper (arrowed) was used for the measurements. The digital Vernier Caliper was calibrated before the start of the measurements.

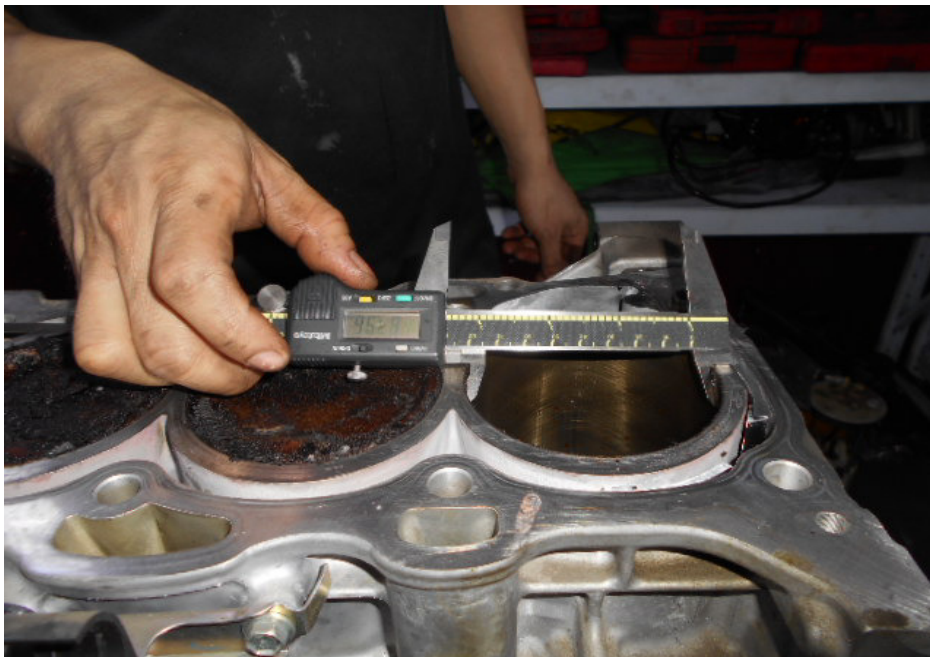
**Photo 6** shows measurement being carried out to the bore of cylinder 1 of the Toyota engine. The measurements were carried out using a digital Vernier Caliper that was calibrated before the start of the measurements.

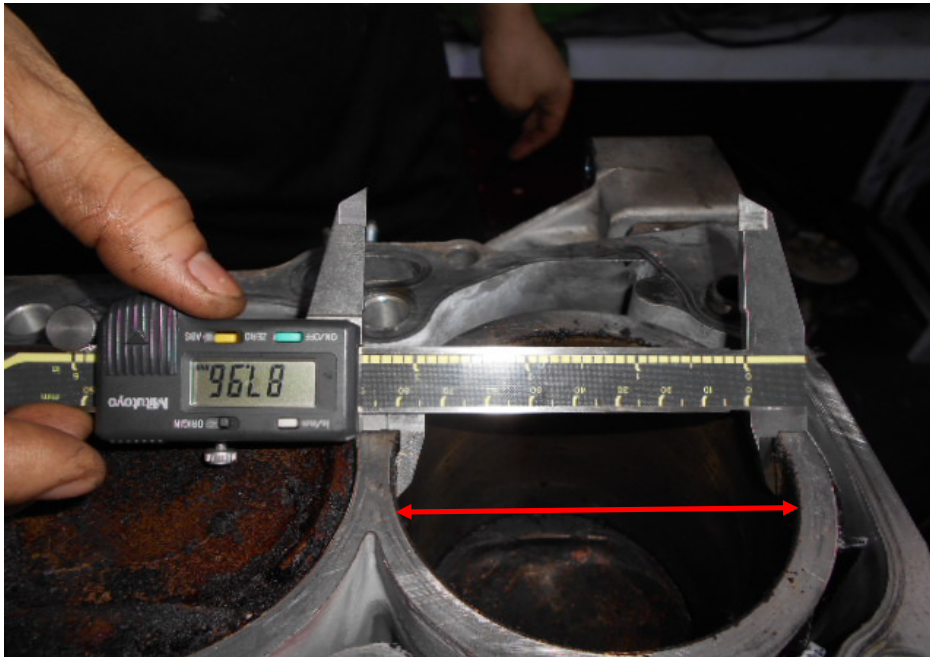
**Photo 7** shows the bore measurement of cylinder 1, which was recorded to be 87.96mm.

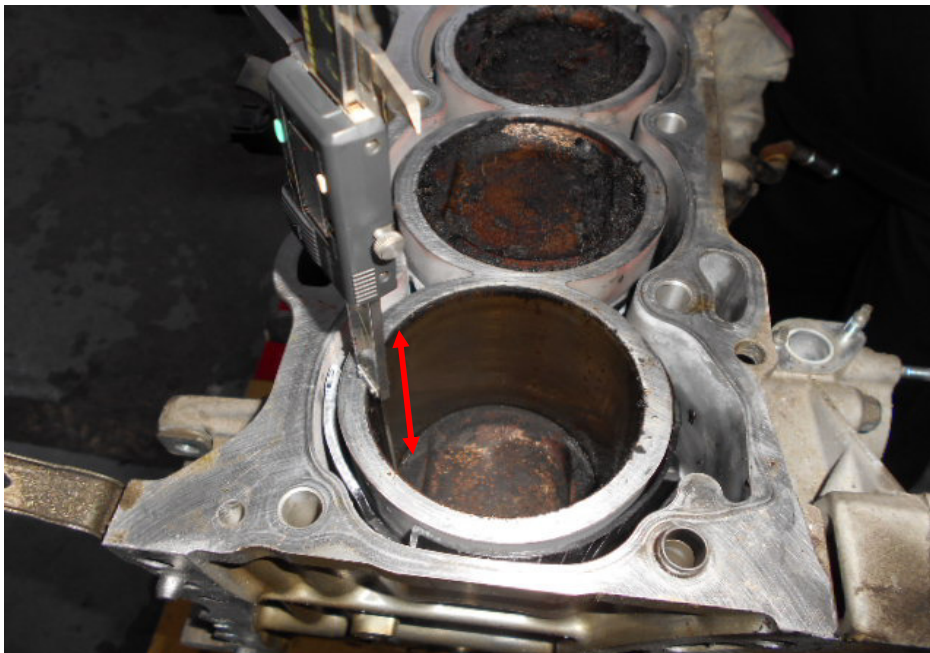
**Photo 8** shows measurement being carried out to the stroke (arrowed) of cylinder 1 of the Toyota engine. The bore and stroke measurements of the Toyota engine were carried out using a digital Vernier Caliper that was calibrated before the start of the measurements.

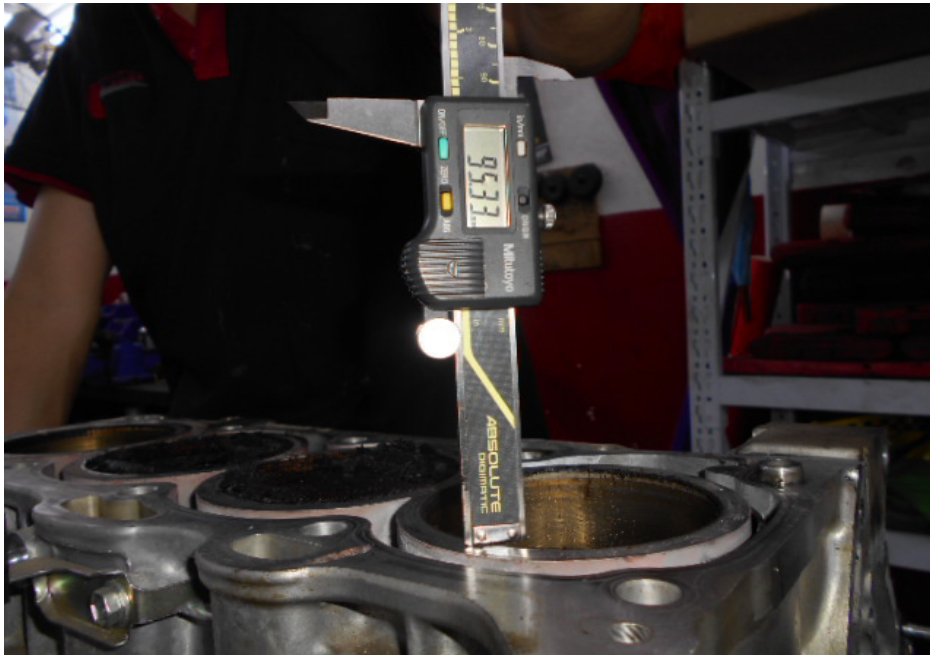
**Photo 9** shows the stroke measurement of cylinder 1, which was recorded to be 95.33mm.

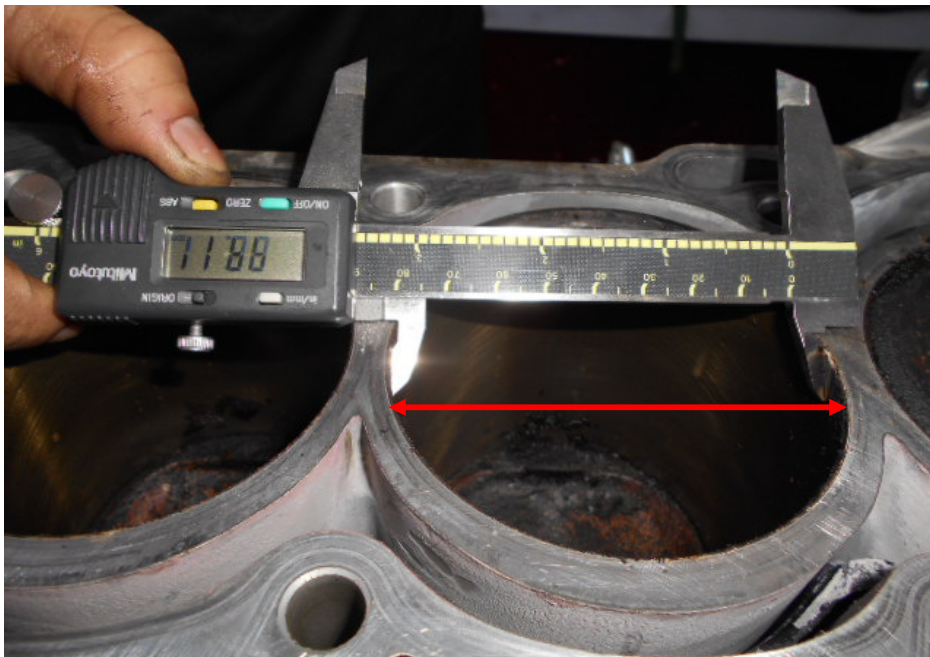
**Photo 10** shows measurement being carried out to the bore (arrowed) of cylinder 2 of the Toyota engine. The bore measurement of cylinder 2 was recorded to be 88.11mm.

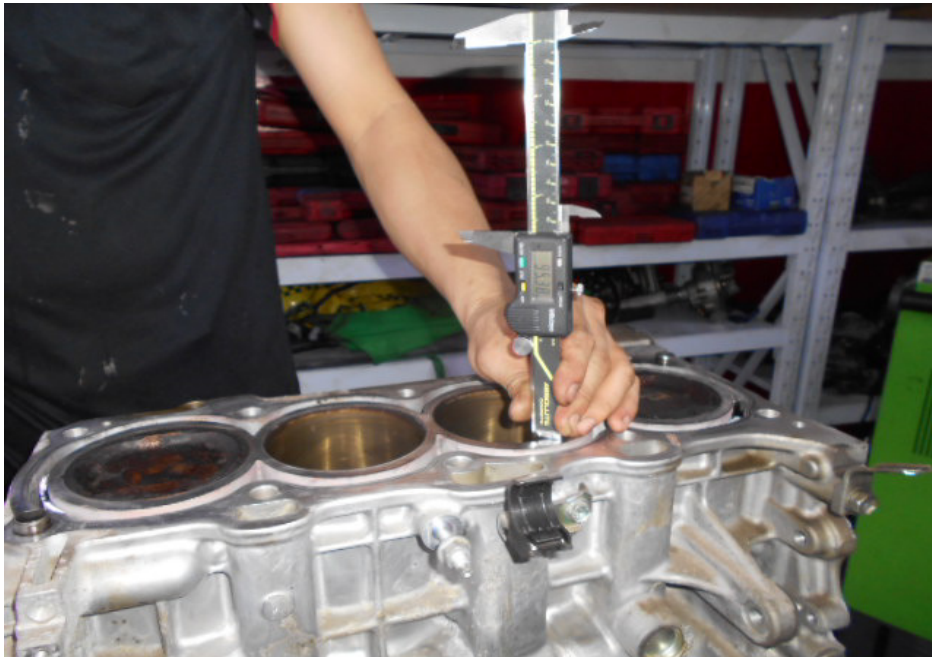
**Photo 11** shows measurement of the stroke for cylinder 2 of the Toyota engine that I had inspected.

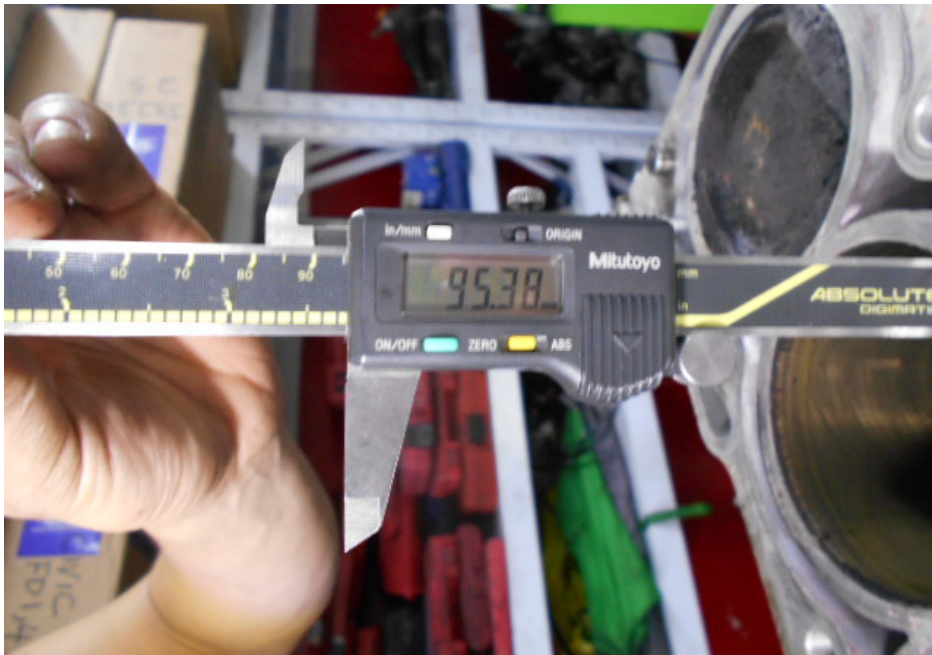
**Photo 12** shows the stroke measurement of cylinder 2, which was recorded to be 95.38mm.

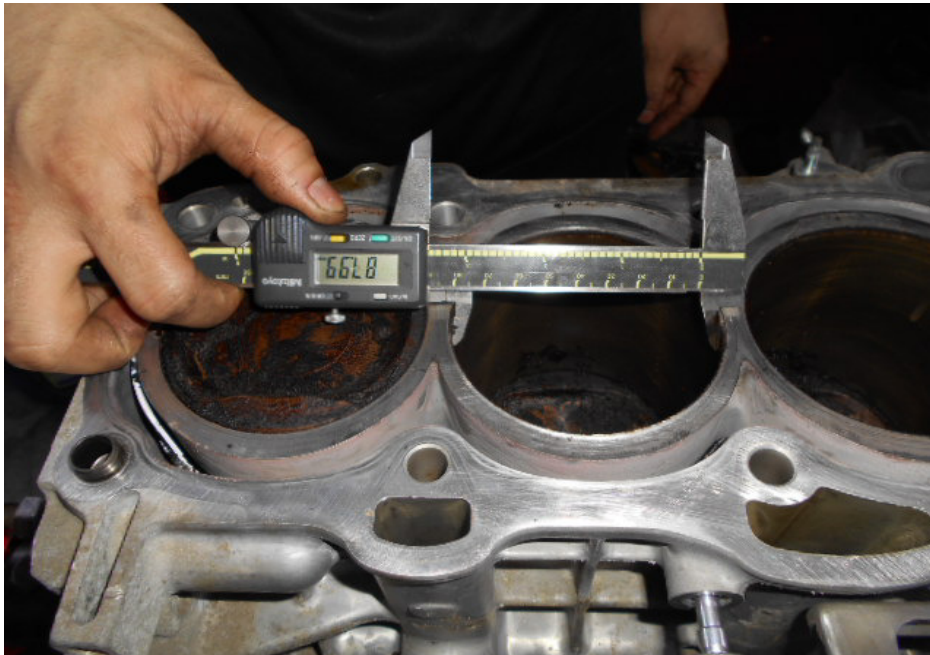
**Photo 13** shows measurement being carried out to the bore of cylinder 3 of the Toyota engine. The bore and stroke measurements of the Toyota engine were carried out using a digital Vernier Caliper that was calibrated before the start of measurements. The bore measurement of cylinder 3 was recorded to be 87.99mm.

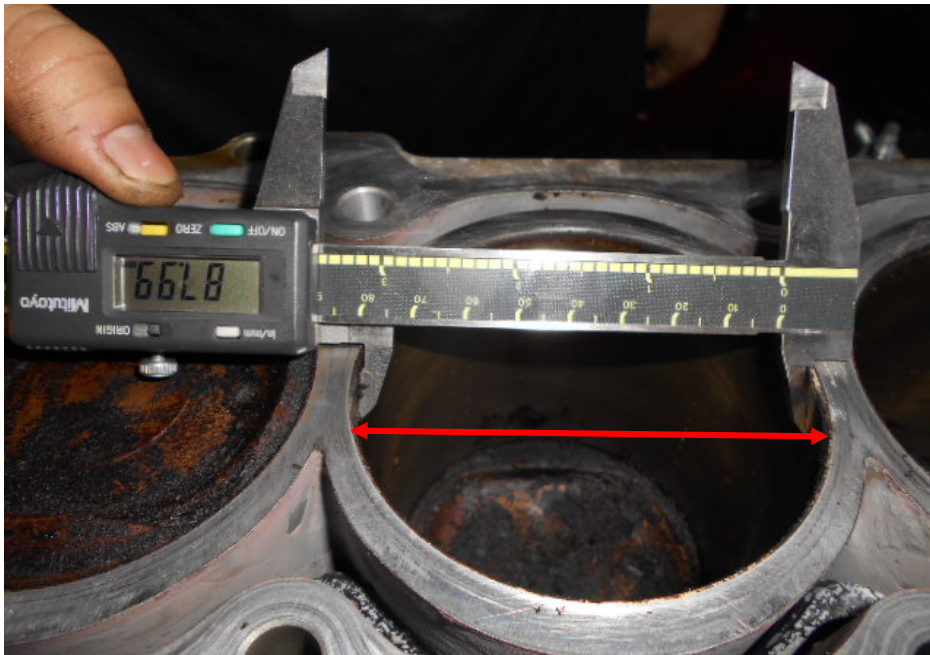
**Photo 14** shows measurement being carried out to the bore (arrowed) of cylinder 3 of the Toyota engine. The bore measurement of cylinder 3 was recorded to be 87.99mm.

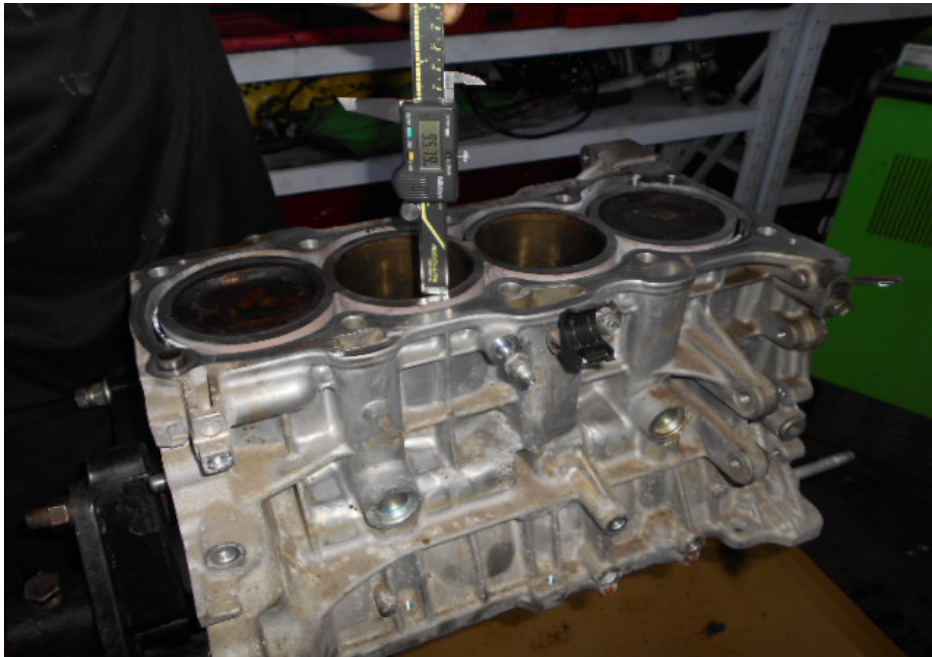
**Photo 15** shows measurement of the stroke for cylinder 3 of the Toyota engine that I had inspected. The bore and stroke measurements of the Toyota engine were carried out using a digital Vernier Caliper that was calibrated before the start of measurements.

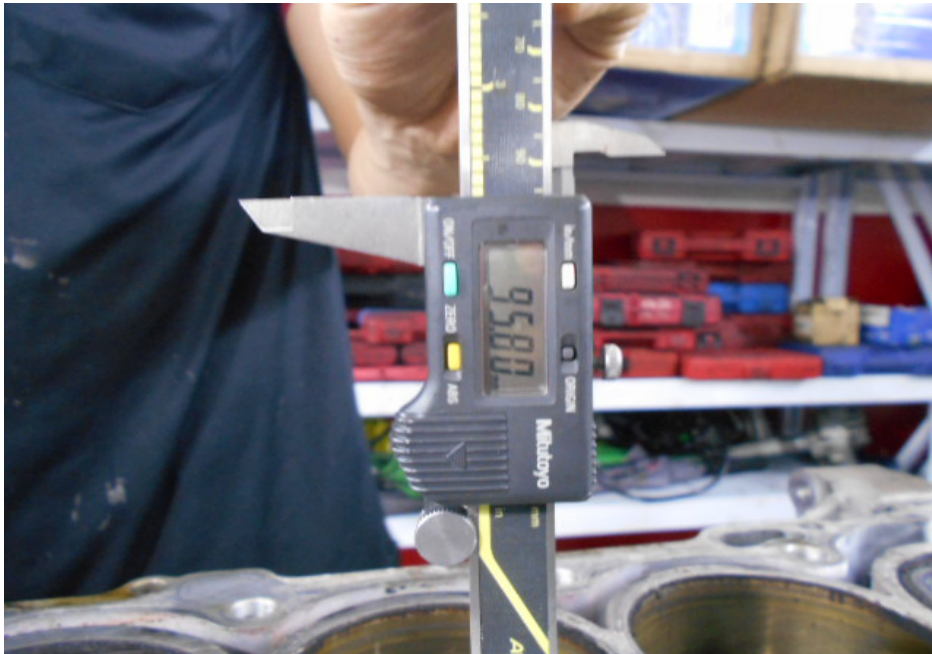
**Photo 16** shows the stroke measurement of cylinder 3, which was recorded to be 95.80mm.

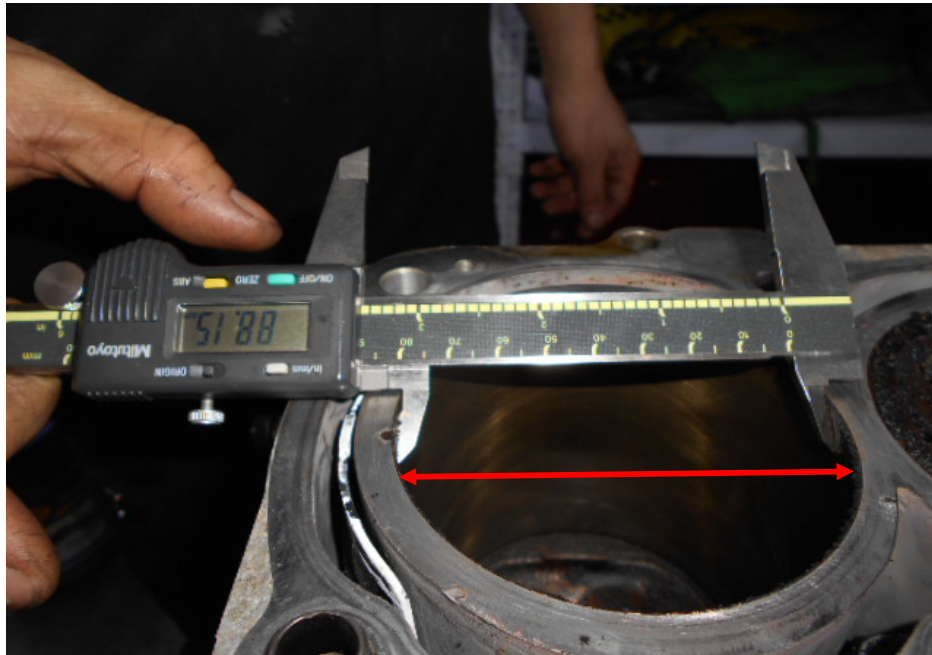
**Photo 17** shows measurement being carried out to the bore (arrowed) of cylinder 4 of the Toyota engine. The bore measurement of cylinder 4 was recorded to be 88.15mm.

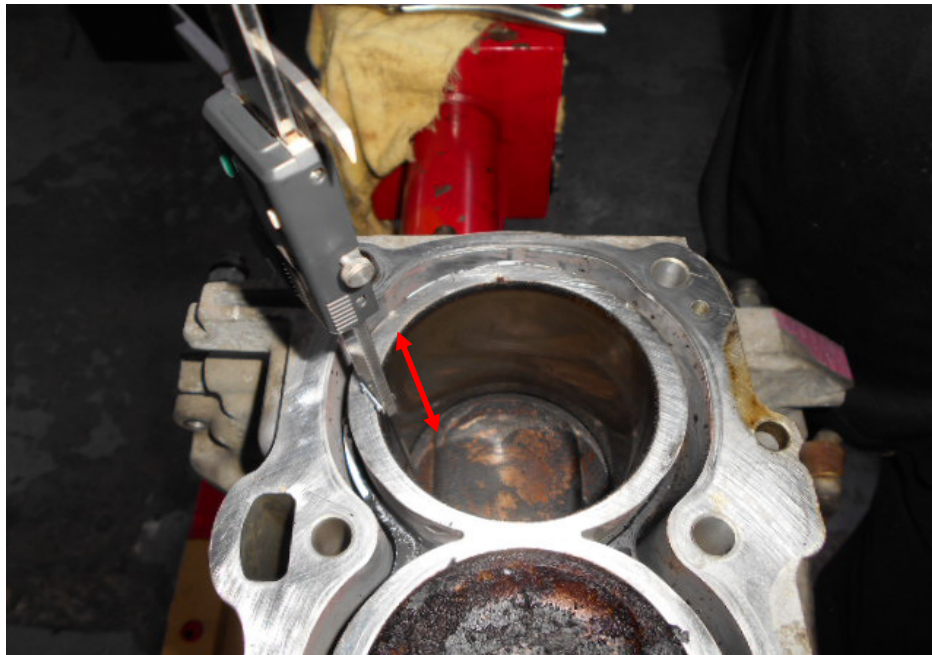
**Photo 18** shows measurement being carried out to the stroke (arrowed) of cylinder 4 of the Toyota engine. The bore and stroke measurements of the Toyota engine were carried out using a digital Vernier Caliper that was calibrated prior to the start of measurements.

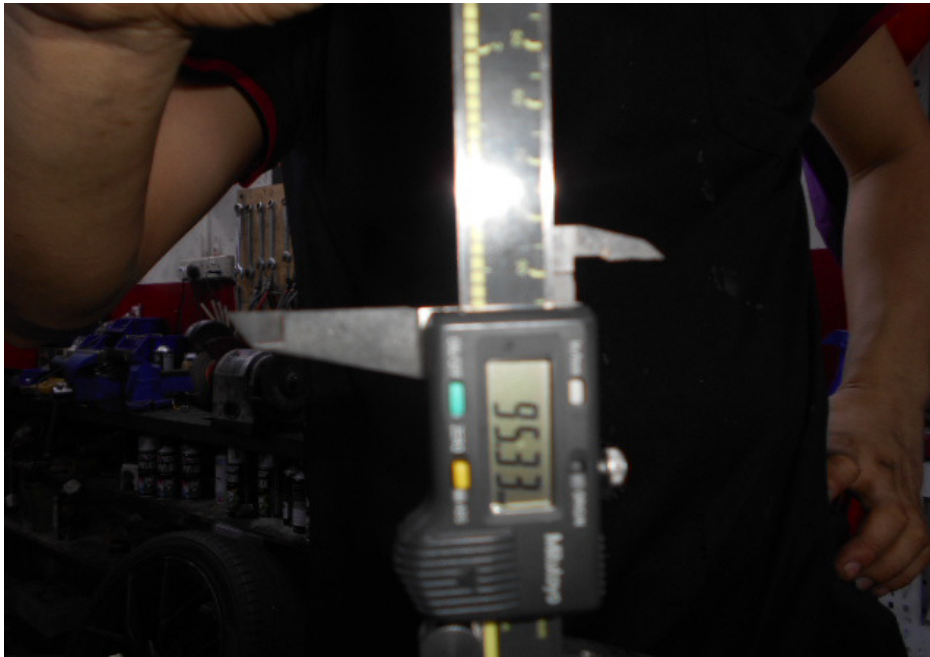
**Photo 19** shows the stroke measurement of cylinder 4, which was recorded to be 95.33mm.
