1. Policy Particulars :- THIRD PARTY CLAIM			
Insured Veh.	SLV 503H	Veh. Inspected	SMB 205L
Policy No.	5096761335-01	Coverage (\$)	0.00
Claim No.	MT/1030239-003	Excess (\$)	0.00
Assign From		Assign Date	31/01/2019

4. Description of Damages			
THE VEHICLE SUSTAINED DAMAGES AT THE FRONT O/S PORTION. DAMAGES SEE DETAILS.			
5. General Information			
Accident Date	30/01/2019	Inspection Date	31/01/2019
Survey held at	SMRT AUTOMOTIVE SERVICES PTE LTD 60 WOODLANDS INDUSTRIAL PARK E4 SINGAPORE 757705		
5a. Remarks			
A)THE INSPECTION WAS CONDUCTED ON A"WITHOUT PREJUDICE" BASIS. B)IN ACCORDANCE TO YOUR INSTRUCTIONS, WE HAVE NOT AUTHORISED REPAIRS.			
5b. Estimate Days of Repair			
ESTIMATED NORMAL PERIOD FOR REPAIR:		3 Working Days

ADJUSTMENT ON REPAIR COST FOR VEHICLE NO. SMB 205L

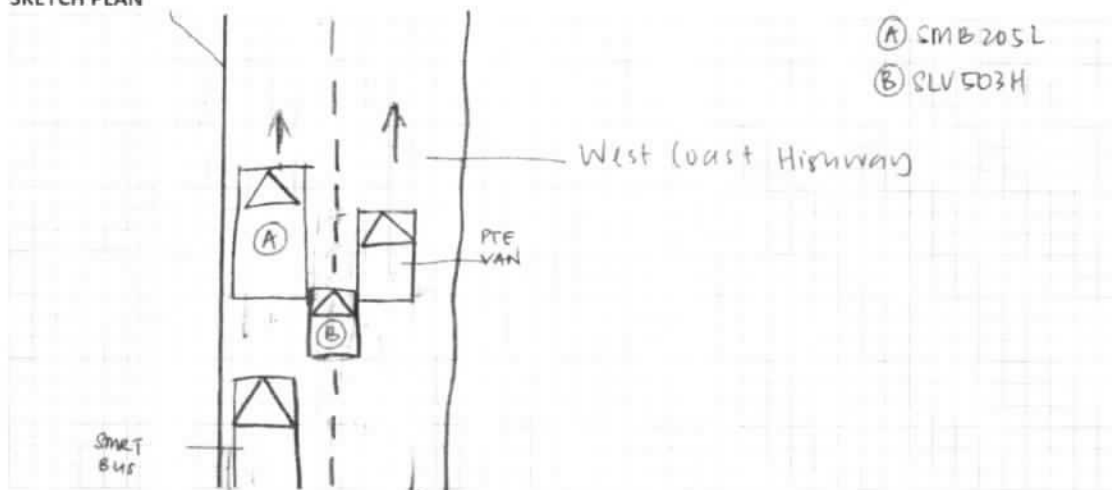
SKETCH PLAN

MY BUS WAS IN STATIONARY POSITION ON THE RIGHT MOST LANE AS TRAFFIC WAS CONGESTED. SUDDENLY I FELT A SLIGHT IMPACT ON THE RIGHT REAR SIDE OF MY BUS. I CHECKED THE RIGHT VIEW MIRROR AND REALISED THAT A PTE CAR (SLV503H) HAD COLLIDED ONTO THE RIGHT REAR PORTION OF MY BUS. WHILE EXCHANGING DETAILS, I WAS INFORMED THAT THE PTE CAR TRIED TO PASS THROUGH BETWEEN LANE 1 AND 2 FOLLOWING OTHER MOTORCYCLES. DUE TO THAT, THE PTE CAR WAS ALSO INVOLVED IN ANOTHER COLLISION WITH VEHICLES ON THE 1ST LANE AS WELL AS ANOTHER SMRT BUS SERVICE THAT WAS BEHIND BUS. THERE WERE NO INJURIES REPORTED.
