Insured Vehicle No	: SLU2711R	Accident Date	: 04/02/2019
TP Vehicle No	: SDS3338J	Assignment Date	: 08/02/2019
Make	: BMW 528i	Est. Duration of Repair	: 7-9.00
Date of Inspection	: 08/02/2019		
Inspection At	: PERFORMANCE MOTORS LIMITED (ALEXANDRA) 303 ALEXANDRA ROAD, SIME DARBY PERFORMANCE CENTRE SINGAPORE 159941

The vehicle sustained impact / damages front n/s portion and n/s body and parts claimed are consistent to the accident.

VEHICLE DAMAGE INSPECTION REPORT

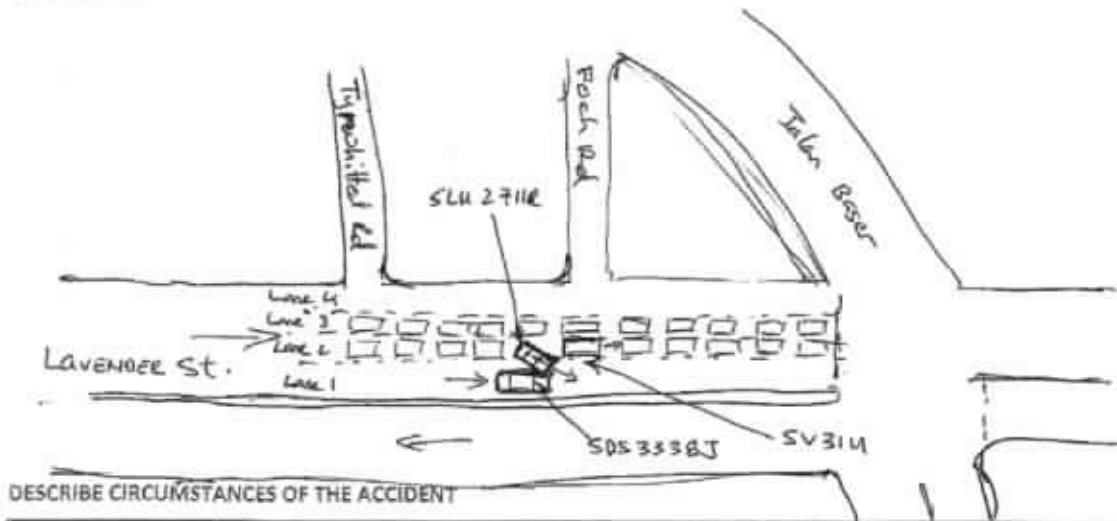
SKETCH PLAN

I alighted from my vehicle and noted that my left front signal light, bumper and left passenger doors were damaged. After taking some photographs of the accident scene and exchanging contact details, the driver of SV31U left prior to police arrival as her vehicle was still able to move. The driver of SLU2711R also claimed that he wanted to merge onto my lane, lane 1 and had turned on his right signal before merging. I did not notice his vehicle signal however when I saw his vehicle suddenly merging into my lane, I quickly stepped on my brakes, sounded my horn to warn him and tried swerving my vehicle towards the right to avoid the collision.

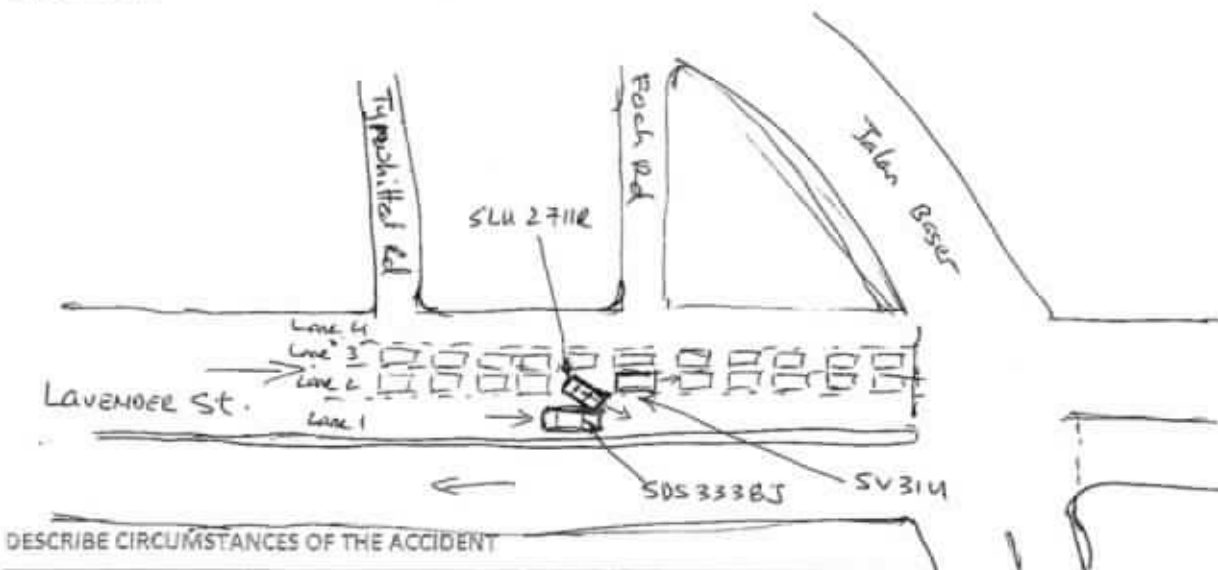
SKETCH PLAN

I alighted from my vehicle and noted that my left front signal light, bumper and left passenger doors were damaged. After taking some photographs of the accident scene and exchanging contact details, the driver of SV31U left prior to police arrival as her vehicle was still able to move. The driver of SLU2711R also claimed that he wanted to merge onto my lane, lane 1 and had turned on his right signal before merging. I did not notice his vehicle signal however when I saw his vehicle suddenly merging into my lane, I quickly stepped on my brakes, sounded my horn to warn him and tried swerving my vehicle towards the right to avoid the collision.
