ACCIDENT INVOLVING SGS 7135R AND XD 781Z ALONG PAN-ISLAND EXPRESSWAY
("PIE") TOWARDS TUAS BEFORE PIONEER ROAD NORTH ON 17.11.2018

SUBJECT : CONSTRUCTIVE TOTAL LOSS
VEHICLE REGISTRATION NO : SGS 7135 R
MAKE/MODEL : Mitsubishi Lancer 1.6 GLX (Auto)

VEHICLE DAMAGE INSPECTION REPORT

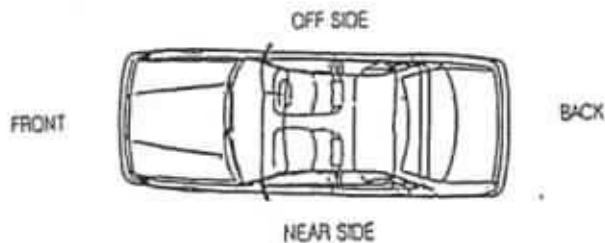
Direction of Impact (→)

Our investigation enclosed that the subject vehicle being involved in a collision with another vehicle and the impact was delivered onto the entire n/s body length. The encroachment resulted in the vehicle to collide with a man-made structure at its n/s front, & subsequently, its n/s front to crash onto a road divider. Apparently, the n/s n/s front & rear & its n/s front wheels were struck-upon, thus, damaging their suspension members/drive trains & misaligning their wheels cambers/geometries.

Damages sustained were the front windscreen -cracked, bonnet & its inner reinforcement- dented/bent/buckled/warped over an extensive area, bonnet hinge n/s & n/s- bent/twisted, bonnet inner lock/catch- bent/shifted/disrupted, front bumper assembly, n/s front fender & its inner panel- dented/buckled, front support panel- thrusts inwards/buckled resulting in the air conditioner condenser & radiator assemblies- bent/shifted/ruptured, front door pillar n/s- buckled, n/s front & rear door & their inner reinforcement- crumpled, front suspension members n/s & n/s- bent/buckled/elongorous, bootlid & its inner reinforcement- dented/bent/buckled/warped over an extensive area, bootlid inner lock/striker- bent inwards/shifted, rear end panel- thrusts inwards/buckled, rear bumper assembly, rear fender n/s- buckled/warped, rear door lock pillar/dog leg n/s- buckled/sandwiched with n/s rear door assembly, centre door pillar n/s- buckled, front & rear chassis members- bent/misaligned etc-----

Remarks: In view of the above damages and cost of repairs, we suggest that this vehicle be written off as a ' CONSTRUCTIVE TOTAL LOSS '. This would save unwarranted time and expenses.
