Preliminary Advice

Vehicle No	: WC4290P	Accident Date	: 24/01/2019
Make	: NISSAN CGB45CLSMNB	Policy No.	: B29088496MKF(COMP)
Assignment Date	: 11/02/2019	Excess	: S\$0.00
Date of Inspection	: 11/02/2019	Est. Duration of Repair	: 14.00
Inspection At	: TAN CHONG INDUSTRIAL MACHINERY PTE LTD (JALAN BUROH) 23 JALAN BUROH SINGAPORE 619479

VEHICLE DAMAGE INSPECTION REPORT

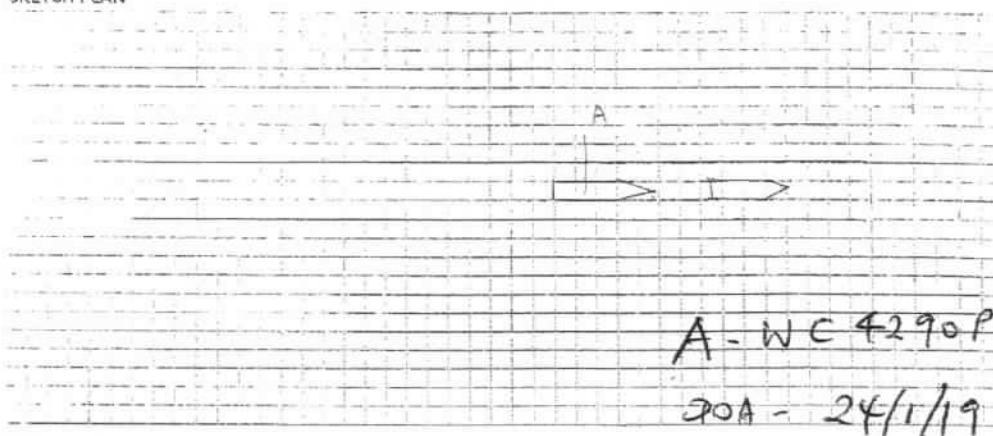
SKETCH PLAN

DESCRIBE CIRCUMSTANCES OF THE ACCIDENT

For Road Alliance plant The the Vehicle
start ready 1/2 hours this Error Running after
1/2 hour's Fire ready after Engine Automatically caught
fire
