### 1. Policy Particulars :- THIRD PARTY CLAIM

### 4. Description of Damages

## ADJUSTMENT ON REPAIR COST FOR VEHICLE NO. SH 9132B

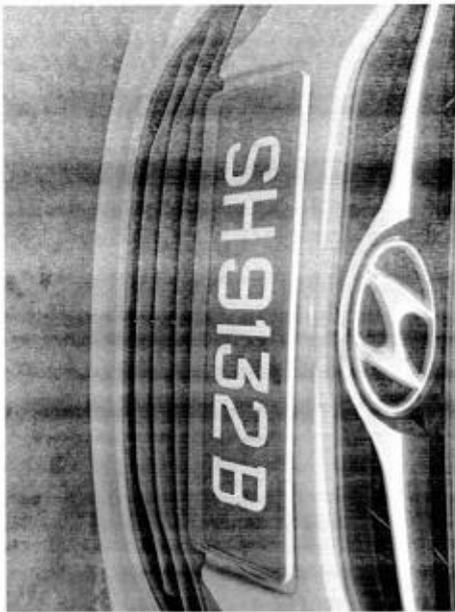
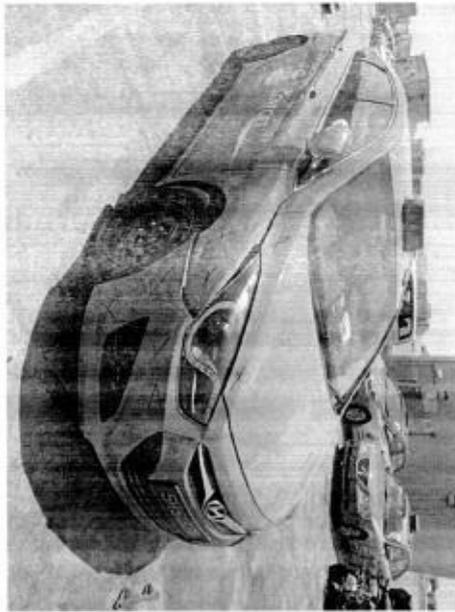
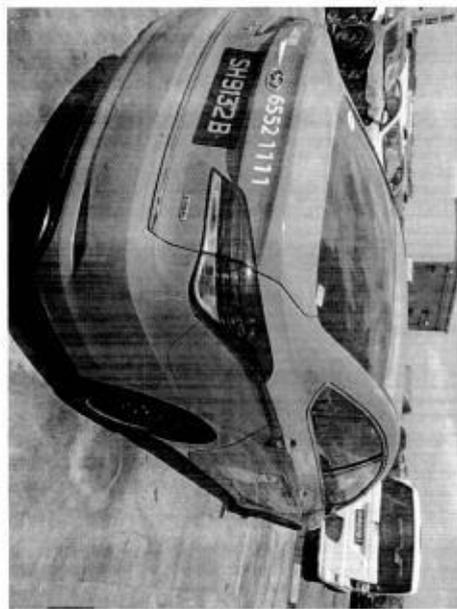
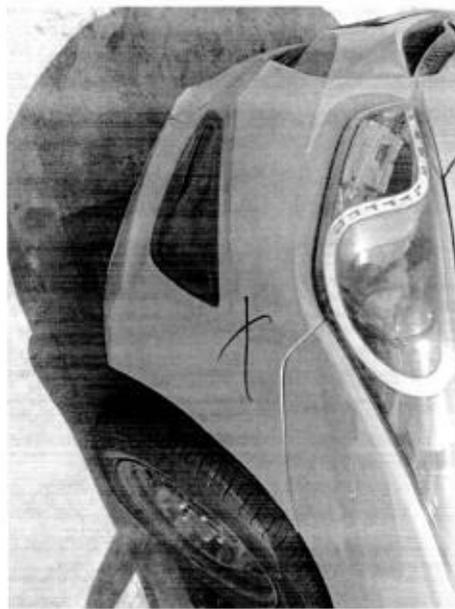
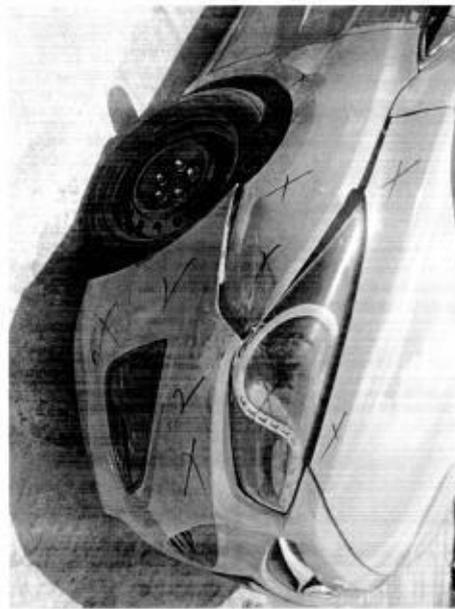
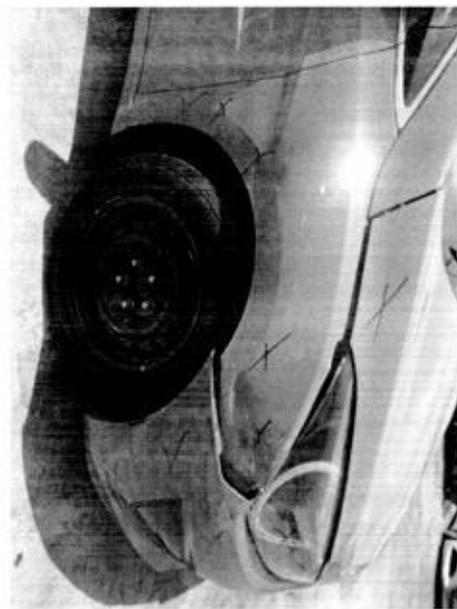
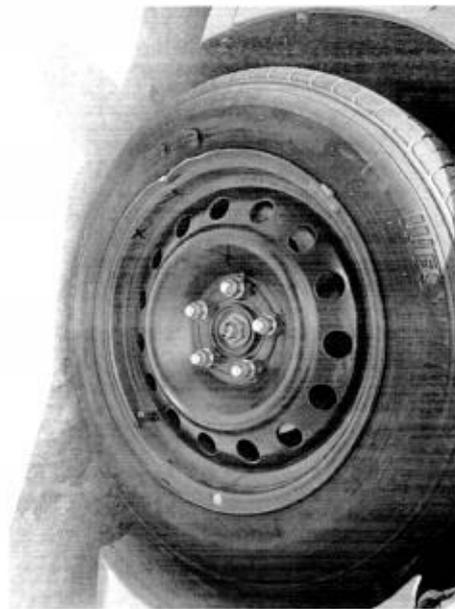
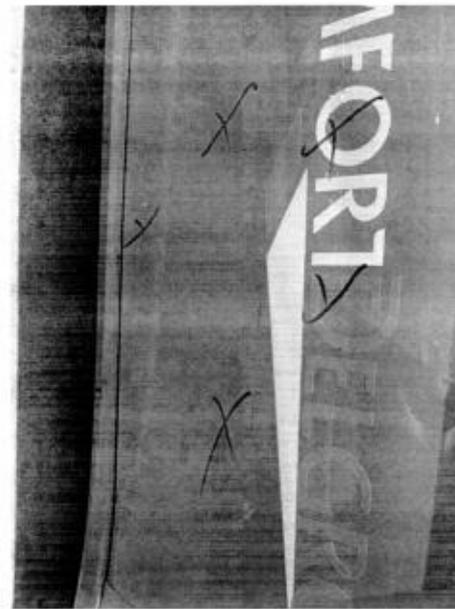
Survey held at EDGE LOYANG  
 Des. of Damages: Frt / Rear / O/S / N/S / U/C / Roof/tp or FRONT O/S  
 The U/C / Chassis frame / Body Structure affected due to collision

THE VEHICLE SUSTAINED DAMAGES AT THE FRONT O/S PORTION. DAMAGES SEE DETAILS.
---

Qty	Description of Parts	Condition	Estimate By Workshop (\$)	Our Adjusted (\$)
<b>REPLACEMENT OF PARTS</b>				
1	FRONT BUMPER COVER	CRACKED	544.50	544.50
1	FRONT BUMPER SPONGE	SERVICEABLE	99.20	-
1	FRONT BUMPER REINFORCEMENT	SERVICEABLE	402.10	-
1	FRONT BUMPER GRILLE (RH)	NOT NECESSARY	41.60	-
1	FRONT BUMPER BRACKET TOP (RH)	SERVICEABLE	22.40	-
1	FRONT BUMPER BRACKET (RH)	SERVICEABLE	24.60	-
1	HEADLAMP (RH)	CRACKED	1,388.00	1,388.00
1	FRONT FENDER (RH)	DEFORMED	566.30	566.30
1	FRONT FENDER SHIELD (RH)	SERVICEABLE	174.90	-
1	FRONT FENDER RETAINER	SERVICEABLE	24.60	-
1	FRONT WHEEL RIM (RH)	DENTED	325.30	325.30
	LESS 20% DISCOUNT		-722.70	-564.82
			2,890.80	2,259.28
<b>SPECIAL NETT ITEMS</b>				
1	FRONT DOOR COMFORT LOGO (RH) (SN)	NECESSARY	75.00	75.00

<b>RECOMMENDED COST OF LUMP SUM REPAIRS (TO ITS PRE-ACCIDENT CONDITION) (CONFIRMED)</b>			<b>2,950.00</b>
---	--	--	-----------------
