NTUC INCOME INSURANCE CO-OPERATIVE LTD Ref: NS/INC19002428/Nsd3e2

### 1. Policy Particulars :- THIRD PARTY CLAIM

### 4. Description of Damages

## ADJUSTMENT ON REPAIR COST FOR VEHICLE NO. SHA 4753J

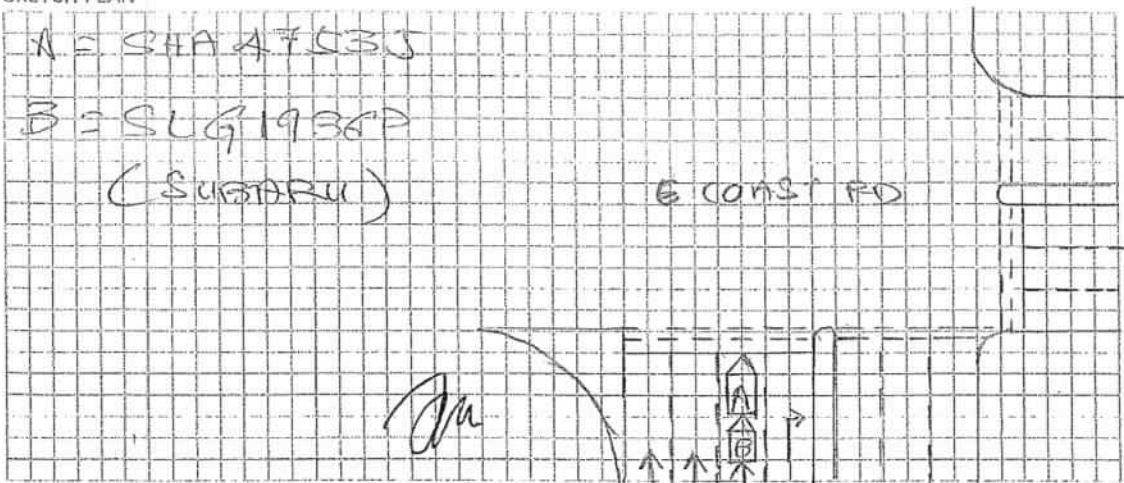
SKETCH PLAN

Describe Circumstances of the Accident.
On the 02/02/2019 @ about 15:30hrs, I was driving along Still Rd S towards E Coast Rd
Direction.
I stop at the traffic light junction waiting for the green light.
Suddenly there's an impact from behind my taxi and found out a vehicle SLG1936P had
collided onto my rear portion of my taxi.
01 male ,02 female & 02 children passenger on board my taxi.
No injury reported at the point of accident.

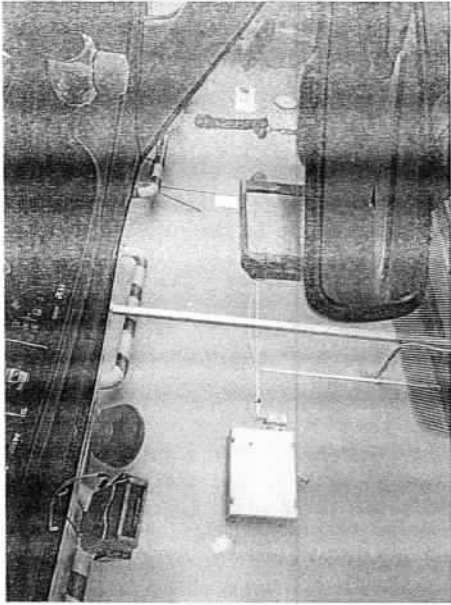
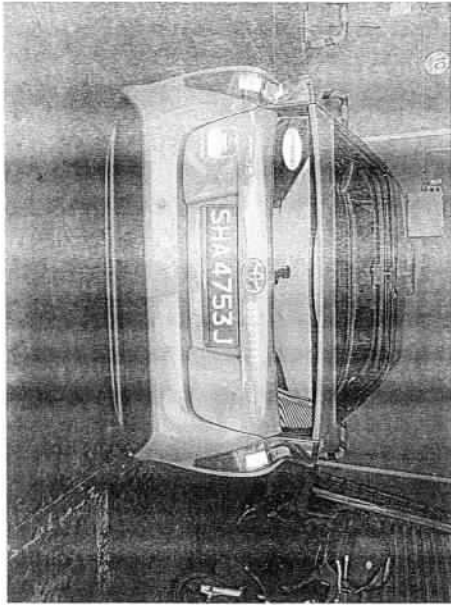
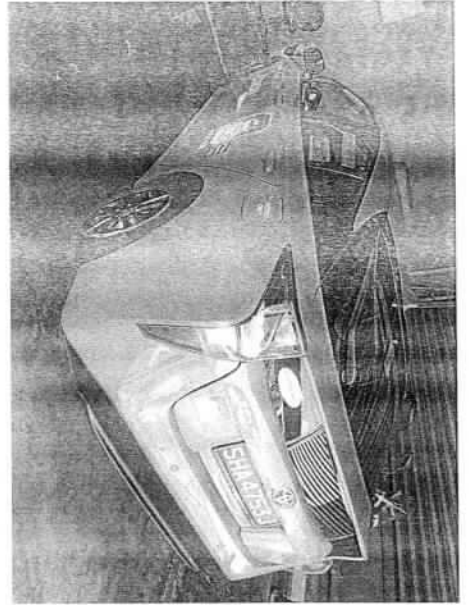
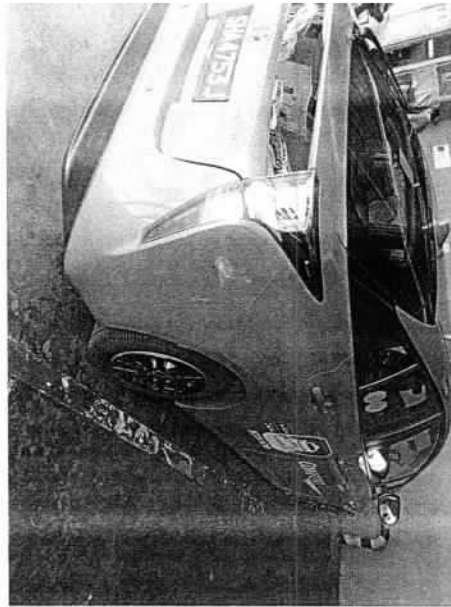
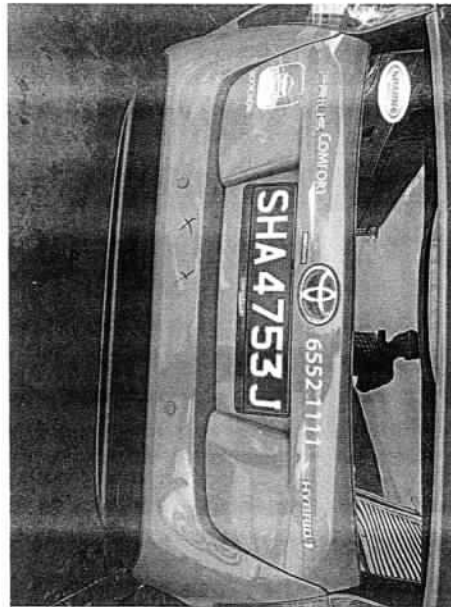
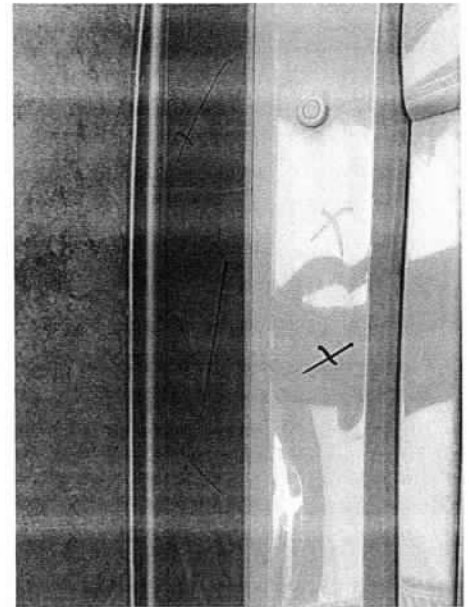
The U/C / Chassis frame / Body Structure affected due to collision

THE VEHICLE SUSTAINED DAMAGES AT THE REAR PORTION. DAMAGES SEE DETAILS.
--

Qty	Description of Parts	Condition	Estimate By Workshop (\$)	Our Adjusted (\$)
	<b><u>REPLACEMENT OF PARTS</u></b>			
1	REAR BUMPER	TO REPAIR SEE LABOUR	458.60	-
1	REAR BUMPER SIDE RETAINER	NOT NECESSARY	112.70	-
10	REAR BUMPER CLIPS	NOT NECESSARY	22.00	-
1	REAR BUMPER UNDER COVER	SCRATCHED	552.60	552.60
	LESS 25% DISCOUNT		-286.47	-138.15
			859.43	414.45
	<b><u>SPECIAL NETT ITEMS</u></b>			
1	REAR BUMPER REVERSE SENSOR (SN)	SERVICEABLE	135.70	-
			135.70	-
	<b><u>LABOUR</u></b>			
	PANEL BEATING. INCLUSIVE OF THE REPAIR OR REAR BUMPER.		400.00	200.00
	SPRAY PAINTING CHARGE.		300.00	200.00
	REMOVE / REFIT REVERSE SENSOR.		30.00	30.00
			730.00	430.00
	<b>GRAND TOTAL</b>		<b>1,725.13</b>	<b>844.45</b>
<b>RECOMMENDED COST OF REPAIRS (CONFIRMED)</b>				<b>844.45</b>
