### VEHICLE DAMAGE INSPECTION REPORT

SLT313A

MERCEDES-BENZ C200 AMG LINE (R18 LED),

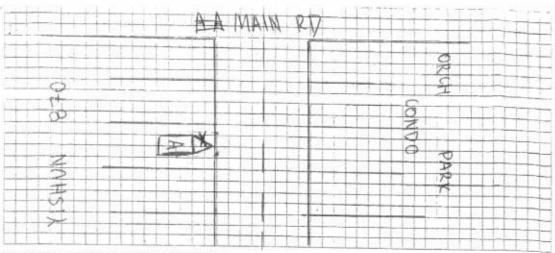
### Accident Sketch Plan Pg. 1

MY	U	1R	UAS	PAR	KED	AT	8	10	YISHV	N	STREET	18	CI	4RPARK	AT	
ARIOU	NO	1	300	OM	05	/02	/19	I	WENT	īc	COLLE	it	MY	LAR	AT	2115
SHE	-N	I	SAW	A	PAP	ER	NO	P	ny ch	NR.	WIND	SCRE	EN	ANO	50	KATCH
ΥŢ	THI		LEFT	FRO	NT	PORT	ION	08	MY	CAR						
-																
		-														
	-	_														
				100-0-								_
