NTUC INCOME INSURANCE CO-OPERATIVE LTD Ref: NS/INC19002690/K1vd3e2

1. Policy Particulars :- THIRD PARTY CLAIM

ADJUSTMENT ON REPAIR COST FOR VEHICLE NO. SHA 2558U

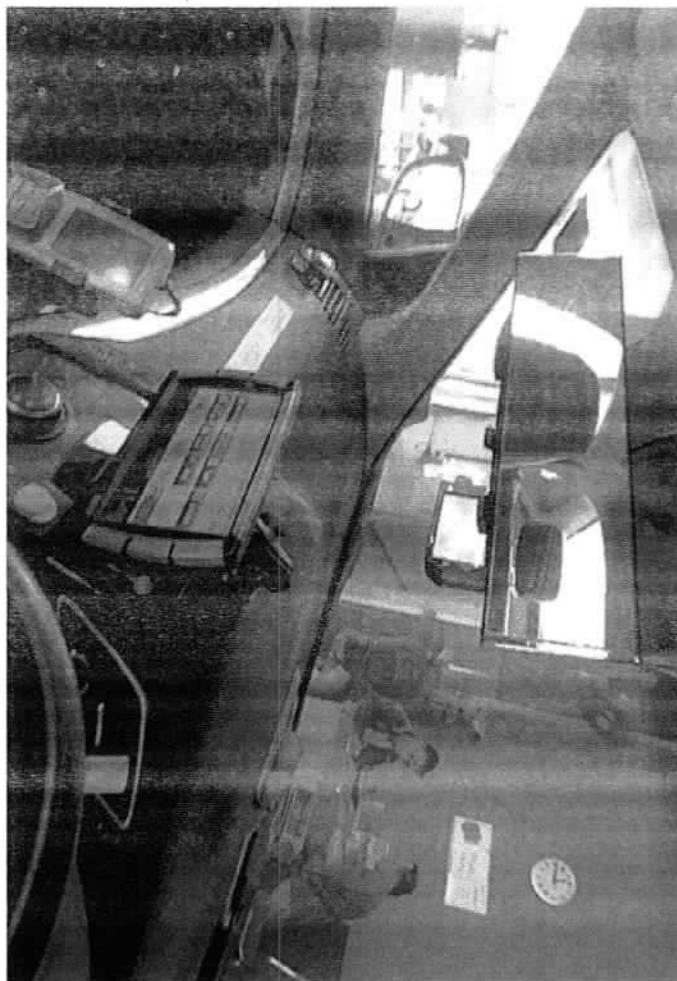
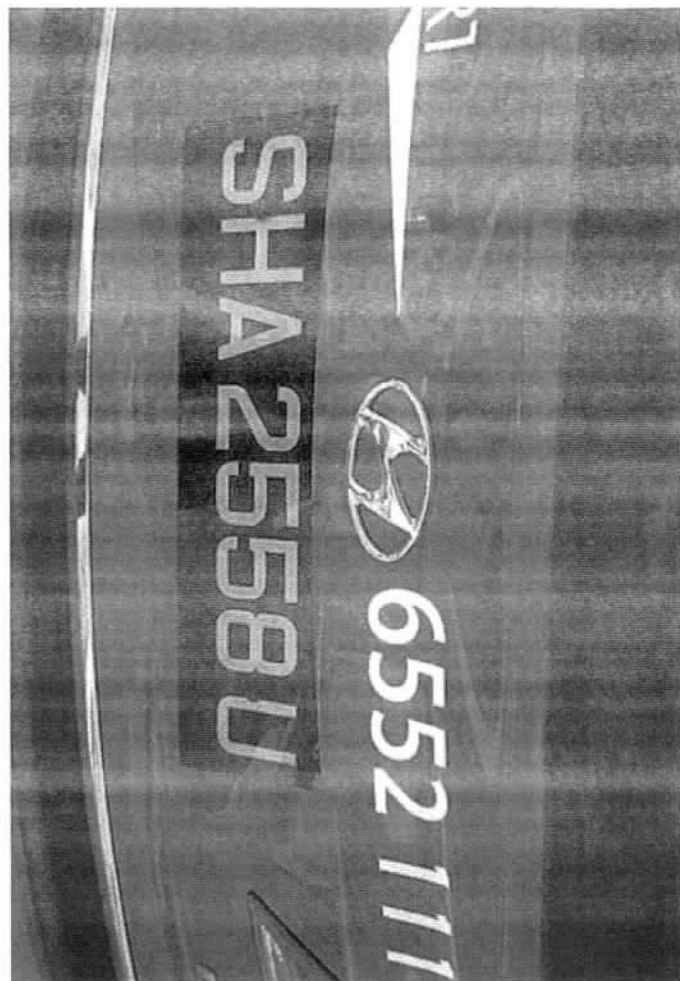
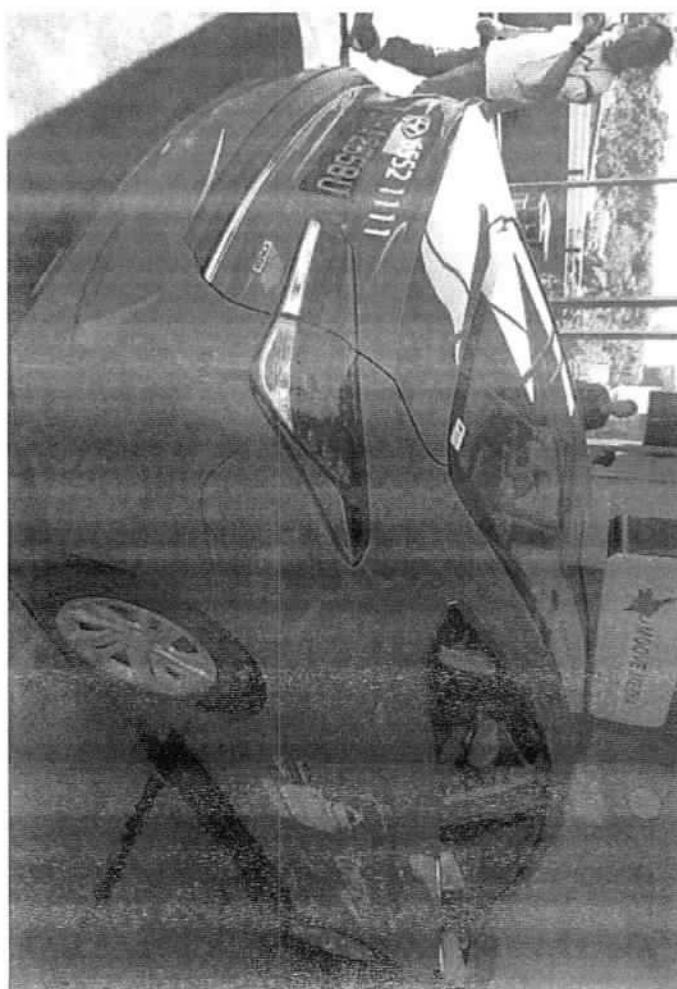
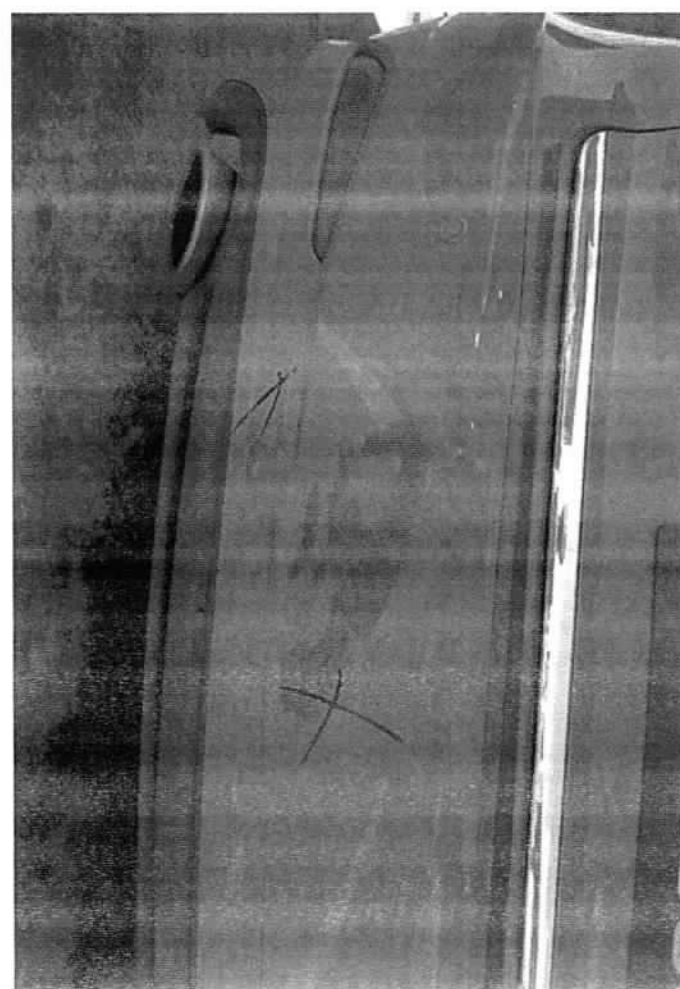
THE VEHICLE SUSTAINED DAMAGES AT THE REAR N/S PORTION.
DAMAGES SEE DETAILS.

Qty	Description of Parts	Condition	Estimate By Workshop (\$)	Our Adjusted (\$)
	<u>REPLACEMENT OF PARTS</u>			
1	REAR BUMPER	DEFORMED	553.00	553.00
10	REAR BUMPER CLIP	NECESSARY	22.00	22.00
1	REAR BUMPER UNDER COVER	CUT	225.00	225.00
	LESS 20% DISCOUNT		-160.00	-160.00
			640.00	640.00
	<u>SPECIAL NETT ITEMS</u>			
1	REAR BUMPER RUBBER MAT (SN)	NECESSARY	50.00	50.00
			50.00	50.00
	<u>LABOUR</u>			
	PANEL BEATING.		400.00	200.00
	SPRAY PAINTING CHARGE.		300.00	200.00
	WIRING CHARGE.	NOT NECESSARY	30.00	-
	REMOVE / REFIX REVERSE SENSOR.		80.00	30.00
			810.00	430.00
	GRAND TOTAL		1,500.00	1,120.00
	RECOMMENDED COST OF LUMP SUM REPAIRS (TO ITS PRE-ACCIDENT CONDITION) (CONFIRMED)			900.00
