VEHICLE NO : SHA 7852L

NTUC INCOME INSURANCE CO-OPERATIVE LTD Ref: NS/INC19002820/K1qd3e2			
73 BRAS BASAH ROAD #05-01 NTUC TRADE UNION HOUSESINGAPORE 189556		Date: 20-02-2019	 
Code: INC4			
<b>1. Policy Particulars :- THIRD PARTY CLAIM</b>			
Insured Veh.	SJM 3601J	Veh. Inspected	SHA 7852L
Policy No.	5036015778-09	Coverage (\$)	0.00
Claim No.	MT/1030640-002	Excess (\$)	0.00
Assign From		Assign Date	13/02/2019
<b>2. Vehicle Particulars &amp; Condition</b>			
Make & Model	HYUNDAI I40	c.c	1685
Engine No.	HIDDEN	Year of Reg.	2015
Chassis No.	KMHLB41UMGU075105	Colour	BLUE
Odometer	588064	Steering	IN ORDER
Brakes	IN ORDER	Modification	STANDARD ALLOY RIM
General	FAIR		
<b>3. Conditions of Tyres</b>			
	Size	Make	Balance
R/H Front Tyre	205/60 R16	WEST LAKE	7 mm
L/H Front Tyre	205/60 R16	WEST LAKE	7 mm
R/H Rear Tyre	205/60 R16	WEST LAKE	7 mm
L/H Rear Tyre	205/60 R16	WEST LAKE	7 mm
<b>4. Description of Damages</b>			
THE VEHICLE SUSTAINED DAMAGES AT THE FRONT N/S PORTION. DAMAGES SEE DETAILS.

**ADJUSTMENT ON REPAIR COST FOR VEHICLE NO. SHA 7852L**

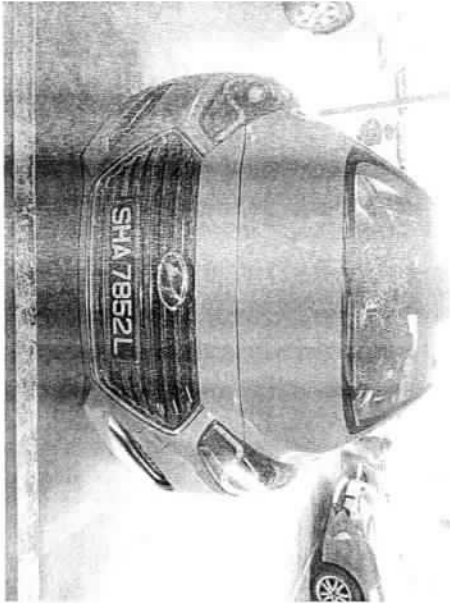
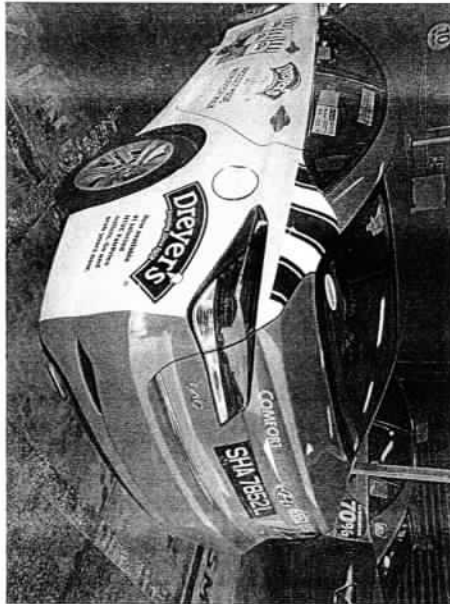
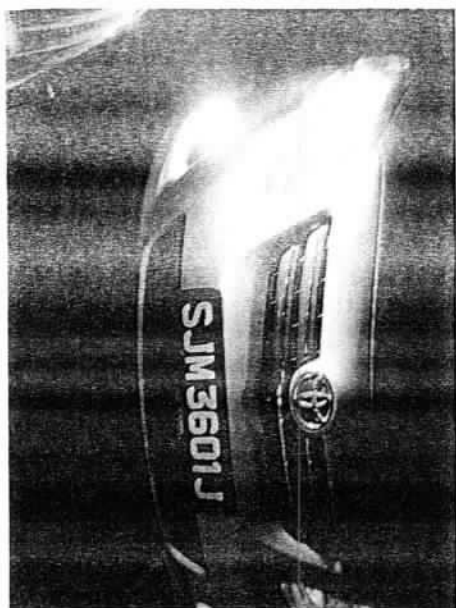
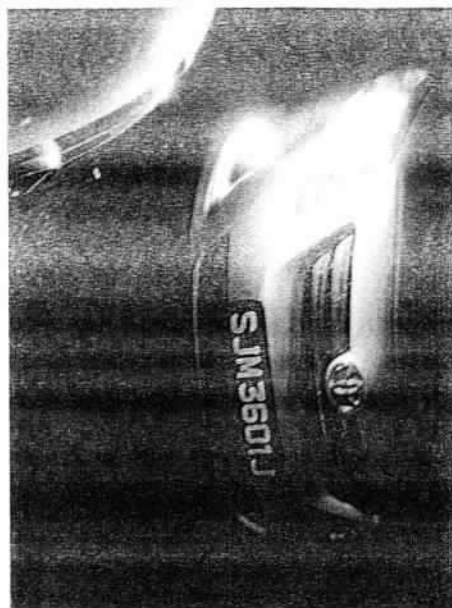
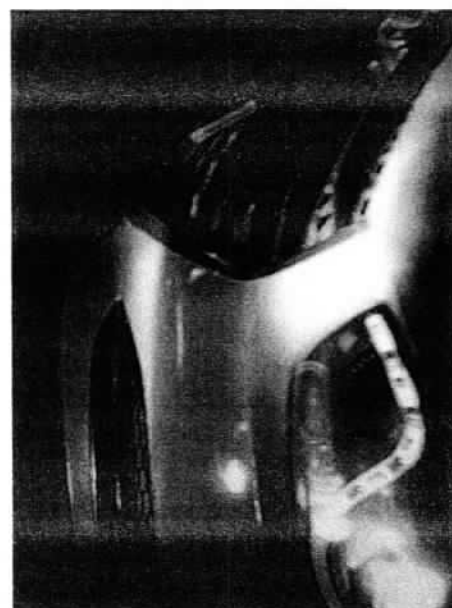
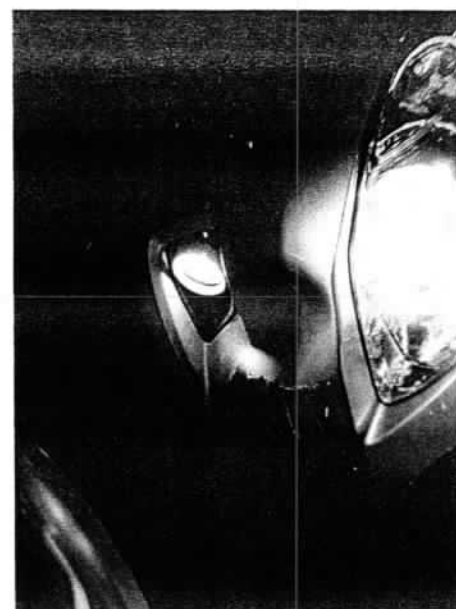
Qty	Description of Parts	Condition	Estimate By Workshop (\$)	Our Adjusted (\$)
<b><u>REPLACEMENT OF PARTS</u></b>				
1	RADIATOR GRILLE	CRACKED	1,110.10	1,110.10
1	RADIATOR GRILLE H EMBLEM	NECESSARY	39.50	39.50
1	FRONT BUMPER COVER	DEFORMED	1,052.20	1,052.20
1	FRONT BUMPER SPONGE	SERVICEABLE	99.20	-
1	FRONT BUMPER REINFORCEMENT	SERVICEABLE	402.10	-
1	FRONT BUMPER BRACKET (LH)	SERVICEABLE	24.60	-
	LESS 20% DISCOUNT		-545.54	-440.36
			2,182.16	1,761.44
<b><u>SPECIAL NETT ITEMS</u></b>				
1	FRONT NUMBER PLATE (SN)	CRACKED	25.00	25.00
1	FRONT NO PLATE TRIM COVER (SN)	SERVICEABLE	30.00	-
			55.00	25.00
<b><u>LABOUR</u></b>				
	PANEL BEATING.		350.00	200.00
	SPRAY PAINTING CHARGE.		250.00	200.00
			600.00	400.00
<b>GRAND TOTAL</b>			<b>2,837.16</b>	<b>2,186.44</b>
<b>RECOMMENDED COST OF LUMP SUM REPAIRS (TO ITS PRE-ACCIDENT CONDITION) (CONFIRMED)</b>				<b>1,750.00</b>
