Veh No: SGC 2075 Y Yr Regn: 2206, Jan.Type: M. Car / M. Cycle / Bus / Van / Lorry / Taxi / Prime Mover /

Make: Toyota Altis c.c. 1598Colour: B. Grey A/C: Insured / Std / Nil / NASp. Reading: 71190 T/Radio: Insured / Std / Nil / NA

The U/C / Chassis frame / Body Structure affected due to collision.

VEHICLE DAMAGE INSPECTION REPORT

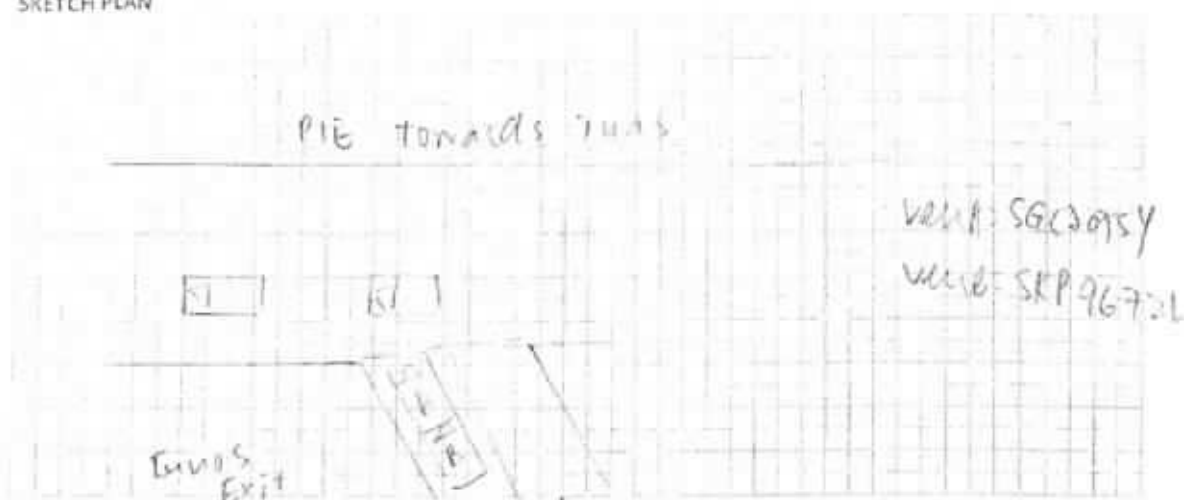
Sketch Plan #2 Pg. 1

I was stationary along lane 2 of PIE towards Thas Ennos Exit on 05.02.2019 @ 11:55hrs. I was waiting the vehicles to clear along the main road. Suddenly, I heard a bang sound and felt an impact from my rear - Vehicle B was collided onto rear portion of my vehicle.
