VEHICLE DAMAGE INSPECTION REPORT

Our File No: CS3/MSG19002903/BCD3S2

Claimant Vehicle No : GBH5825M

Make & Model: NISSAN NV200, 1.5 (M)

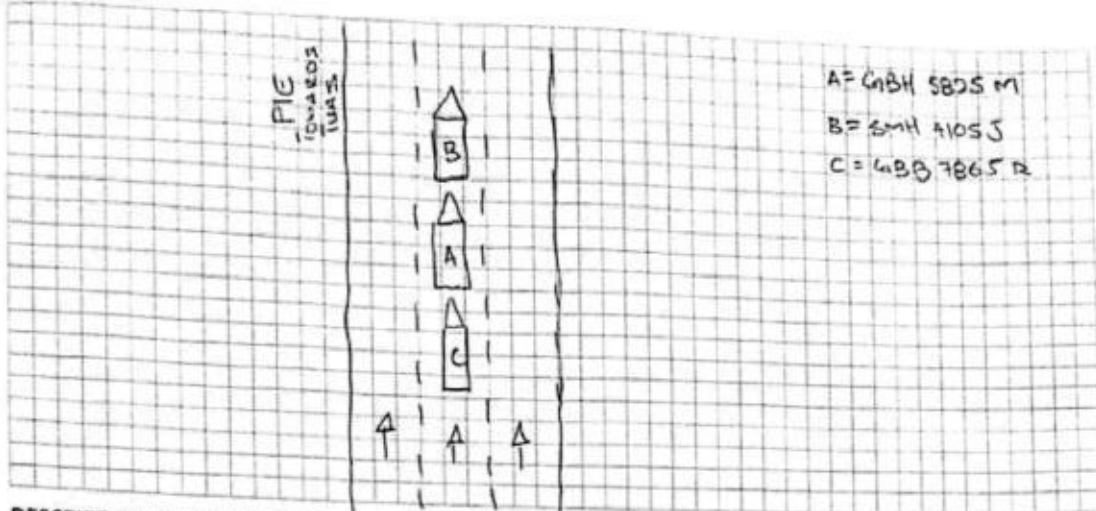
SKETCH PLAN

On 13/02/2019, at about 1422hrs, I was driving my vehicle, GBH 5825M, on PIE towards Tuas, when vehicle B, brake, I slowed down my vehicle. Suddenly, vehicle C, GBB 7865 R, hit the rear of my vehicle thus moving my vehicle forward to hit vehicle B.
