VEHICLE DAMAGE INSPECTION REPORT

Our File No: CS/SMO19003373/UTD3N2

Handling Insurer:	Sompo Insurance Singapore Pte. Ltd.	Policy No:	D18MTPCVE001770
Claimant Vehicle No :	PC814M	Insured Vehicle No :	GU5113G
Date of Loss:	18/02/2019	Nature of Claim:	TP
		Claim No:	CMTD1900972

Reg No:	PC814M	Engine No:	1KD2096537
Make & Model:	TOYOTA HIACE, 3.0 D High-roof 14 Seater (A)	Chassis No:	JTFST22P000010721
Reg. Date:	08/07/2011 (Man. Year: 2011)	Odometer:	614272 km
Colour:	White		
Engine Capacity:	2982 cc		
Market Value/New Car Price:	N/A		
Sum Insured (S\$):	Market Value/New Car Price

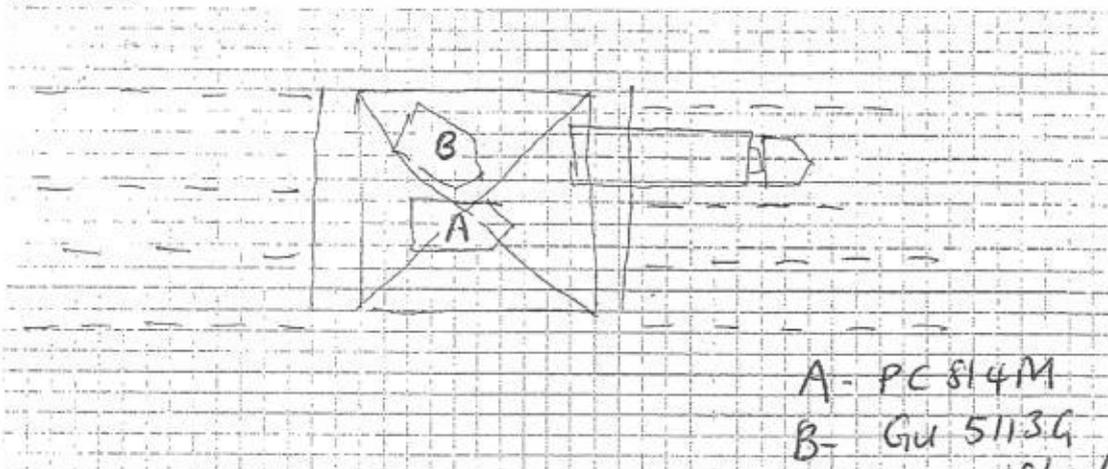
SKETCH PLAN

A - PC 814M
 B - GU 5113G
 DOA - 18/2/19

AROUND 10.12AM I WAS TRAVELLING ALONG YISHUN AVE 1, ALMOST NEAR TRAFFIC LIGHT JUNCTION. I WAS AT 2ND LANE THE MINI VAN WAS TRAVELLING AT 3rd LANE, ONCE THE TRAFFIC LIGHT CHANGE TO GREEN ALL MOVE AS PER NORMAL. ON THAT TIME THERE IS A TRAILER IN FRONT OF THE MINI VAN. SO ~~THE~~ THE DRIVER HAS NO PATIENCE HE DECIDE TO CHANGE TO 2nd LANE WITHOUT SIGNALING AND JUST CHANGE. HE CLAIM THAT HE CAN'T SEE MY VEHICLE.
