To Inspect Vehicle No:

SFV1541L

**- PRE-REPAIR INSPECTION - ACCIDENT INVOLVING OUR INSURED VEHICLE SLG472S AND SFV1541L ON 21/02/2019...**

## VEHICLE DAMAGE INSPECTION REPORT

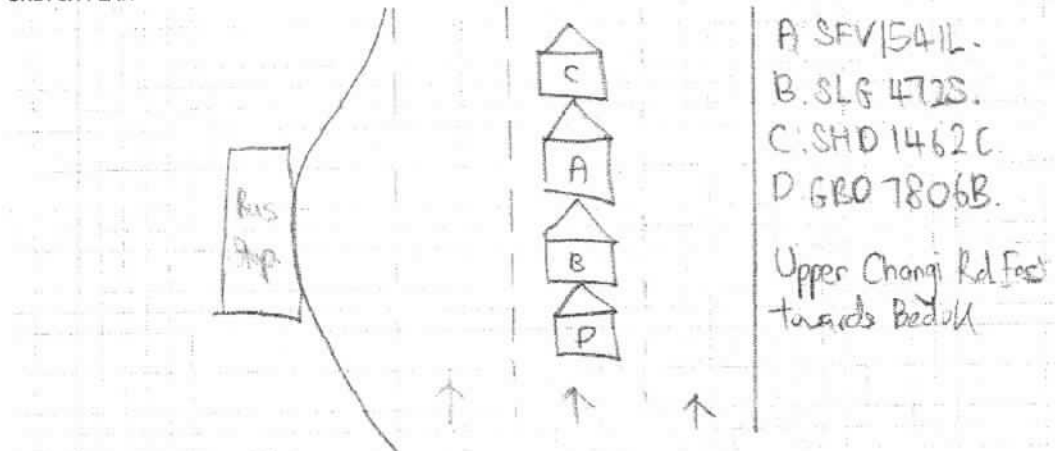
SKETCH PLAN

DESCRIBE CIRCUMSTANCES OF THE ACCIDENT

I was driving along Upper Changi Rd East and the traffic was very ~~congested~~ <sup>slow</sup> and traffic was moving along slowly. All of a sudden, I felt a massive impact from the rear of my Vehicle A. I was shocked by the impact. After I took a while to compose myself, I exited my Vehicle A and noticed Vehicle B had collided with the rear of my Vehicle. It was a chain collision. We exchanged particulars and left the scene.
