REF: NS/INC/19003533/KLSd3s2

1. Policy Particulars :- THIRD PARTY CLAIM

4. Description of Damages

ADJUSTMENT ON REPAIR COST FOR VEHICLE NO. SHD 6745D

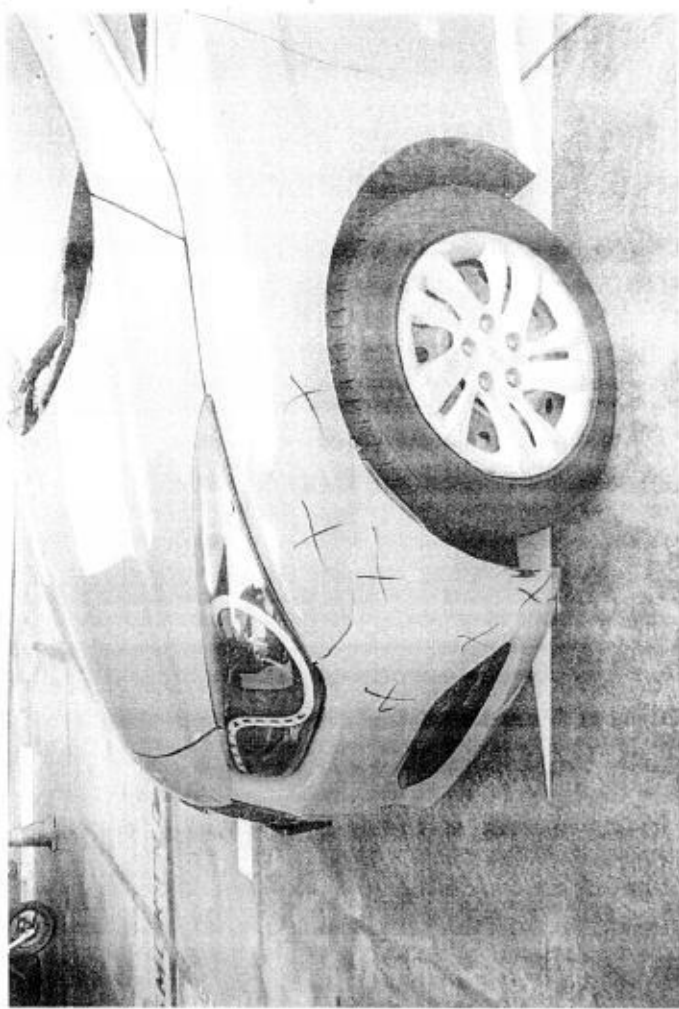
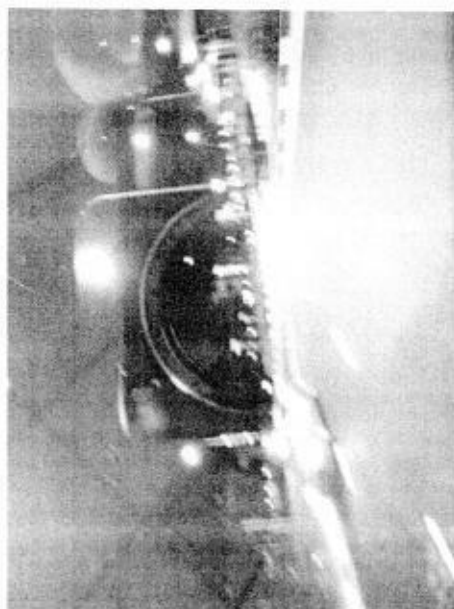
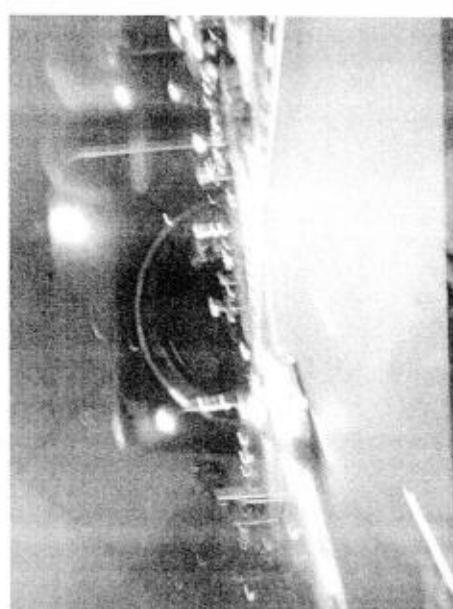
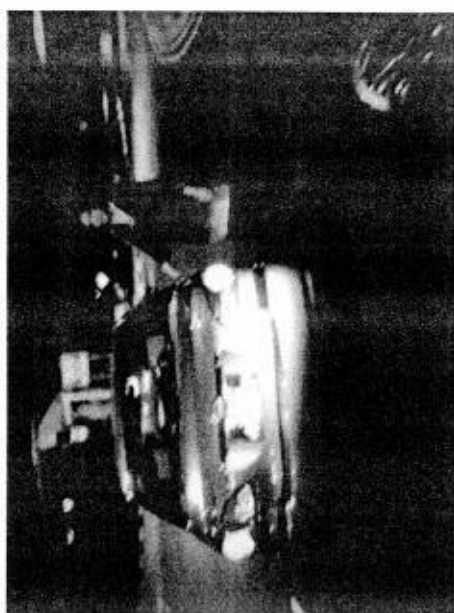
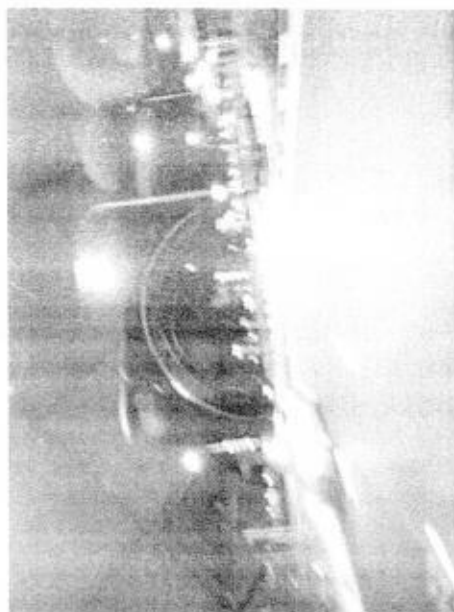
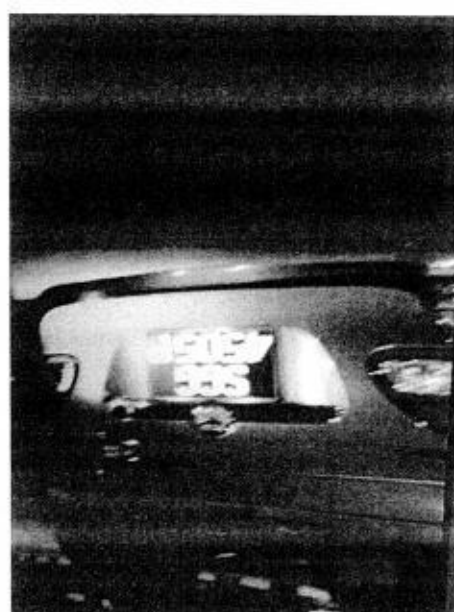
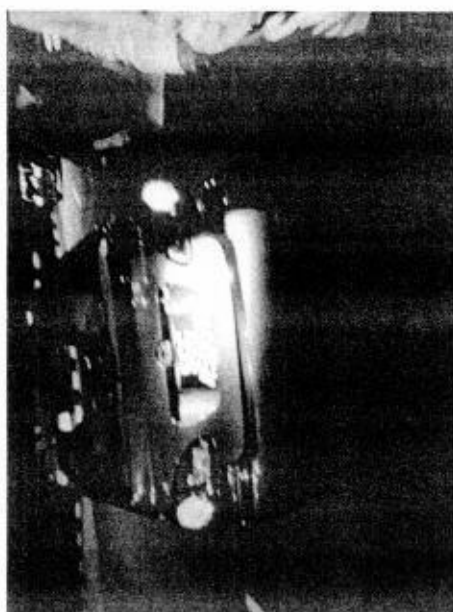
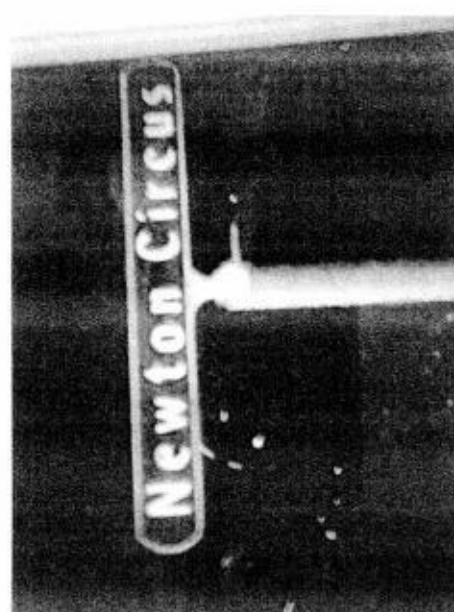
N/S Front.

The U/C / Chassis frame / Body Structure affected due to collision.

THE VEHICLE SUSTAINED DAMAGES AT THE N/S FRONT PORTION. DAMAGES SEE DETAILS.

Qty	Description of Parts	Condition	Estimate By Workshop (\$)	Our Adjusted (\$)
<u>REPLACEMENT OF PARTS</u>				
1	FRONT BUMPER COVER	CRACKED	1,052.20	1,052.20
1	FRONT BUMPER BRACKET TOP (LH)	SERVICEABLE	22.40	-
1	FRONT BUMPER BRACKET (LH)	SERVICEABLE	24.60	-
1	HEADLAMP (LH)	SERVICEABLE	1,388.00	-
1	FRONT FENDER (LH)	DENTED	566.30	566.30
1	FRONT FENDER SHIELD (LH)	SERVICEABLE	174.90	-
1	FRONT WHEEL HUB CAP (LH)	SERVICEABLE	107.10	-
	LESS 20% DISCOUNT		-667.10	-323.70
			2,668.40	1,294.80
<u>SPECIAL NETT ITEMS</u>				
1	FRONT FENDER ADVERTISEMENT LOGO (LH) (SN)	NECESSARY	100.00	100.00
1	FRONT TYRE (LH) (SN)	SERVICEABLE	216.00	-

316.00	100.00
<u>LABOUR</u>				
	PANEL BEATING.		500.00	300.00
	SPRAY PAINTING CHARGE.		500.00	400.00
	WIRING CHARGE.	NOT NECESSARY	50.00	-
	TUFF KOTE.		50.00	20.00
	FRT WHEEL ALIGNMENT.	NOT NECESSARY	120.00	-
			1,220.00	720.00
GRAND TOTAL			4,204.40	2,114.80
RECOMMENDED COST OF LUMP SUM REPAIRS (TO ITS PRE-ACCIDENT CONDITION) (CONFIRMED)				1,700.00
