CS3/ALG19003601/Acd302

- PRE-REPAIR INSPECTION - ACCIDENT INVOLVING OUR INSURE...

VEHICLE DAMAGE INSPECTION REPORT

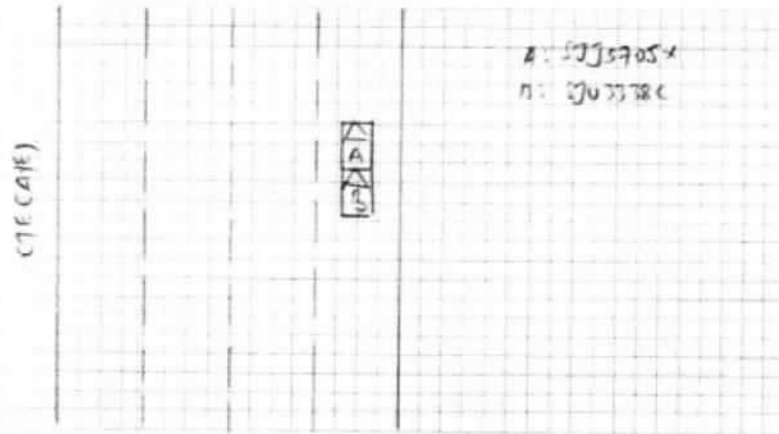
SKETCH PLAN

Type Of Accident	COLLISION - HEAD TO REAR
Weather Conditions	CLEAR
Road Surface	DRY

Refer to police report - 1/10/190225/2077.
