NS/INC19003743/Kld3 n2

Insured Veh.	GBH 8108E	Veh. Inspected	SHC 1383C
Policy No.	5104013902	Coverage (\$)	0.00
Claim No.	MT/1033751-002	Excess (\$)	0.00
Assign From		Assign Date	26/02/2019

THE VEHICLE SUSTAINED DAMAGES AT THE FRONT PORTION. DAMAGES SEE DETAILS.

ADJUSTMENT ON REPAIR COST FOR VEHICLE NO. SHC 1383C

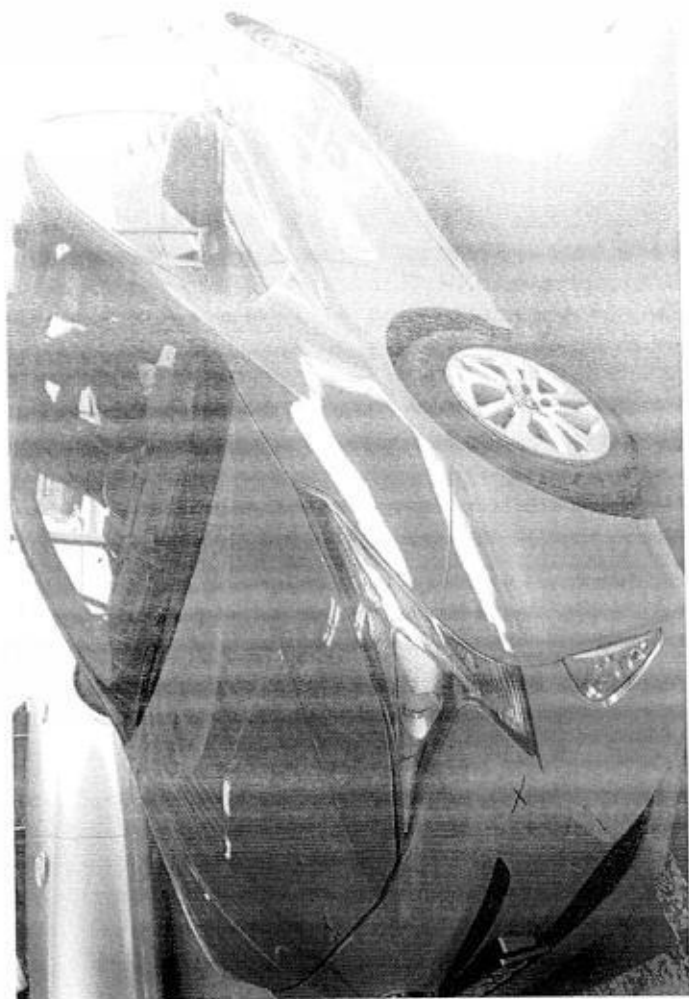
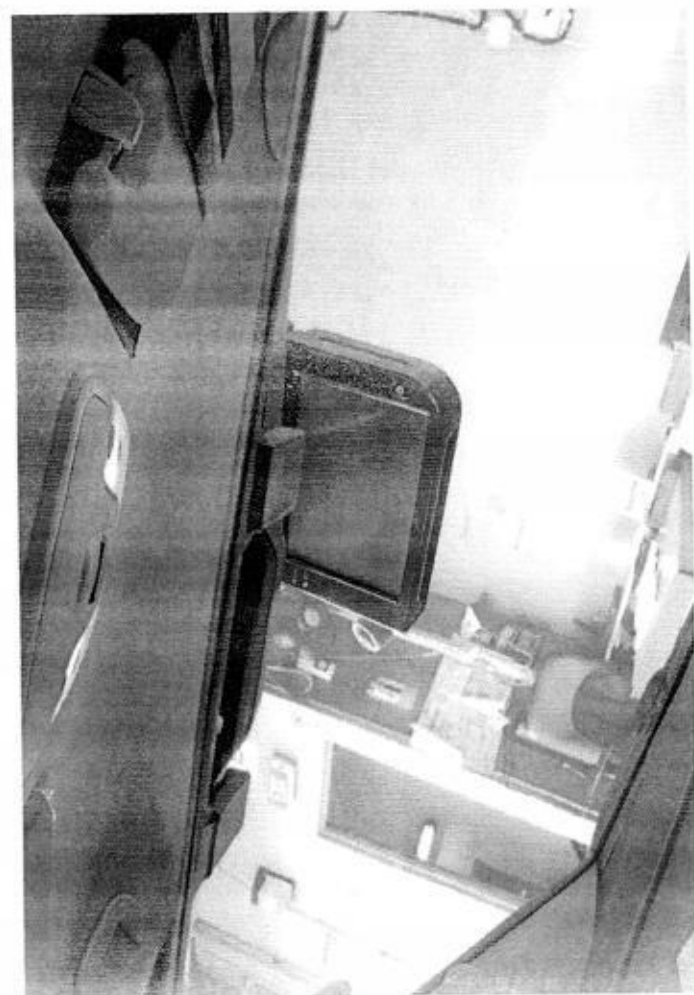
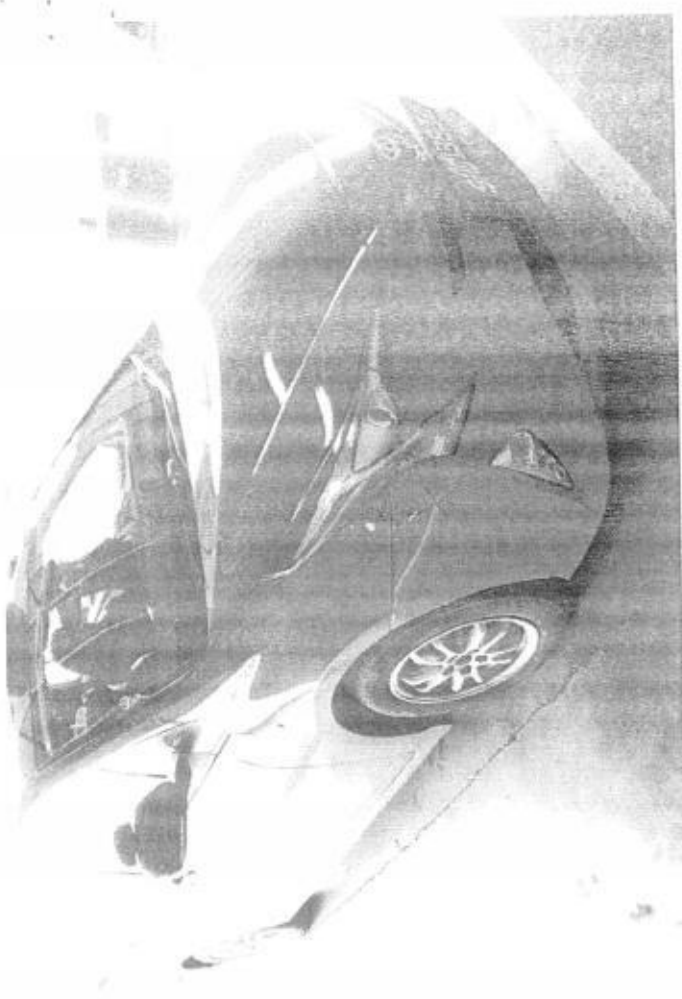
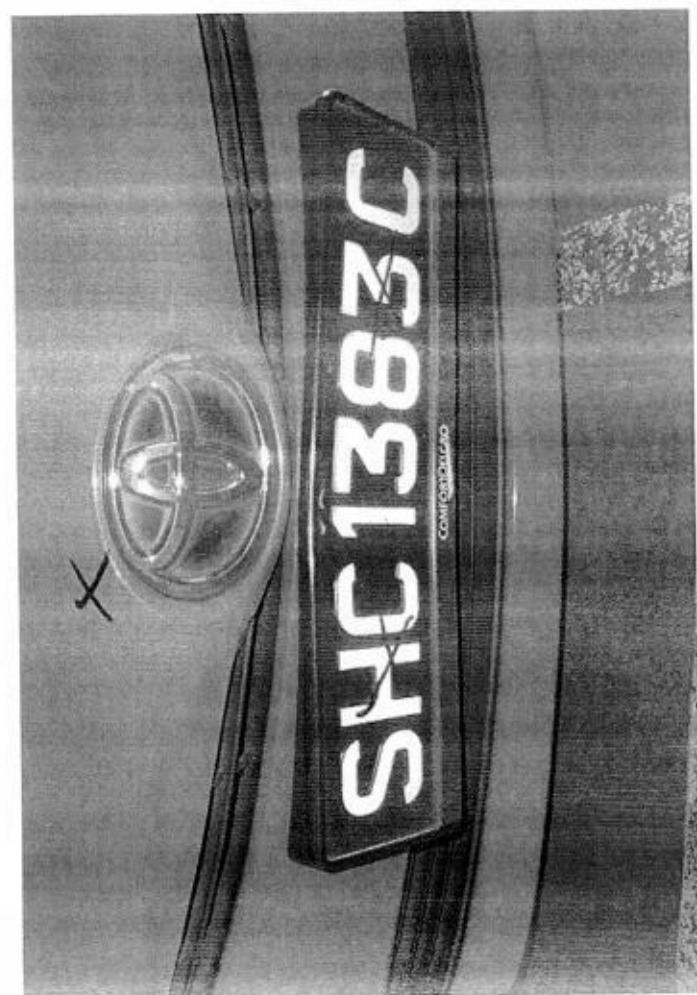
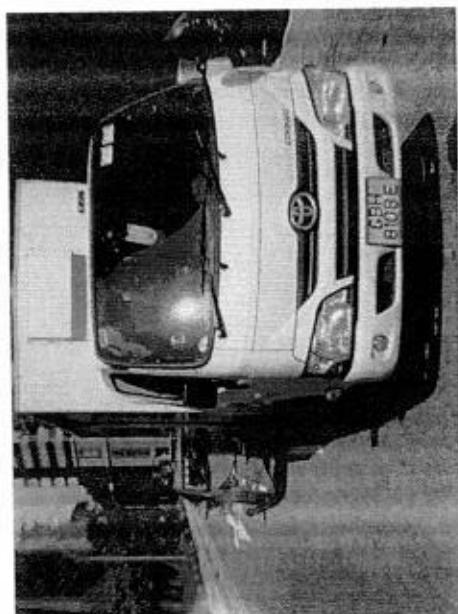
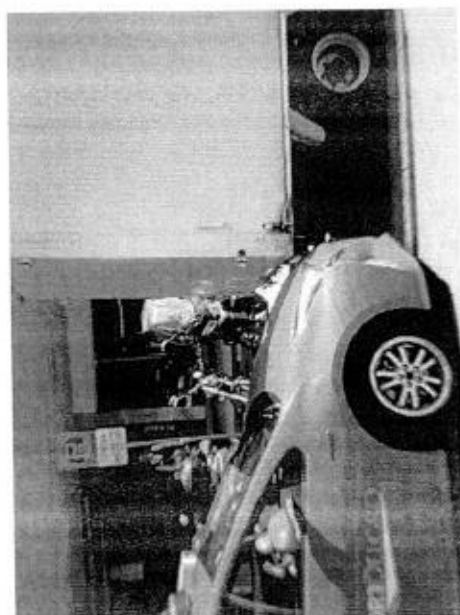
The UIC / Chassis frame / Body Structure affected due to collision.

Qty	Description of Parts	Condition	Estimate By Workshop (\$)	Our Adjusted (\$)
REPLACEMENT OF PARTS				
1	FRONT BUMPER COVER	TO REPAIR SEE LABOUR	499.90	-
10	FRONT BUMPER CLIPS	NOT NECESSARY	22.00	-
2	FRONT BUMPER SIDE RETAINER @\$77.00	SERVICEABLE	154.00	-
1	FRONT FENDER HYBRID EMBLEM,RH	NOT NECESSARY	53.50	-
1	FRONT BONNET (NPA)	TO REPAIR SEE LABOUR	-	-
	LESS 25% DISCOUNT		-182.35	-
			547.05	-
NETT ITEMS				
1	FRONT NO PLATE (N)	BENT	25.00	25.00
1	FRONT NO PLATE TRIM COVER (N)	CRACKED	30.00	30.00
	LESS 10% DISCOUNT		-	-5.50
			55.00	49.50
LABOUR				
	PANEL BEATING.INCLUSIVE OF THE REPAIR OF FRONT BUMPER COVER AND FRONT BONNET.		400.00	200.00
	SPRAY PAINTING CHARGE.		600.00	400.00
	TUFF KOTE.	NOT NECESSARY	50.00	-
			1,050.00	600.00
GRAND TOTAL			1,652.05	649.50
RECOMMENDED COST OF REPAIRS (CONFIRMED)				649.50
