To Inspect Vehicle No: SKE 470U Insured: YK 5323G

PAPER SURVEY OF SKE470U

4. Description of Damages			
THE VEHICLE SUSTAINED DAMAGES AT THE FRONT PORTION. DAMAGES SEE DETAILS.			
5. General Information			
Accident Date	15/12/2018	Inspection Date	19/12/2018
Survey held at	ENG SOON PAINTING SVC BLK 4 YEW TEE IND EST 393 - J WOODLANDS ROAD SINGAPORE 677969		
5a. Remarks			
A)THE INSPECTION WAS CONDUCTED ON A"WITHOUT PREJUDICE" BASIS. B)IN ACCORDANCE TO YOUR INSTRUCTIONS, WE HAVE NOT AUTHORISED REPAIRS.			
5b. Estimate Days of Repair			
ESTIMATED NORMAL PERIOD FOR REPAIR:		5 Working Days

ADJUSTMENT ON REPAIR COST FOR VEHICLE NO. SKE 470U

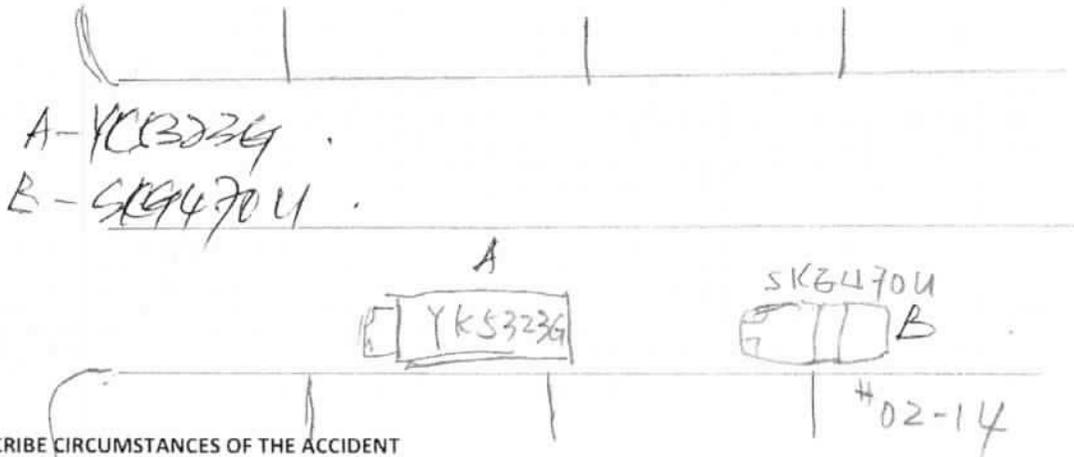
SKETCH PLAN

本人方定國於15-12-2018年早上去大士貨倉
 拿貨 #02-14, 有一輛車 SK6470U
 I Tuas View Place
 停在貨倉門口, 因 YK5323G 後退時判斷錯誤,
 車尾右邊車把碰到 SK6470U 車頭部份。
 On 5/12/18, in the morning, I was driving my vehicle
 into Tuas Warehouse to collect goods. The unit number
 is #02-14 (I Tuas View Place). There was a vehicle,
 SK6470U which was parked in front of warehouse entrance.
 Due to my judgement of YK5323G when I reversing,
 vehicle YK5323G's rear collided into vehicle
 SK6470U's front side.

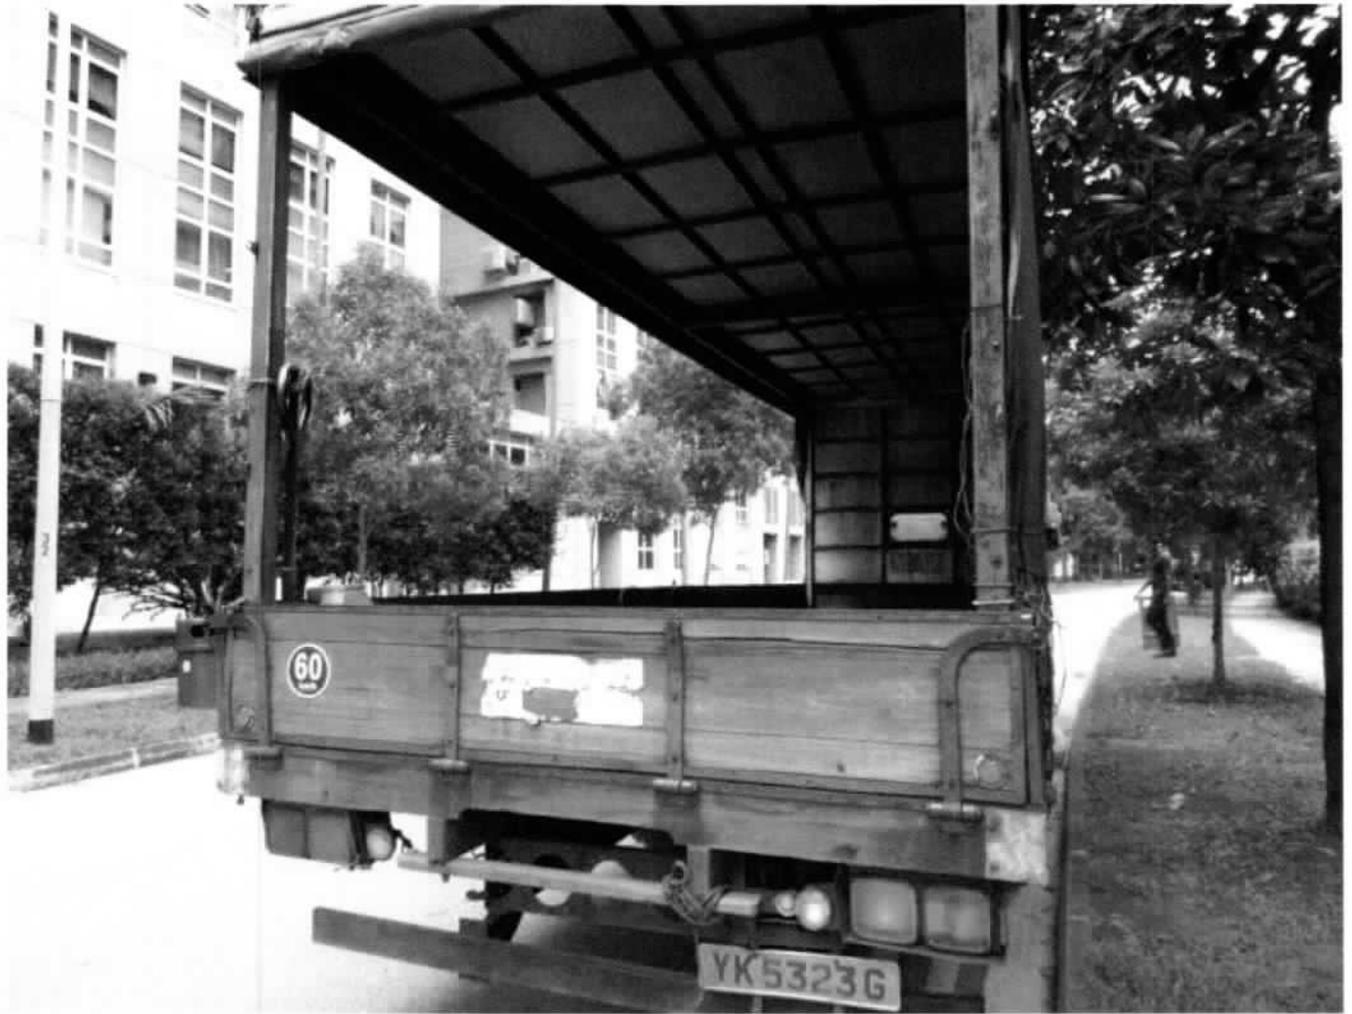
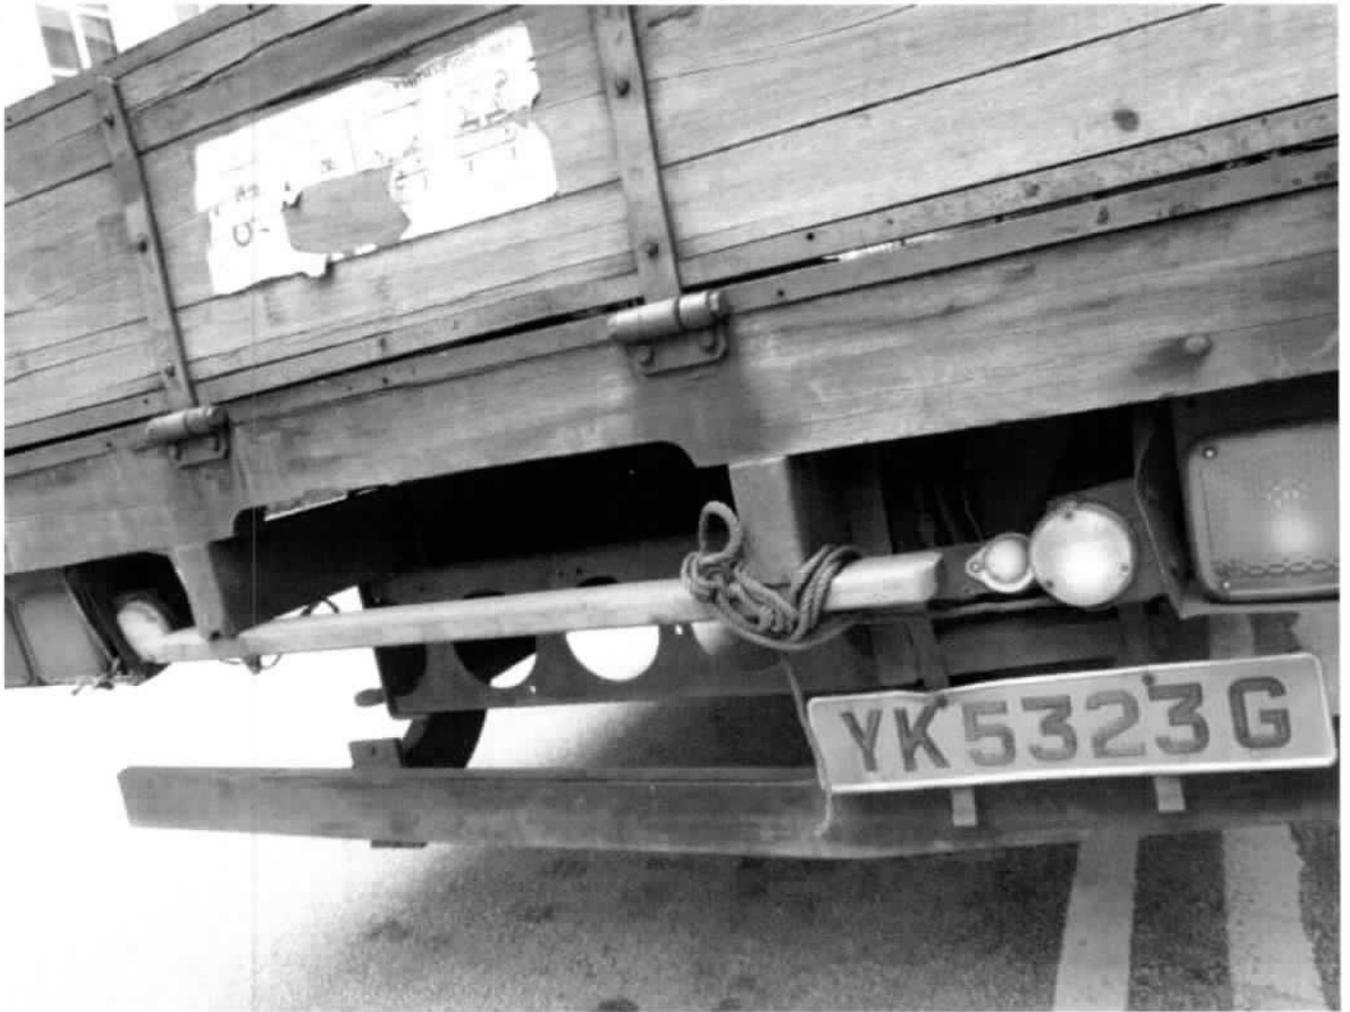
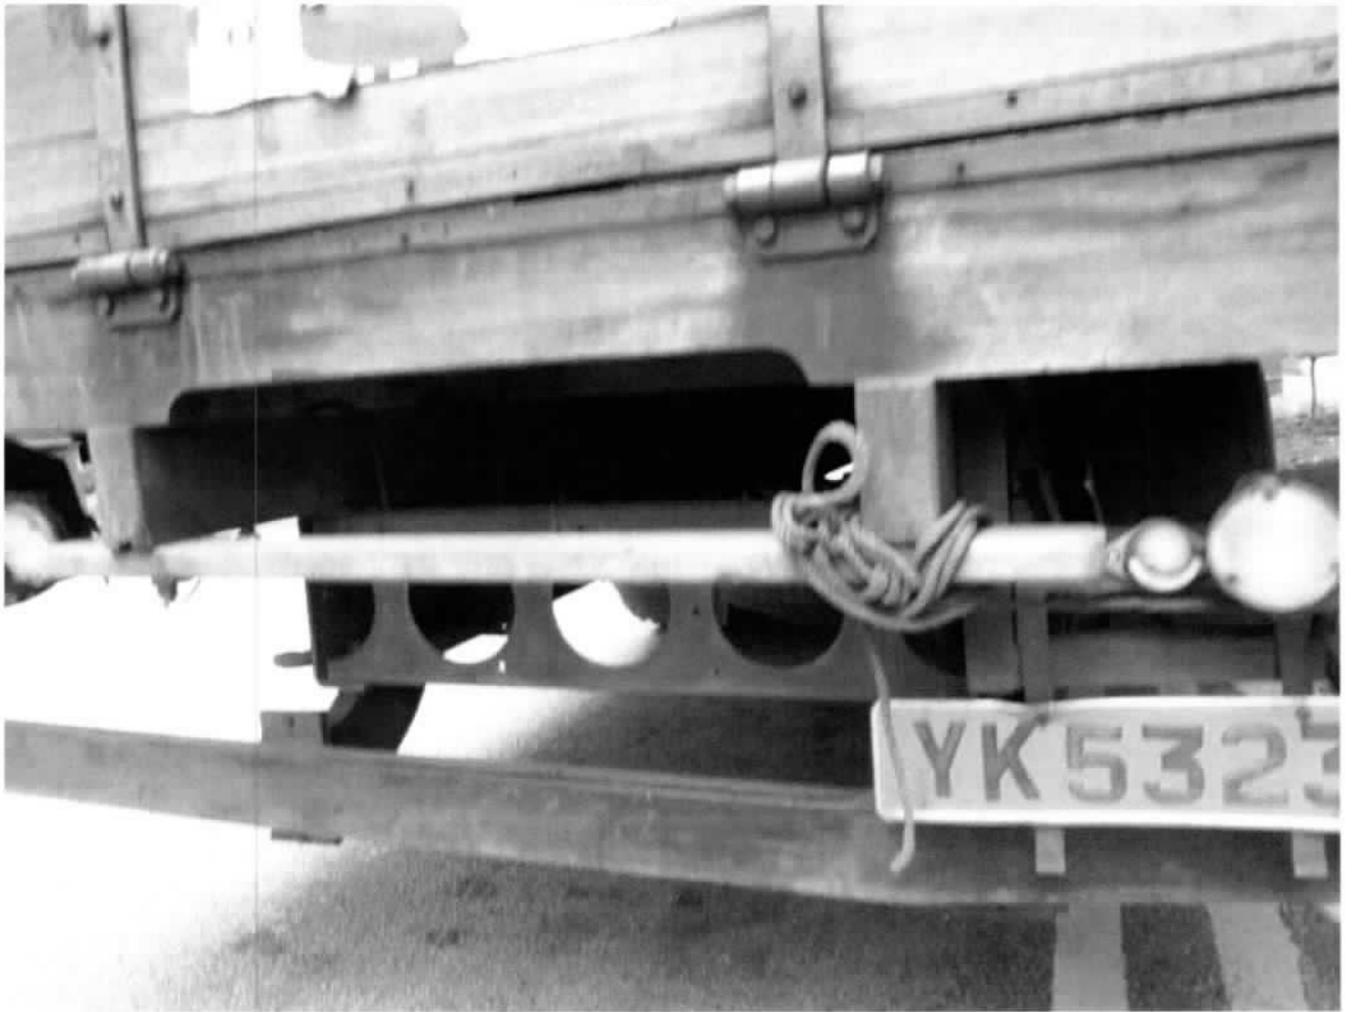
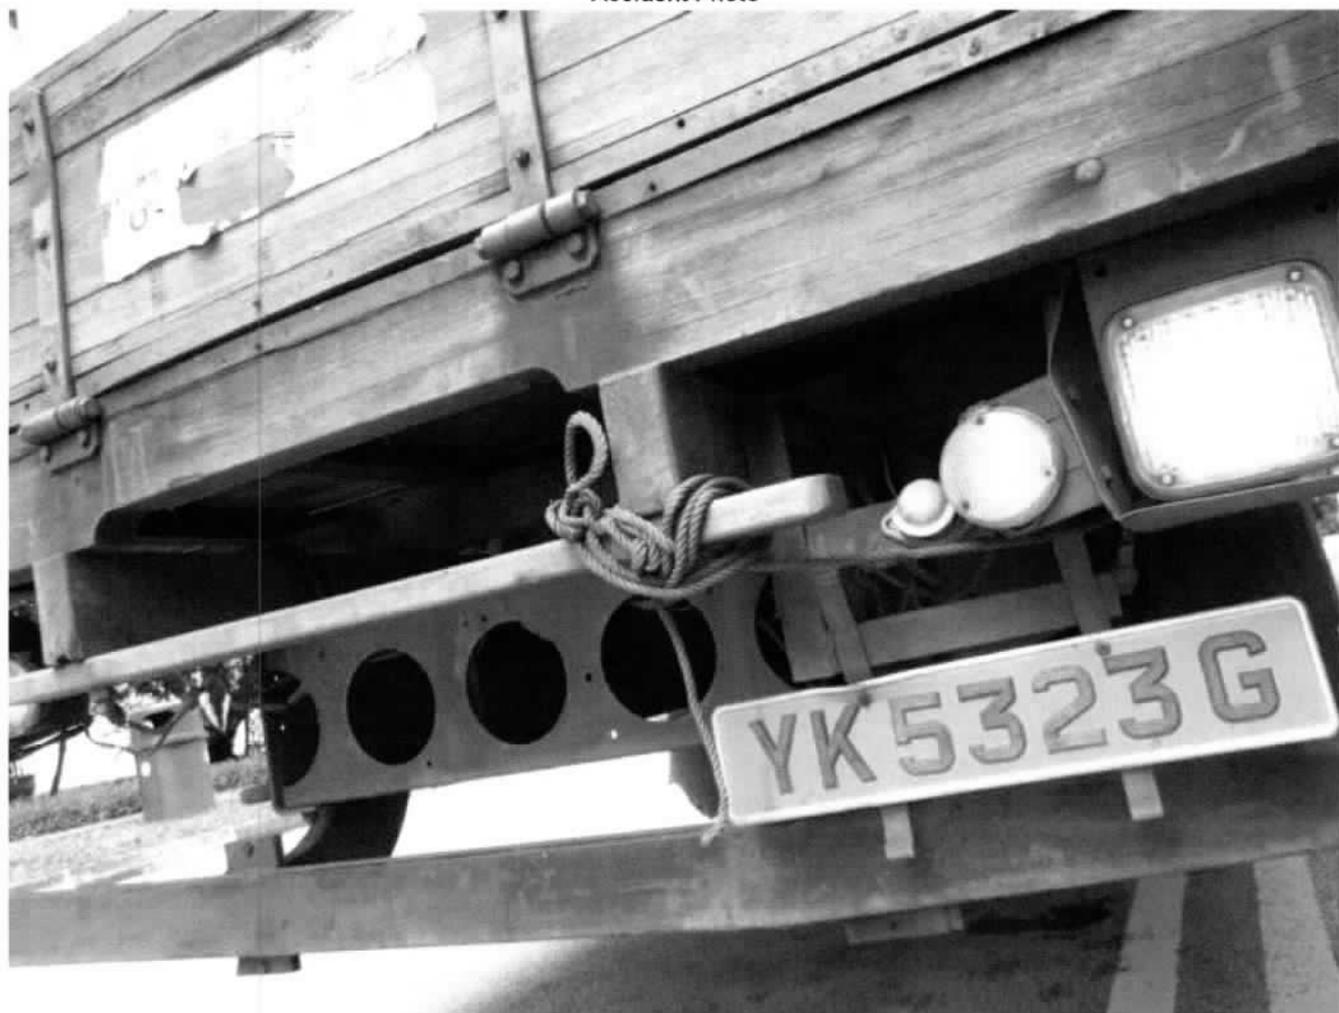
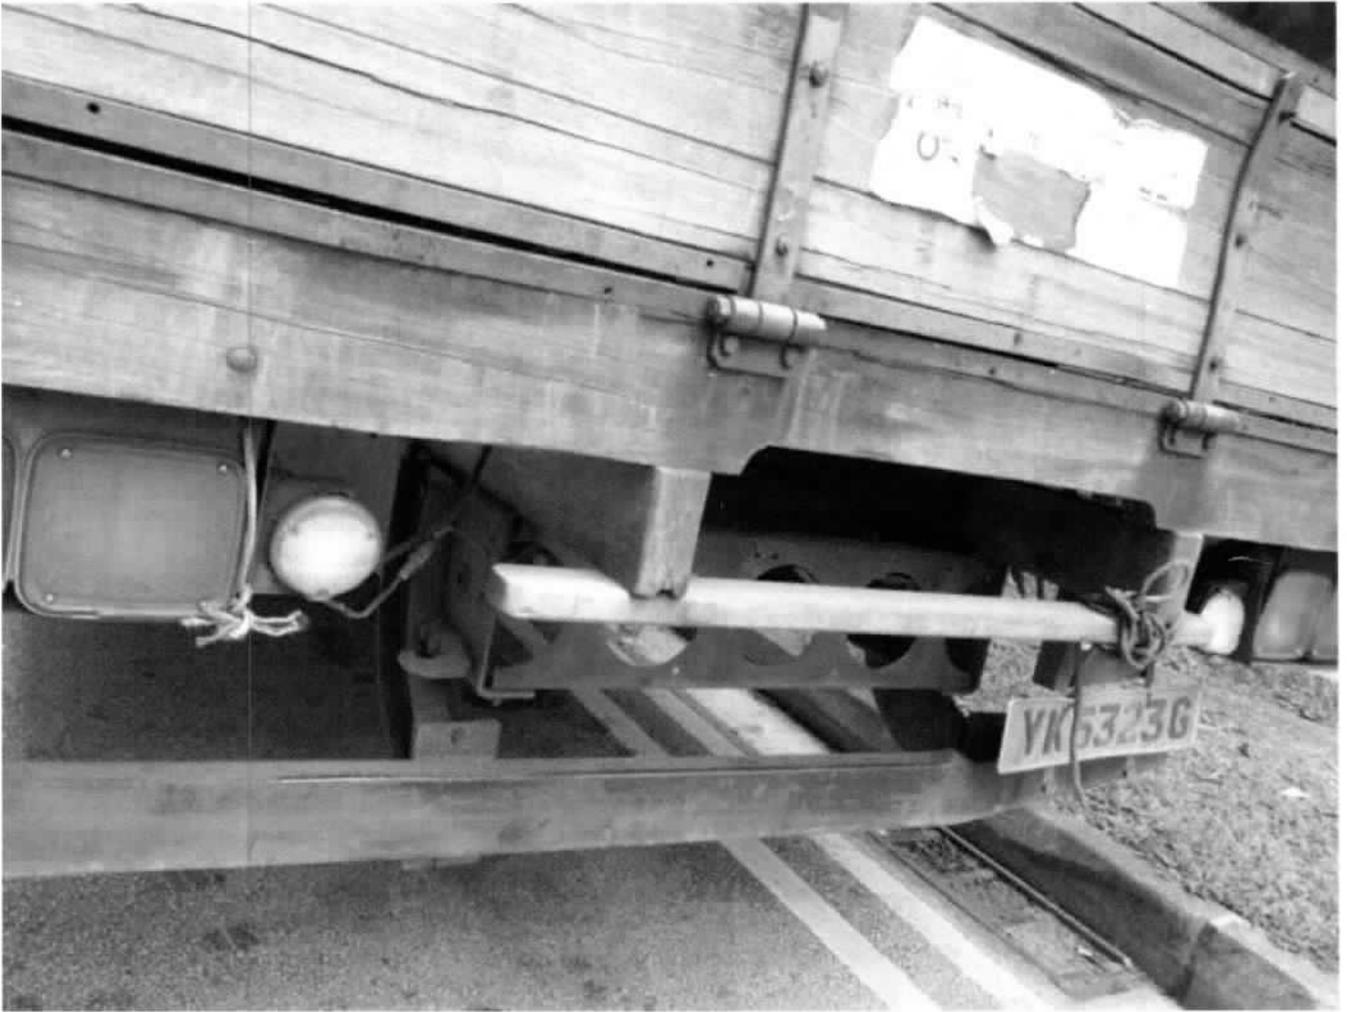
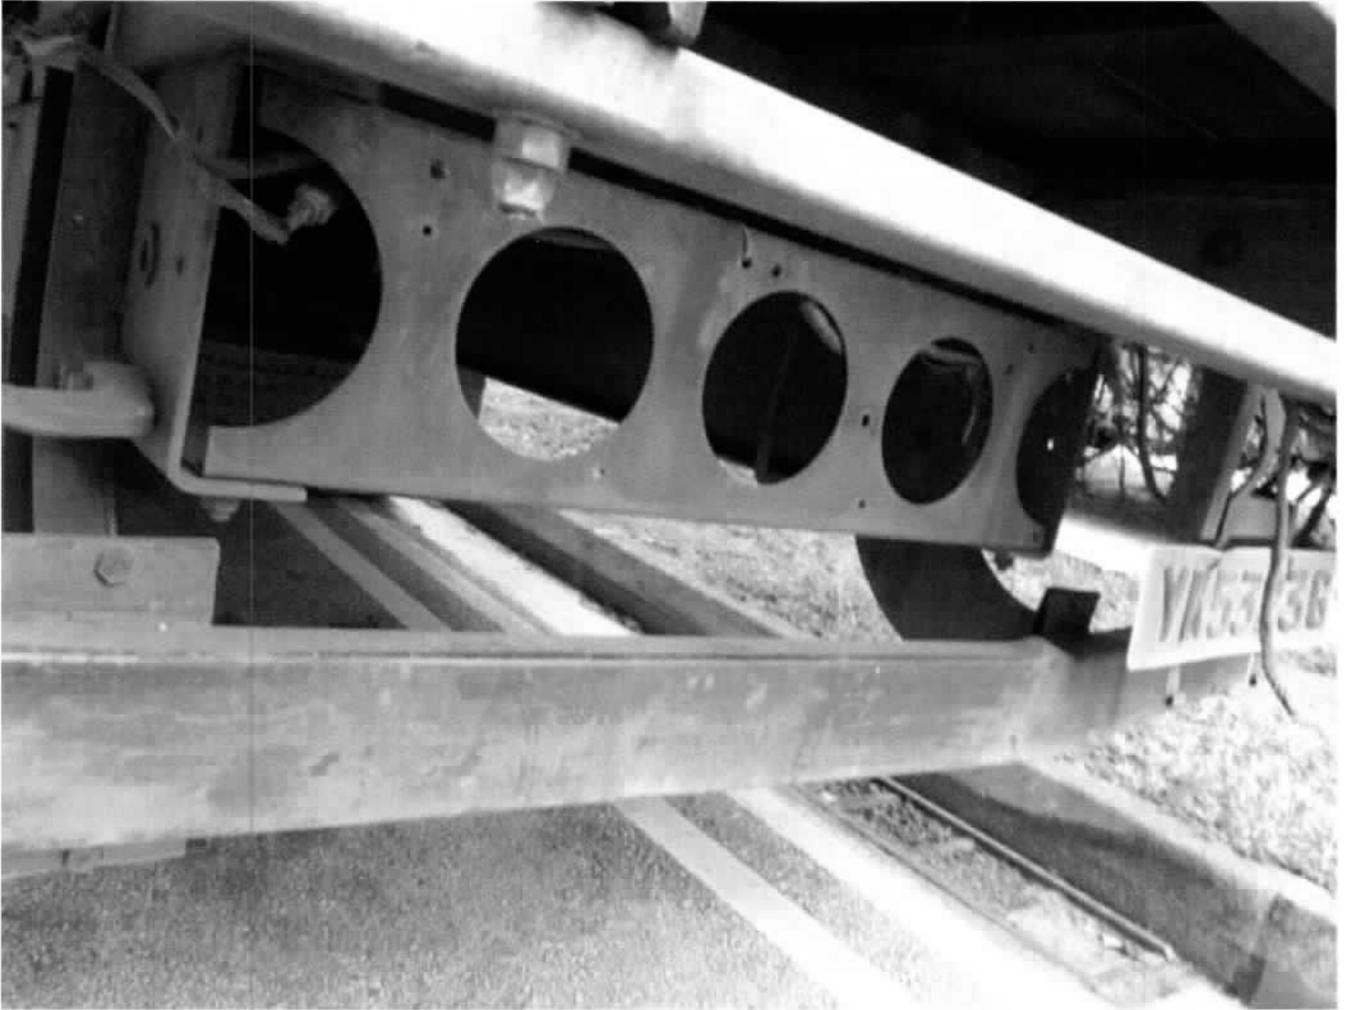
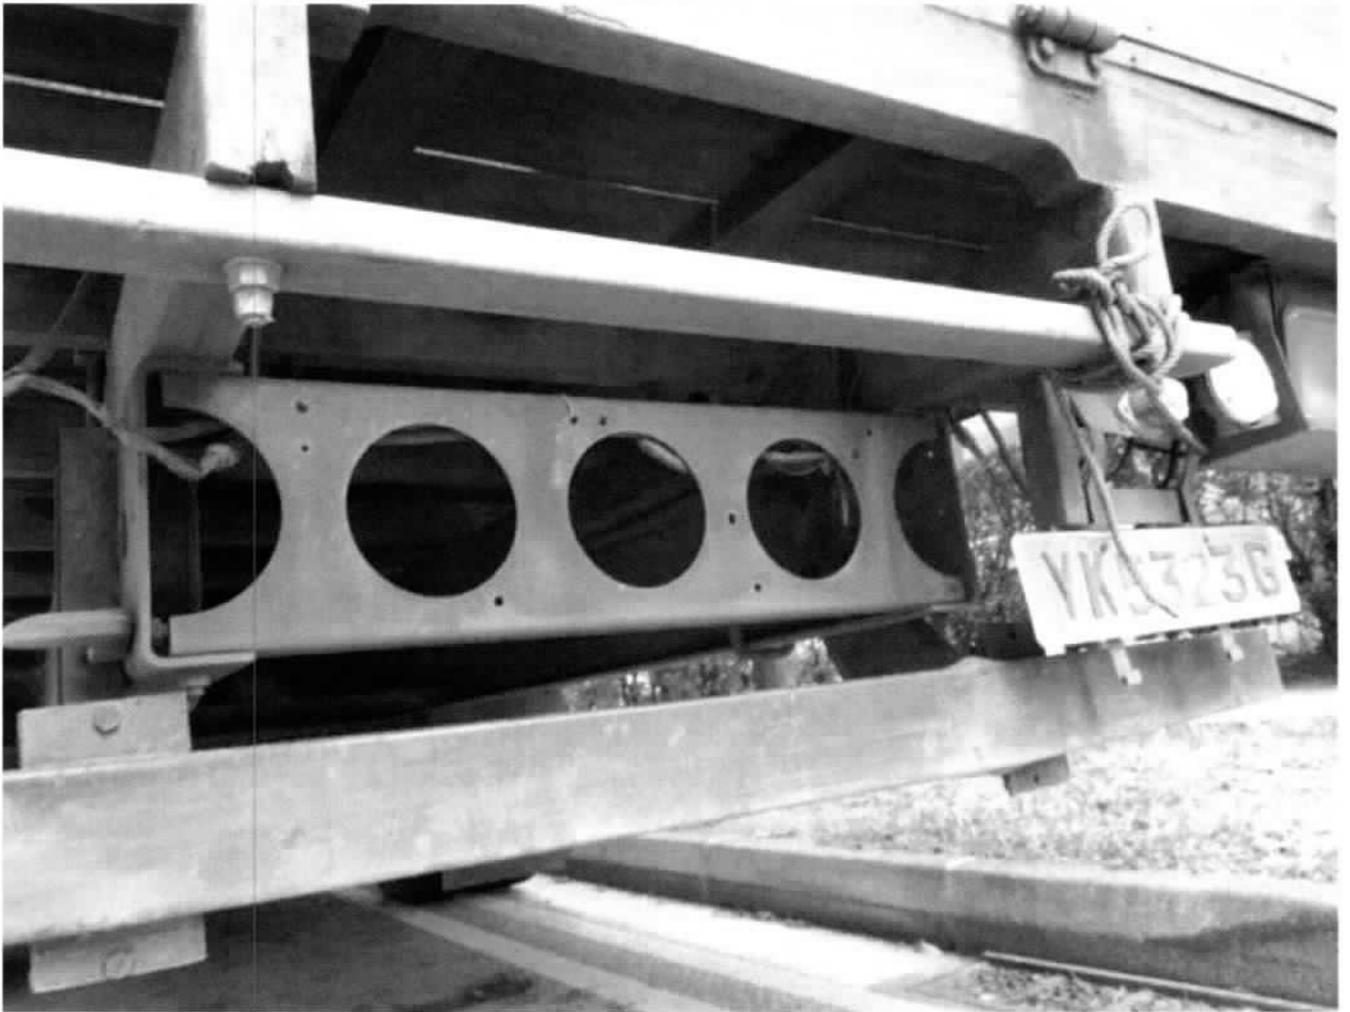
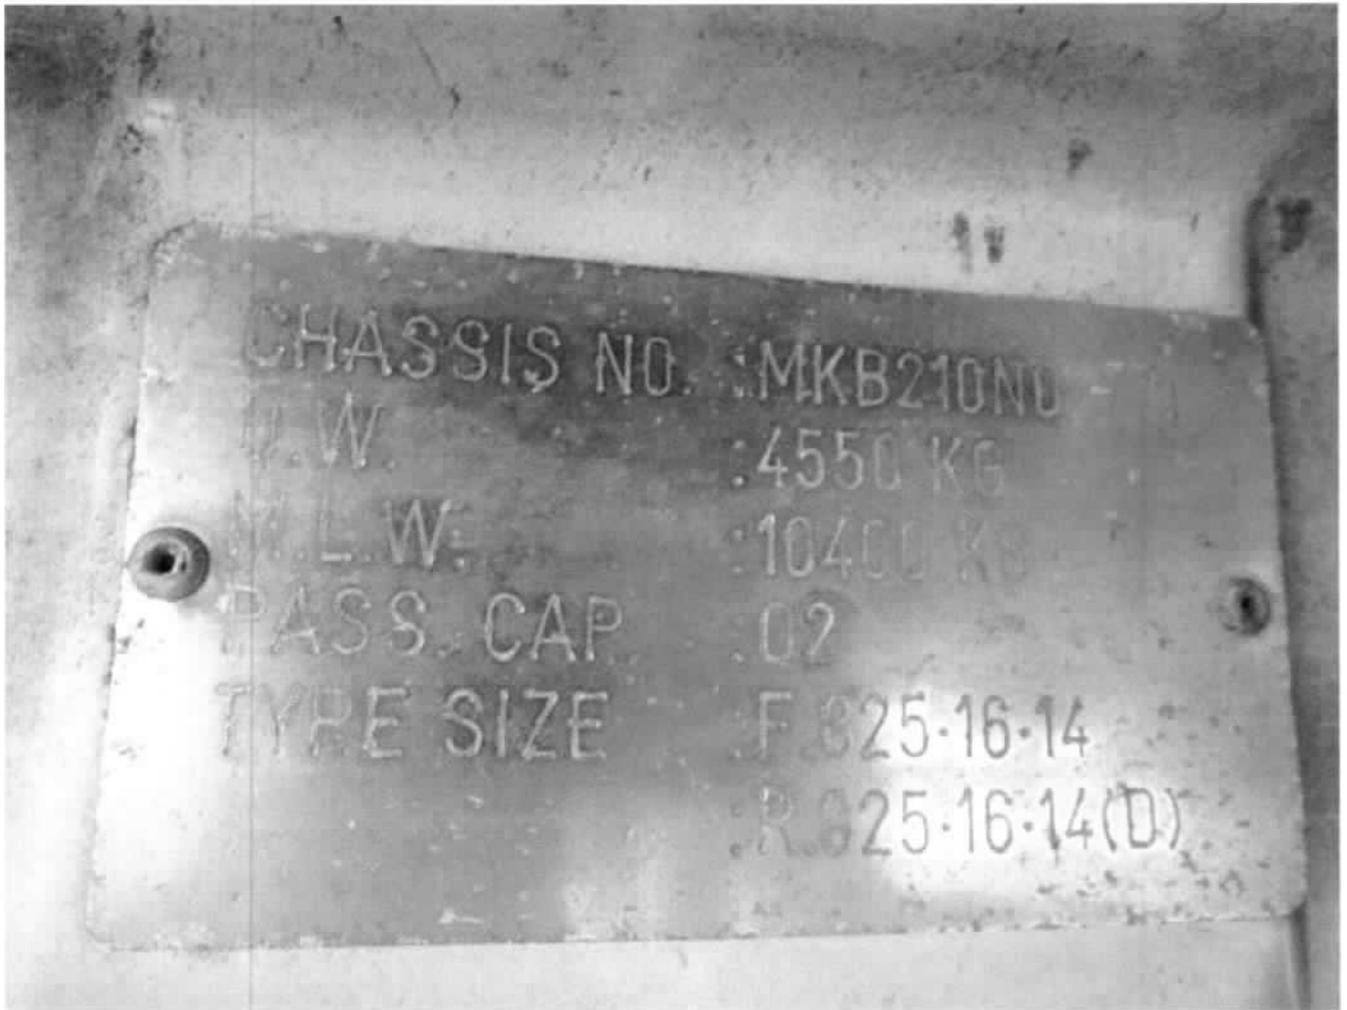
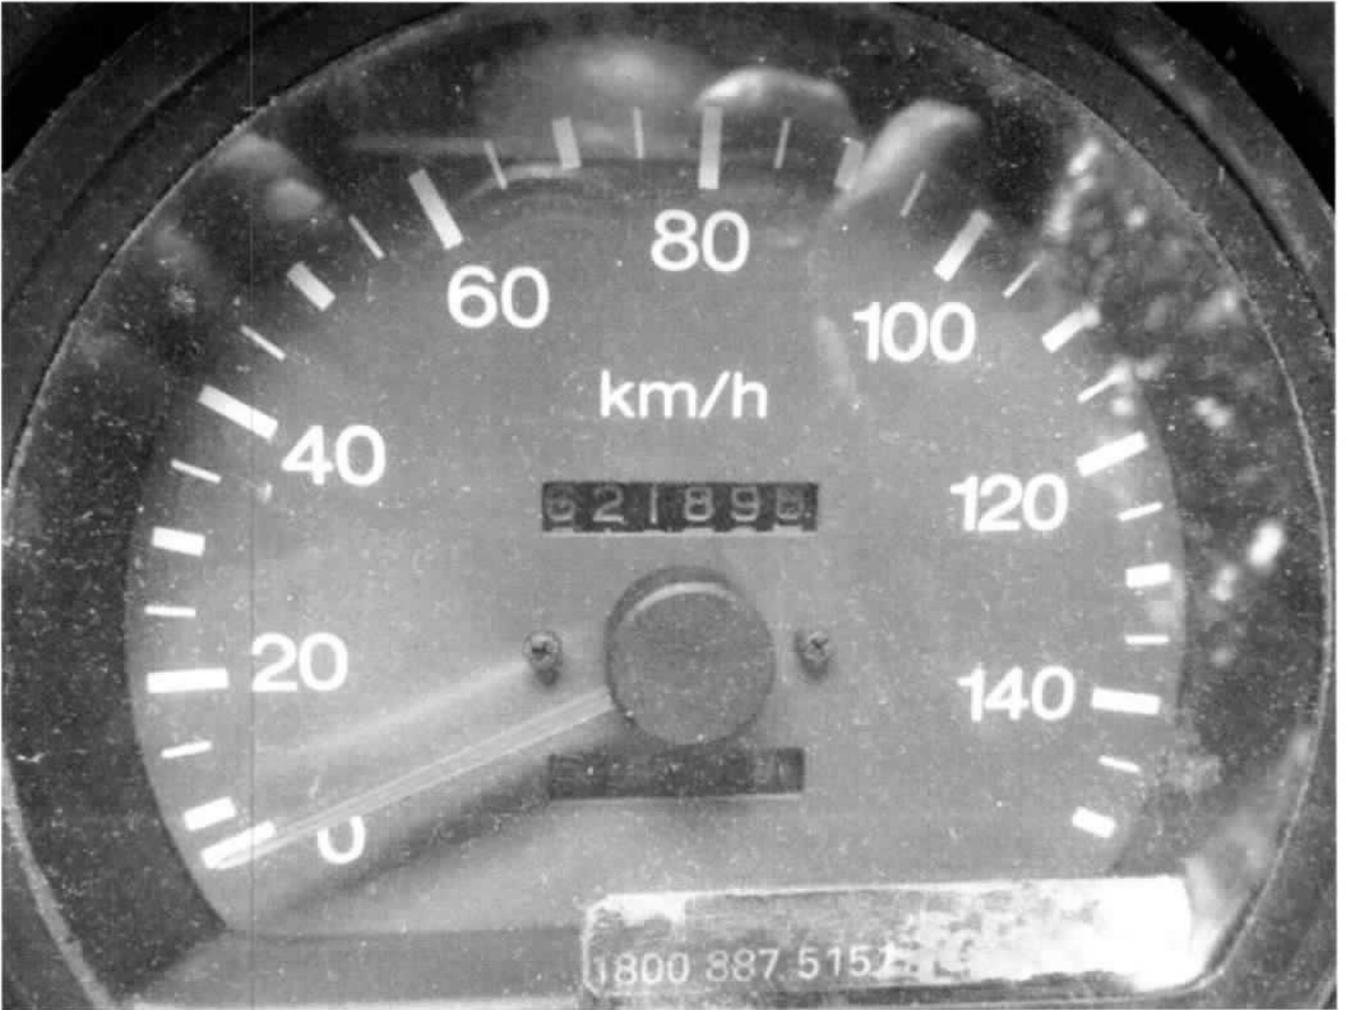
Accident Photo

At the time of inspection, we noted that the vehicle has sustained an impact damages on the **front & rear** portion(s). For more detail of the damages, please see photograph attached.

Qty	Description of Parts	Condition	Estimate By Workshop (\$)	Our Adjusted (\$)
	TO REMOVE & REPLACE AIR CON CONDENSER, PIPING, VACUUM & TOP UP GAS.	NOT NECESSARY	180.00	120.00
	TO REMOVE & REPLACE RADIATOR & TOP UP COOLANT.		120.00	-
	TO RENEW DAMAGED PARTS, STRAIGHENER AND REPAIR FRONT CHASSIS MEMBER & ALIGNED ALL PARTS. INCLUSIVE OF THE REPAIR OF FRONT SUPPORT PANEL.		1,600.00	400.00
			4,000.00	1,160.00
	GRAND TOTAL		9,592.54	3,843.77
	RECOMMENDED COST OF LUMP SUM REPAIRS (TO ITS PRE-ACCIDENT CONDITION)			3,100.00
