REF: NS/INC19003847/Klsd3n2

### 1. Policy Particulars :- THIRD PARTY CLAIM

### 4. Description of Damages

## ADJUSTMENT ON REPAIR COST FOR VEHICLE NO. SHB 4875K

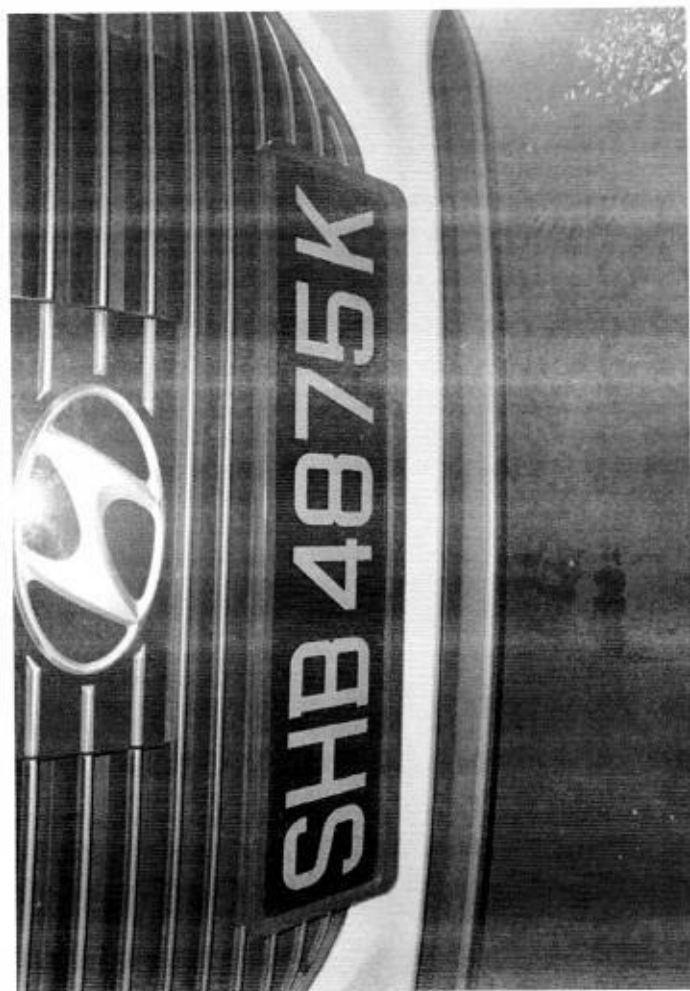
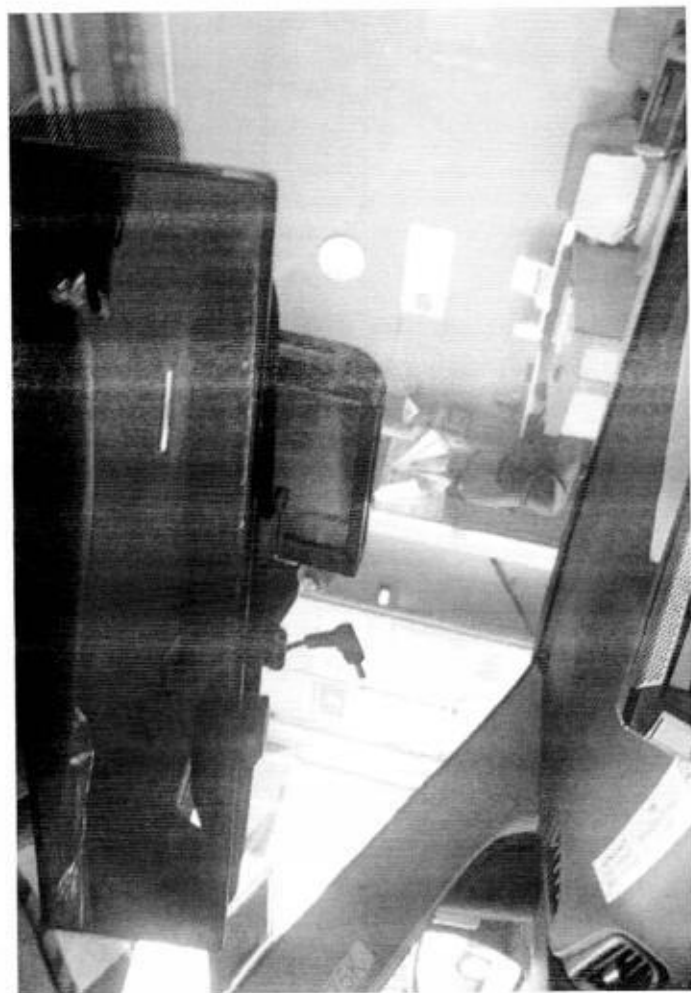
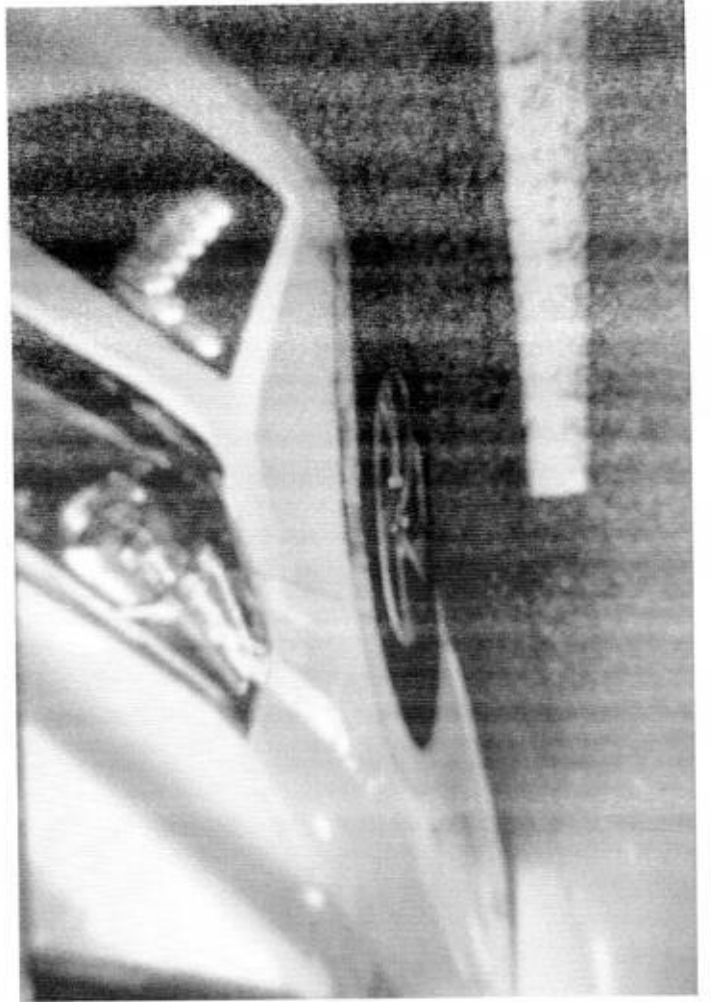
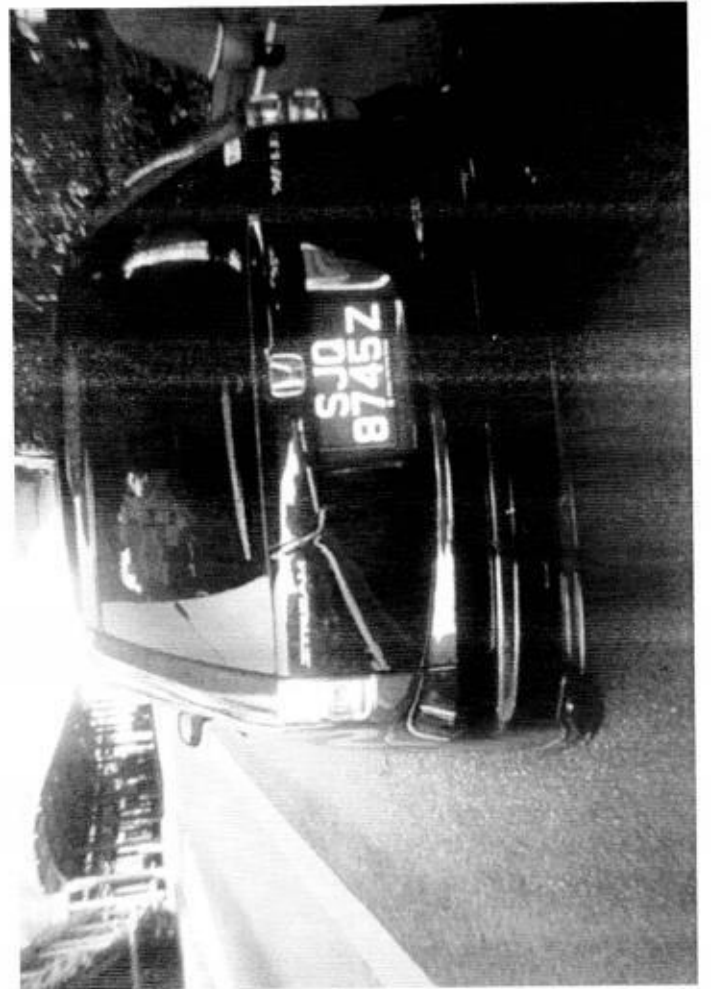
THE VEHICLE SUSTAINED DAMAGES AT THE O/S FRONT PORTION.  
DAMAGES SEE DETAILS.

Qty	Description of Parts	Condition	Estimate By Workshop (\$)	Our Adjusted (\$)
<b>REPLACEMENT OF PARTS</b>				
1	FRONT BUMPER COVER	TO REPAIR SEE LABOUR	418.30	-
1	FRONT BUMPER BRACKET TOP (RH)	SERVICEABLE	35.00	-
1	FRONT BUMPER BRACKET (RH)	SERVICEABLE	28.00	-
10	FRONT BUMPER CLIPS	NOT NECESSARY	22.00	-
1	FRONT FENDER (RH)	TO REPAIR SEE LABOUR	490.70	-
1	FRONT FENDER SHIELD (RH)	SERVICEABLE	114.70	-
1	FRONT FENDER RETAINER	SERVICEABLE	41.40	-
1	EMBLEM-BLUE DRIVE (RH)	NECESSARY	26.60	26.60
1	FRONT WHEEL HUB CAP (RH)	SERVICEABLE	346.40	-
	LESS 20% DISCOUNT		-304.62	-5.32
			1,218.48	21.28
<b>LABOUR</b>				
	PANEL BEATING, INCLUSIVE OF THE REPAIR OF FRONT BUMPER COVER AND FRONT FENDER (RH).		400.00	200.00
	SPRAY PAINTING CHARGE.		600.00	400.00
	TUFF KOTE.	NOT NECESSARY	50.00	-
	FRT WHEEL ALIGNMENT.	NOT NECESSARY	120.00	-
			1,170.00	600.00
<b>GRAND TOTAL</b>			<b>2,388.48</b>	<b>621.28</b>
<b>RECOMMENDED COST OF REPAIRS (CONFIRMED)</b>				<b>621.28</b>
