Veh No: SLT8465S Yr/Regn: 2010 / Augst - 1

Make: Nissan Teana C.C. 2496

### SINGAPORE ACCIDENT STATEMENT

### VEHICLE DAMAGE INSPECTION REPORT

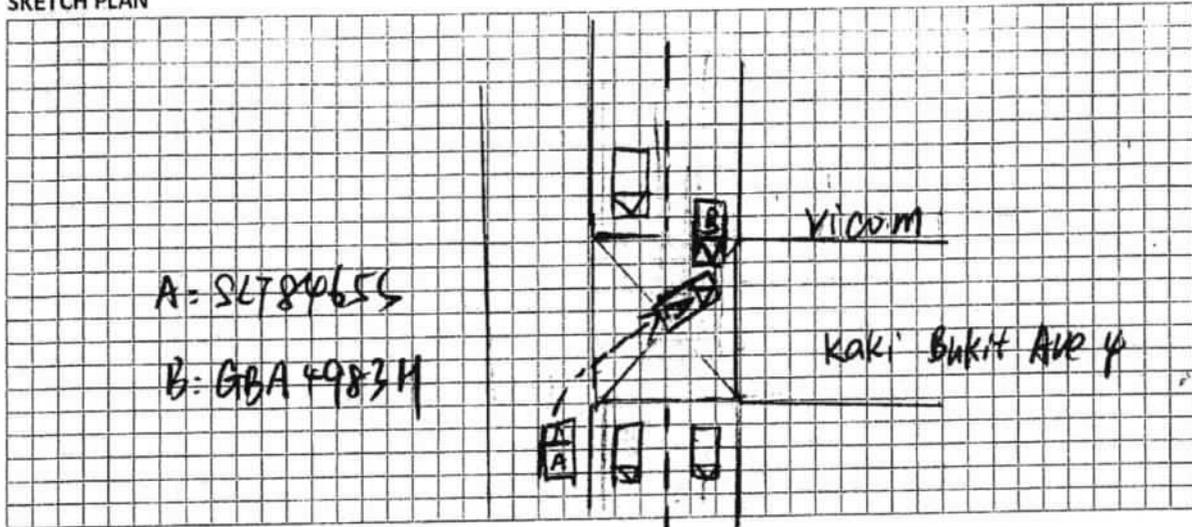
SKETCH PLAN

A: SLT84655

B: GBA4983H

On 27/02/2019 at around 1440hrs, I was driving SLT84655 going to Vicom to pay roadtax. At the intersection, there was a jam due to the traffic lights. As I was turning in slowly (due to the fact that one heavy vehicle was blocking my view) I am watching for incoming traffic. When I saw that it is clear, I move forward and stop to double check that the outer lane was clear of traffic. As I move slowly out to get a view, the other party GBA4983H was speeding down the lane. I was already stationary when I was hit by vehicle B, resulting my car to end up in a parallel position aligned to the ~~road~~ lane
