Preliminary Advice

Insured Vehicle No	: SLL903P	Accident Date	: 19/03/2019
TP Vehicle No	: SHC8462L	Assignment Date	: 20/03/2019
Make	: HYUNDAI I40	Est. Duration of Repair	: 7.00
Date of Inspection	: 21/03/2019		
Inspection At	: CHUNNI MOTOR WORK PTE LTD - AMK (HQ) BLK 10 #01-05/06, AMK AUTOPOINT SINGAPORE 568047

VEHICLE DAMAGE INSPECTION REPORT

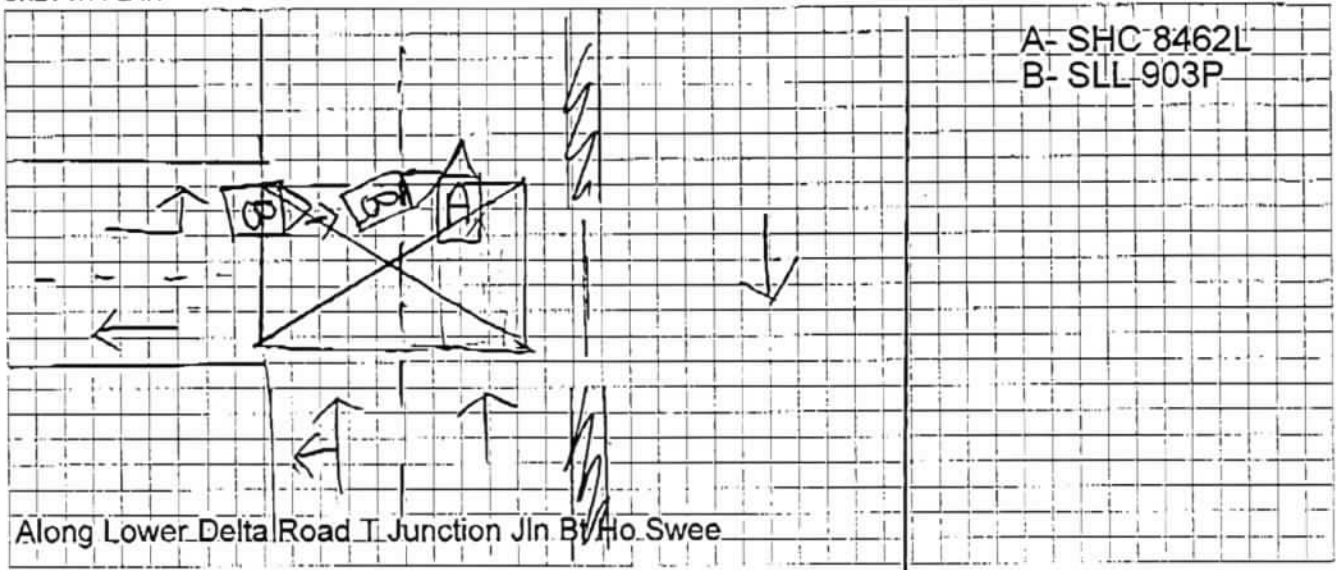
SKETCH PLAN

A- SHC 8462L
B- SLL 903P

On 19.03.2019 @ 0920hrs I was travelling along Lower Delta Road T Junction Jln Bt Ho Swee with 2 male driver onboard.

I was travelling straight and suddenly veh(B) SLL 903P dashed out from my left and hit onto my vehicle front left portion.
