SKX 838T

VEHICLE INSPECTION REPORT

Report No. : PAS/TP/0060219

Vehicle Registration No. : SKX838T
Make & Model : Toyota Corolla Axio
Date of Registration : 15/01/2016
Colour : White

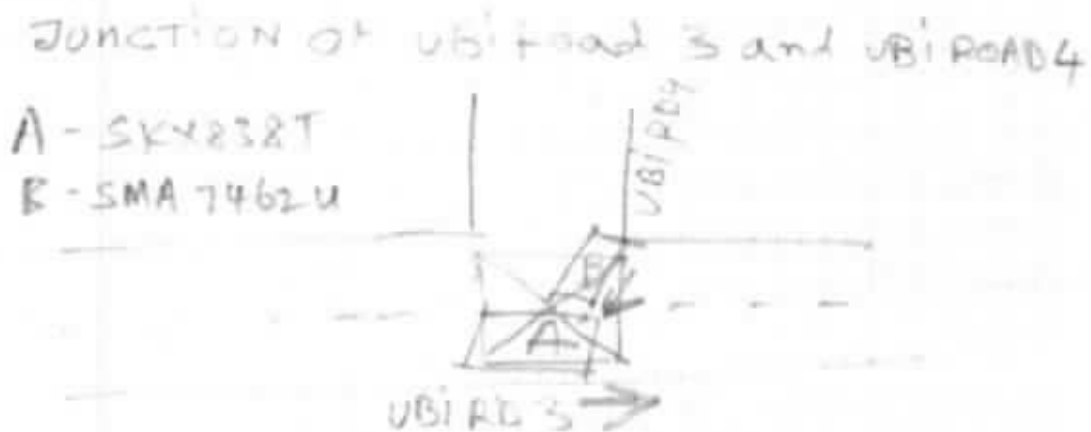
SKETCH PLAN

DESCRIBE CIRCUMSTANCES OF THE ACCIDENT

Vehicle A ~~SKX838T~~ was driving in UBI Road 3 and the vehicle B SMA 7462U was driving from UBI Road 4 towards UBI Road 3. Then hit vehicle A SKX838T front left ~~wheel~~ wheel and front bumper and LEFT SIDE FARM including wheel rim -
