Preliminary Advice

Insured Vehicle No	: SLC2112P	Accident Date	: 22/03/2019
TP Vehicle No	: SHA4763E	Assignment Date	: 25/03/2019
Make	: HYUNDAI I40	Est. Duration of Repair	: 8 days
Date of Inspection	: 25/02/2019		
Inspection At	: Chunni Motor Work Pte Ltd - Amk (HQ) Blk 10 #01-05/06, AMK Autopoint Singapore 568047

VEHICLE DAMAGE INSPECTION REPORT

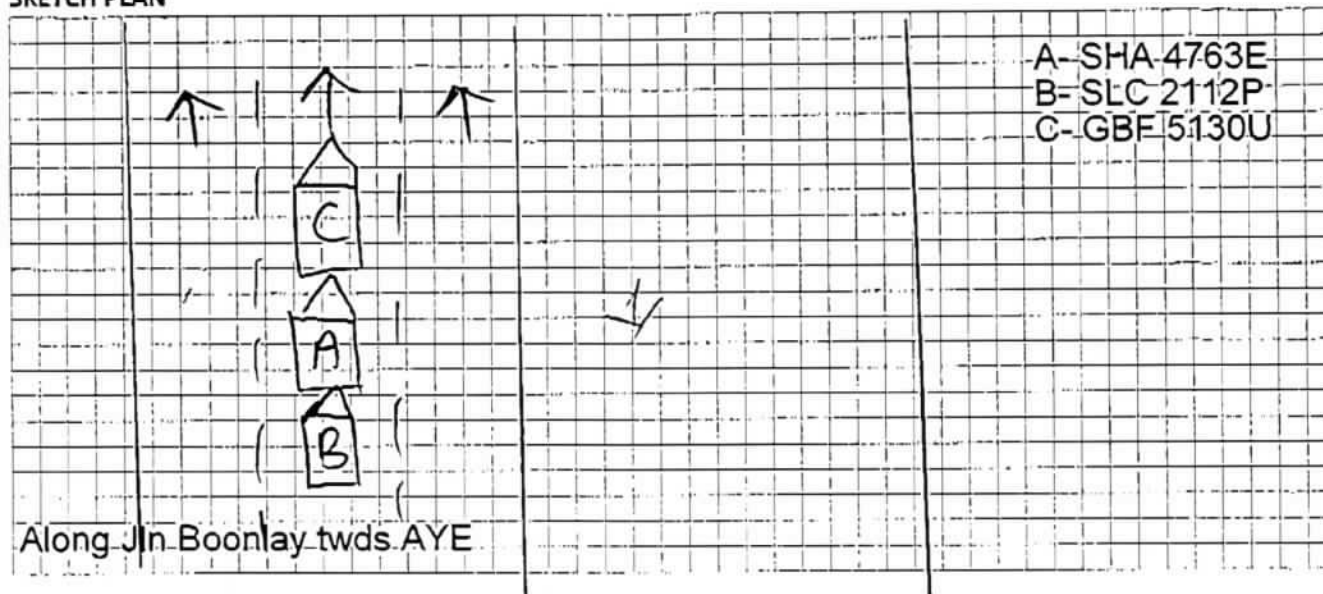
SKETCH PLAN

On 22.03.2019 @ 0810HRS I was travelling along Jln Boonlay twds AYE
with one female passenger onboard.

As I was travelling straight veh(C) GBF 5130U slowed down and I followed suddenly
I felt an impact from my rear from veh(B) SLC 2112P.

There are 3 vehicles involved in this chain accident.
