ACCIDENT INVOLVING YP8013E & GBG3788E ON 21.03.2019

Preliminary Advice

Insured Vehicle No	: YP8013E	Accident Date	: 21/03/2019
TP Vehicle No	: GBG3788E	Assignment Date	: 25/03/2019
Make	: NISSAN NV200	Est. Duration of Repair	: 12
Date of Inspection	: 26/3/2019		
Inspection At	: MR CAR CONSULANT PTE LTD

VEHICLE DAMAGE INSPECTION REPORT

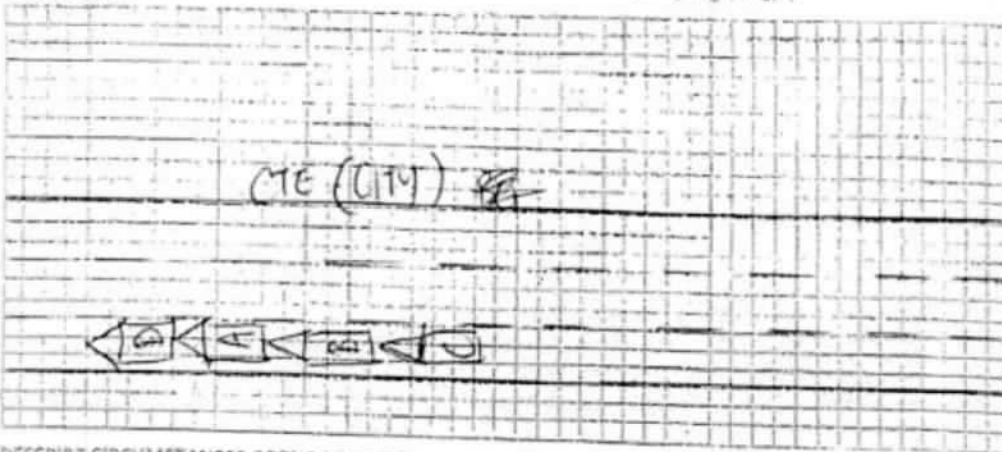
SKETCH PLAN

A: G863788E
B: YP8013E
C: GZ8209T
D: YN6751G

ON THE STATED TIME AND DATE, I WAS ~~DRIVING~~ (G863788E) WAS TRAVELLING AT A SLOW SPEED ALONG THE STATE VENUE ON THE LEFT MOST ~~FA~~ LANE. TRAFFIC WAS SLOW AS IT WAS RAINING HEAVILY. AS THE FRONT VEHICLE APPLIED BRAKES, I ^{FOLLOWED SUIT.} A SUDDENT THERE WAS A HUGE IMPACT FROM MY REAR, CAUSING MY VEHICLE TO PROPEL FORWARD AND COLLIDE ONTO (YN6751G). AFTER ALIGHTING, I REALISED IT WAS A CHAIN COLLISION CAUSED BY (GZ8209T) WHO COLLIDED ONTO (YP8013E) THUS COLLIDING ONTO ME AND FINALLY PUSHING MY VEHICLE FORWARD TO (YN6751G)
