To Inspect Vehicle No: FBB676R Insured: YM 8837K

Piaggio PX 200E

VEHICLE DAMAGE INSPECTION REPORT

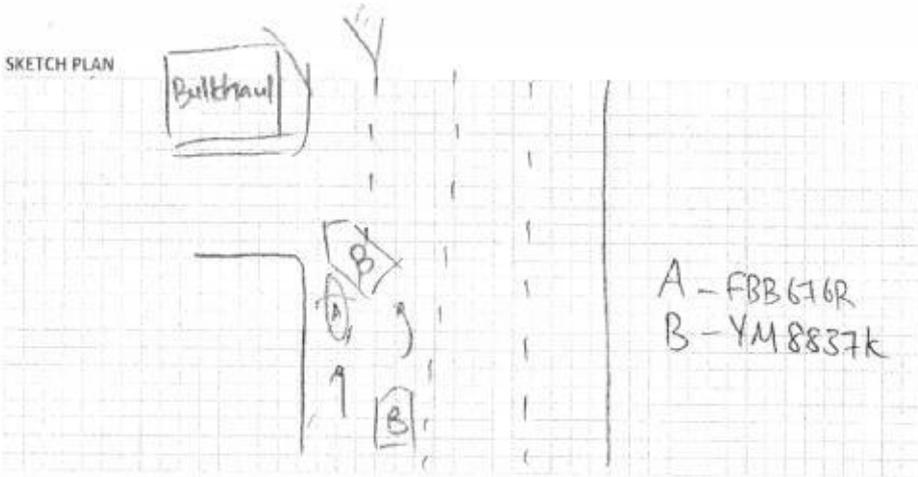
SKETCH PLAN

DESCRIBE CIRCUMSTANCES OF THE ACCIDENT

While travelling down middle road towards beach ~~road~~, the other party made a left turn towards the small road. While attempting to turn the other party did not notice the motorcycle beside and the side of the lorry hit the motorcycle before the turn was completed.

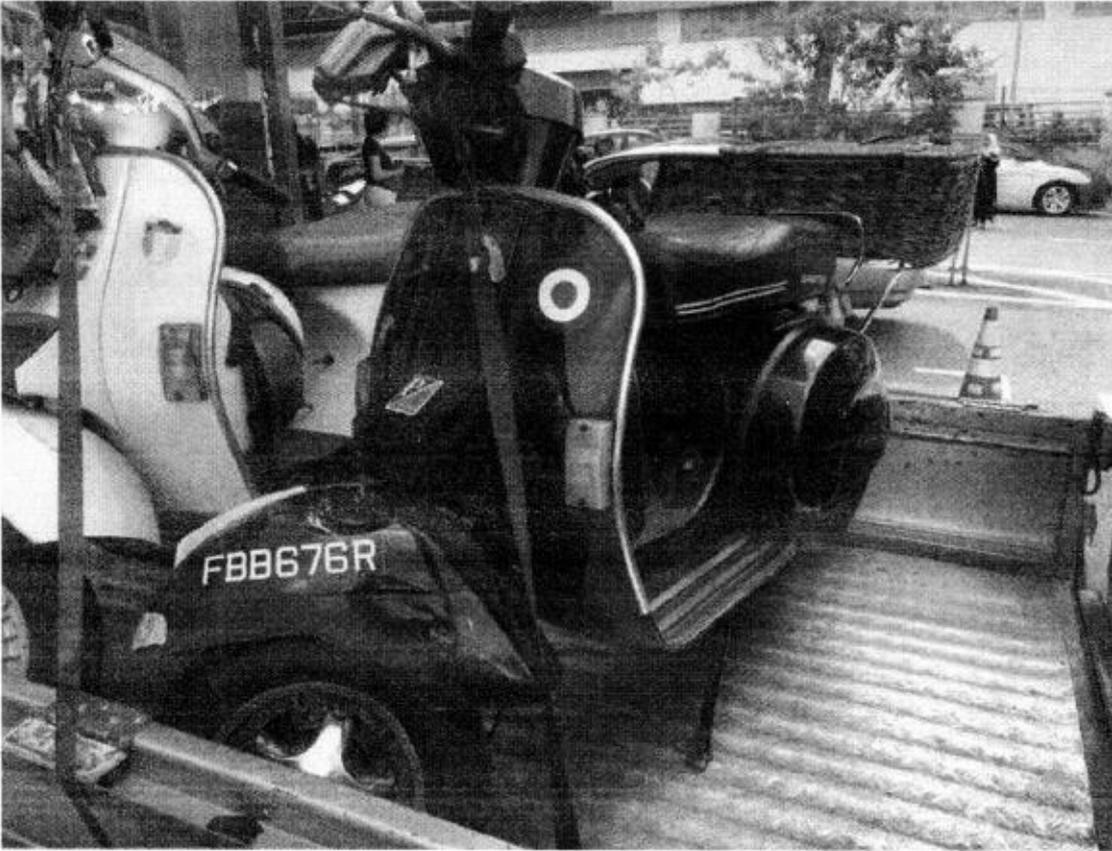
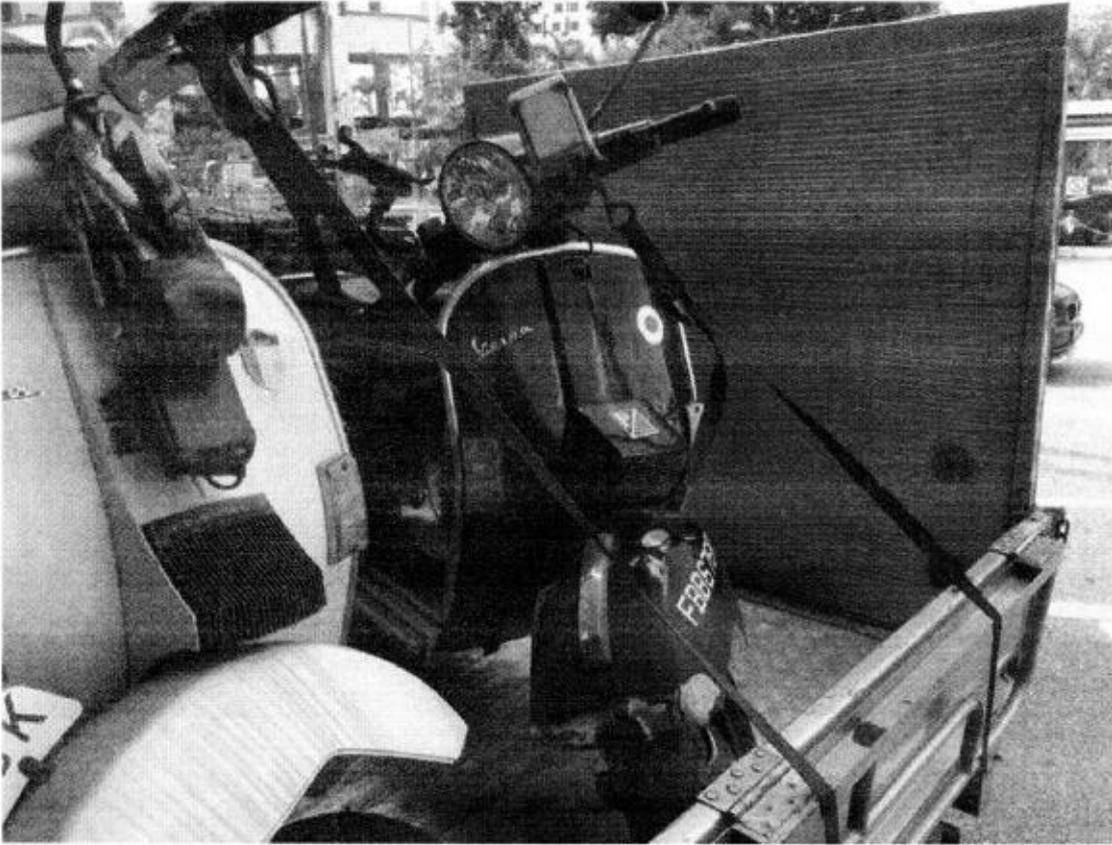
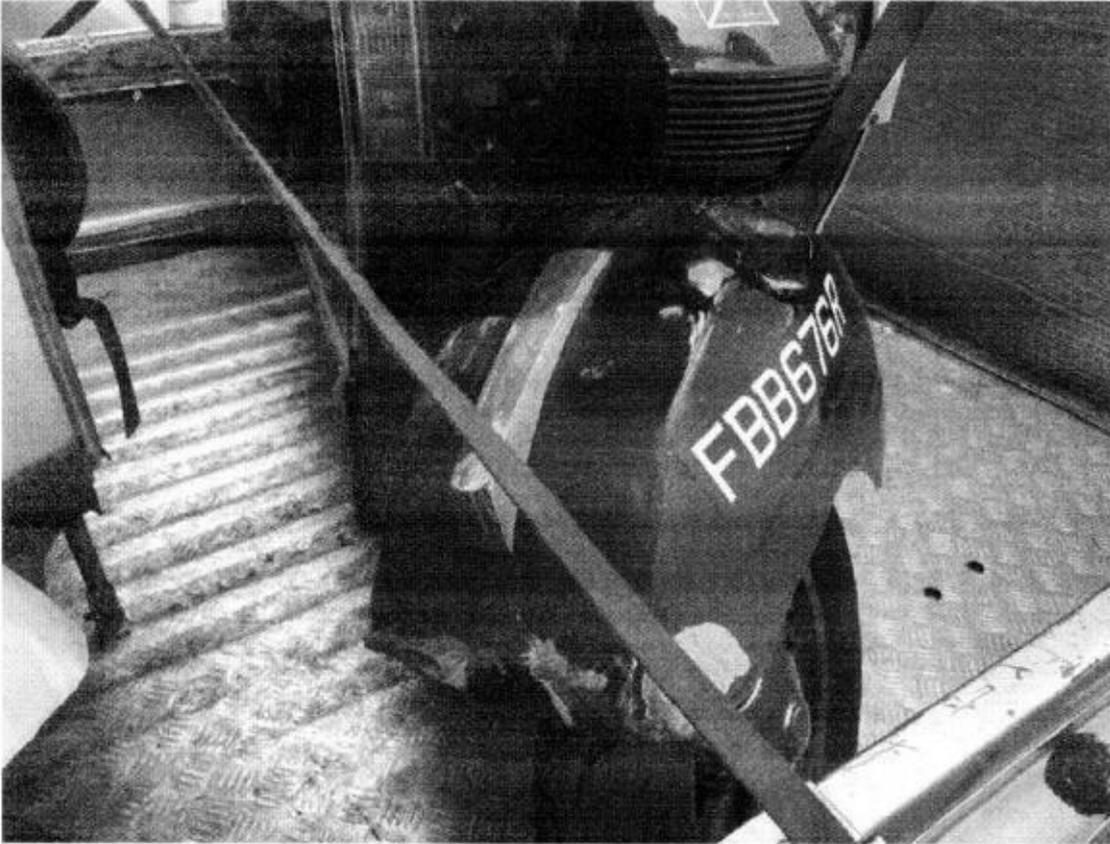
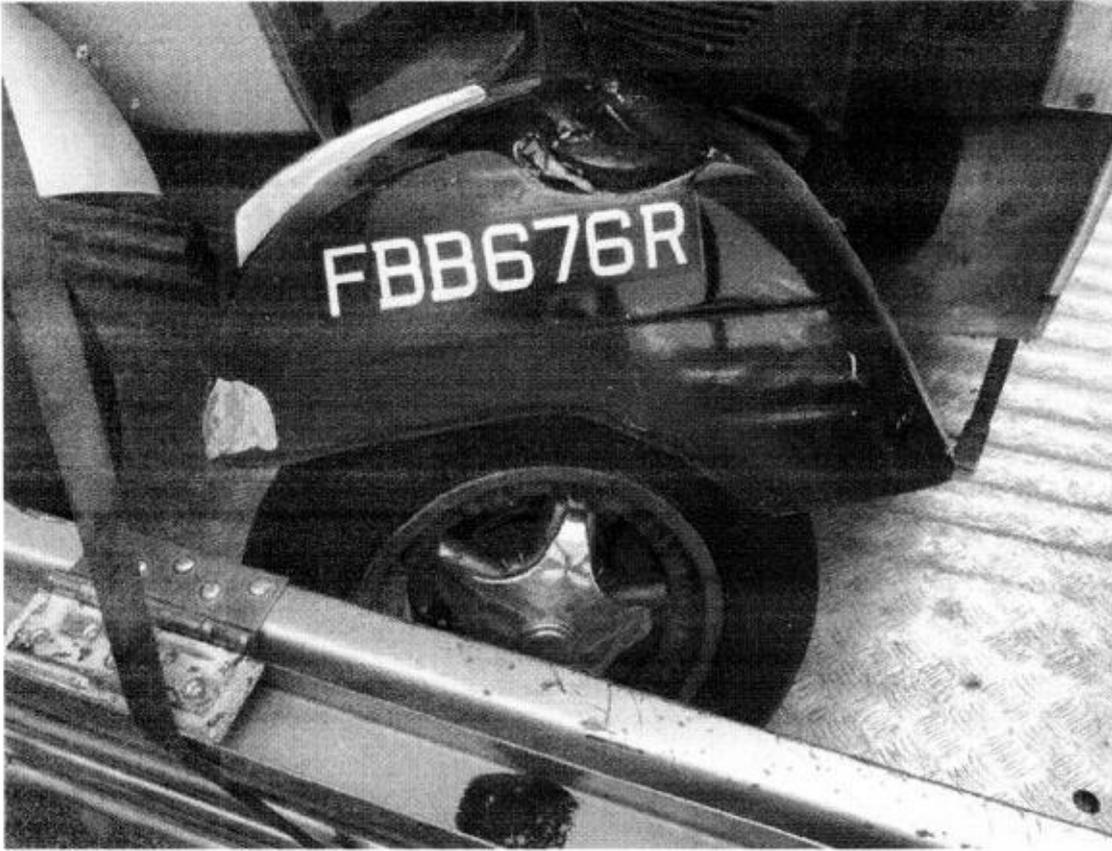
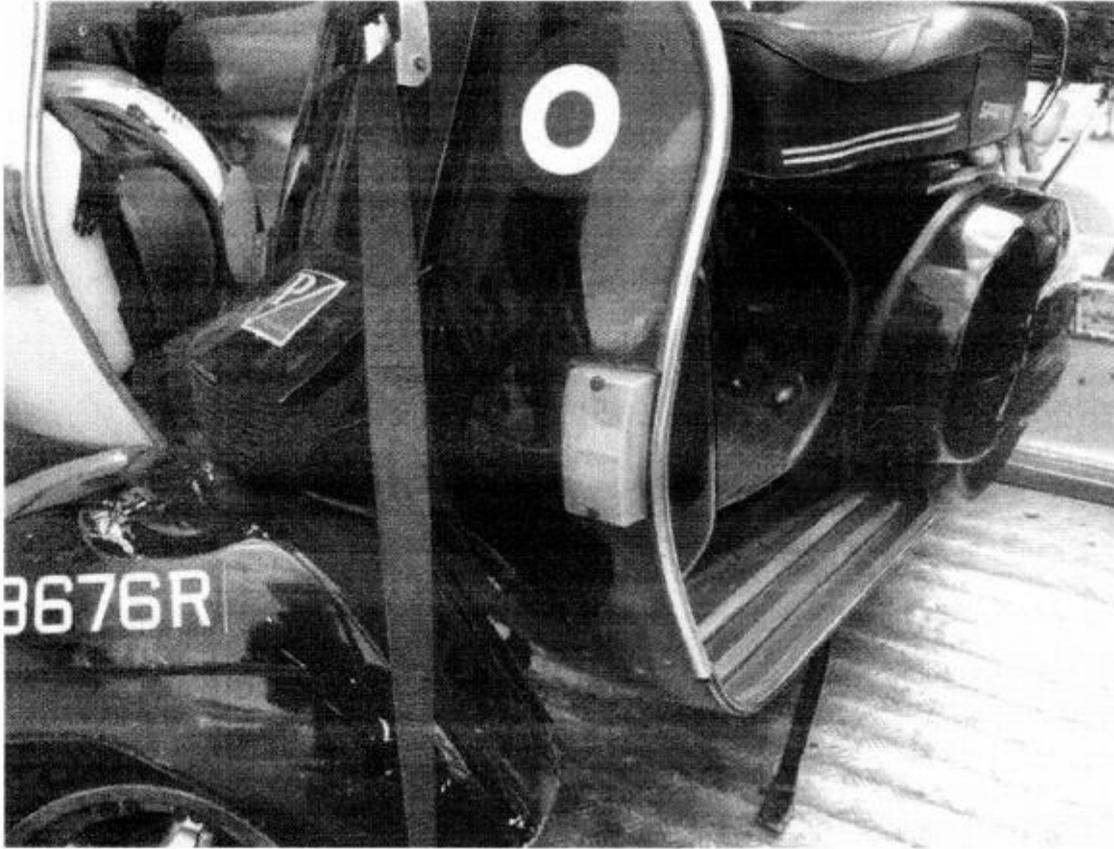
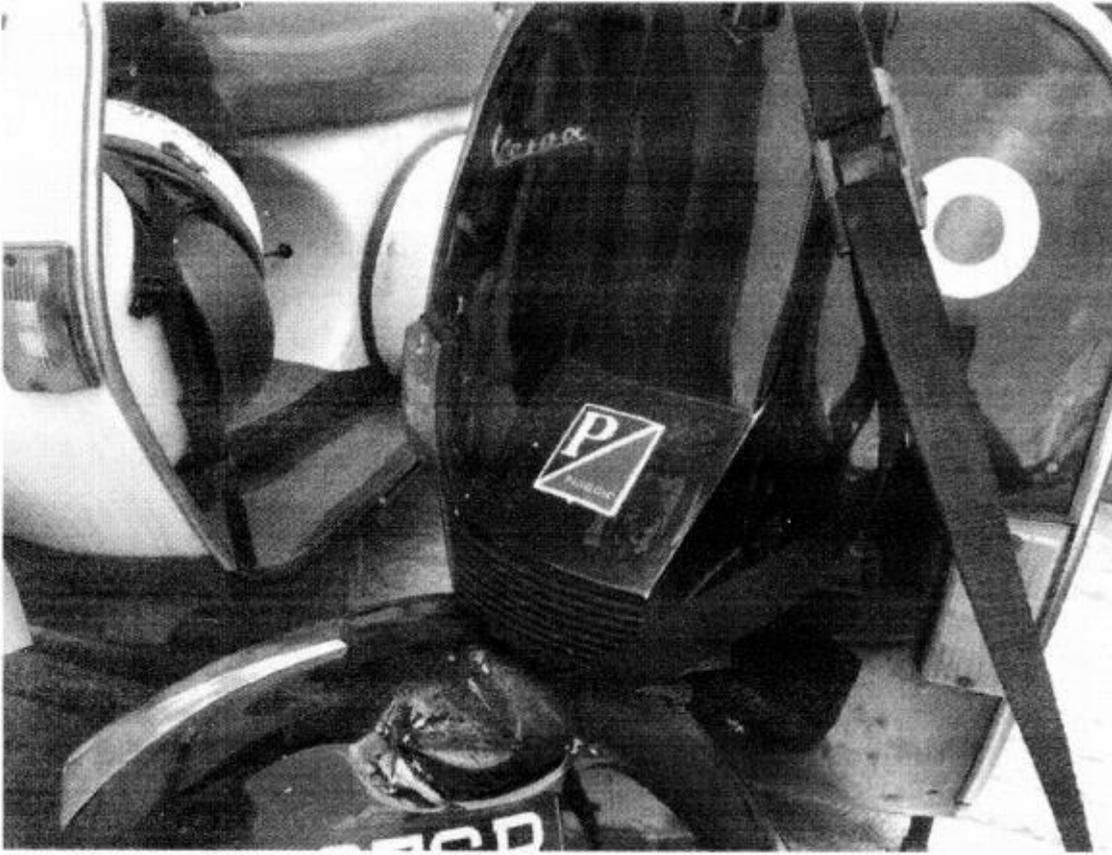
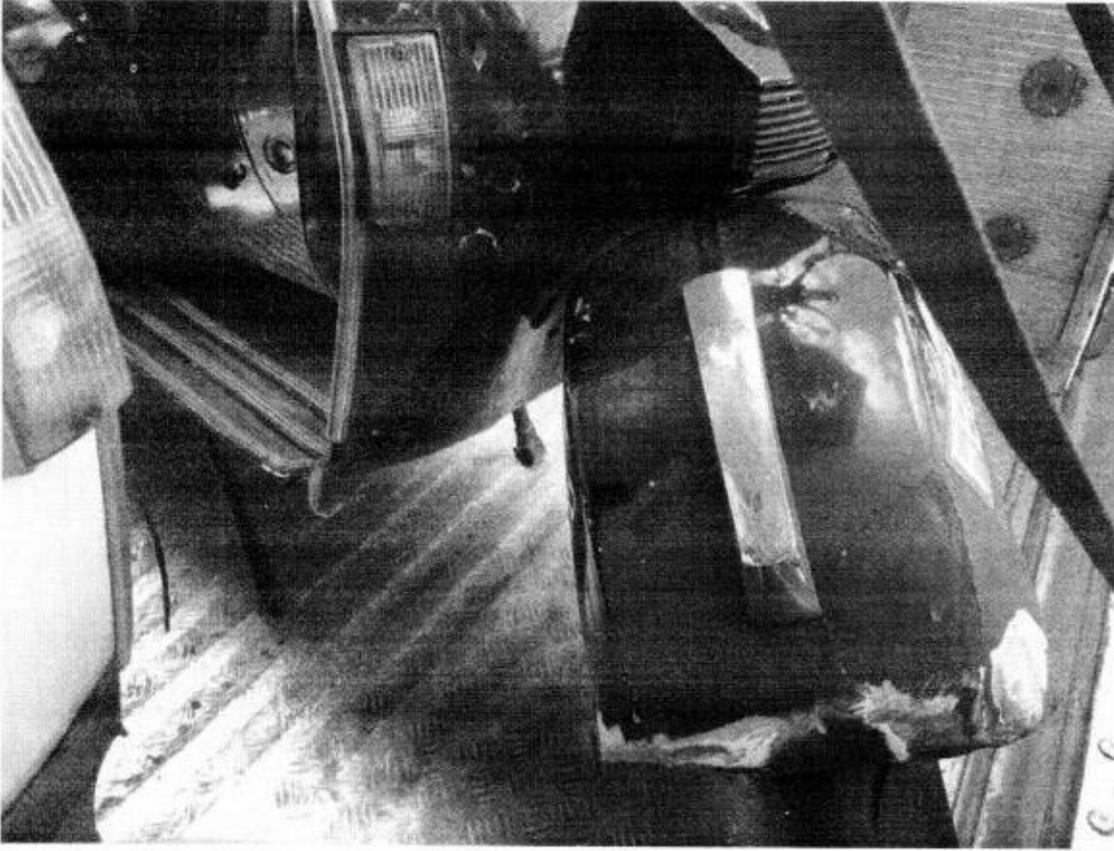
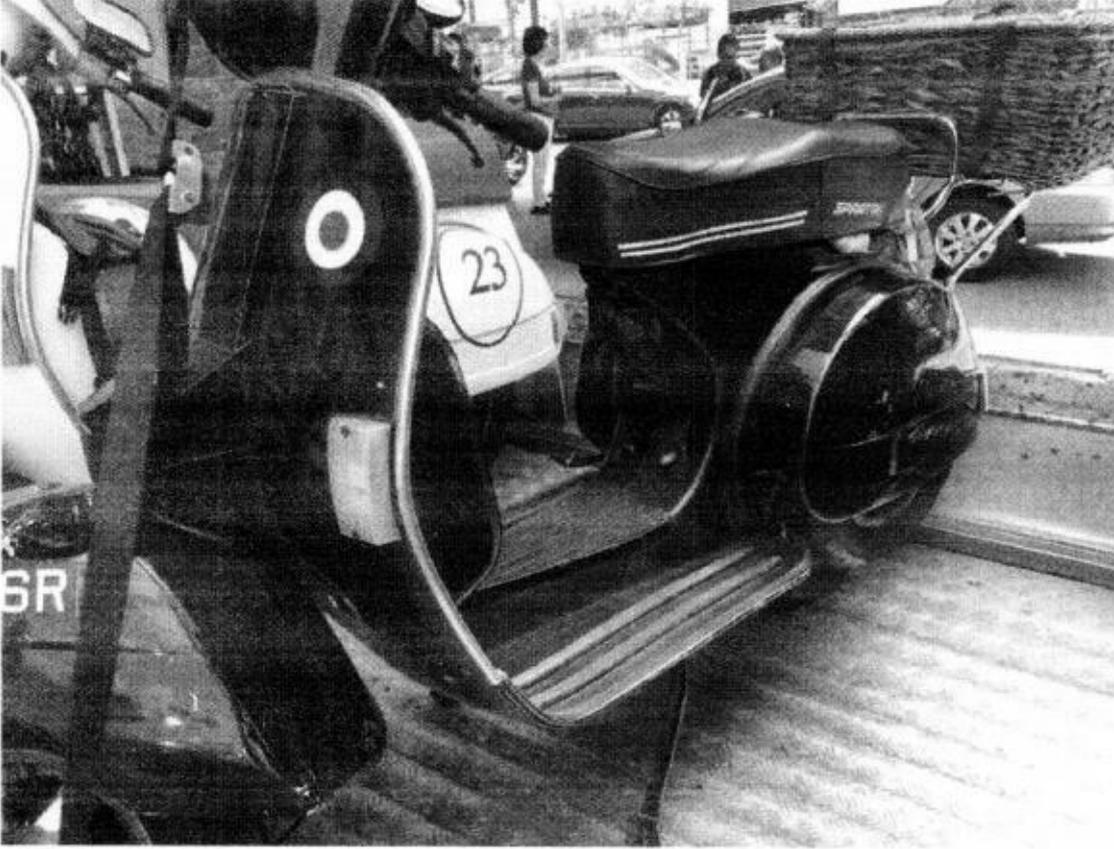
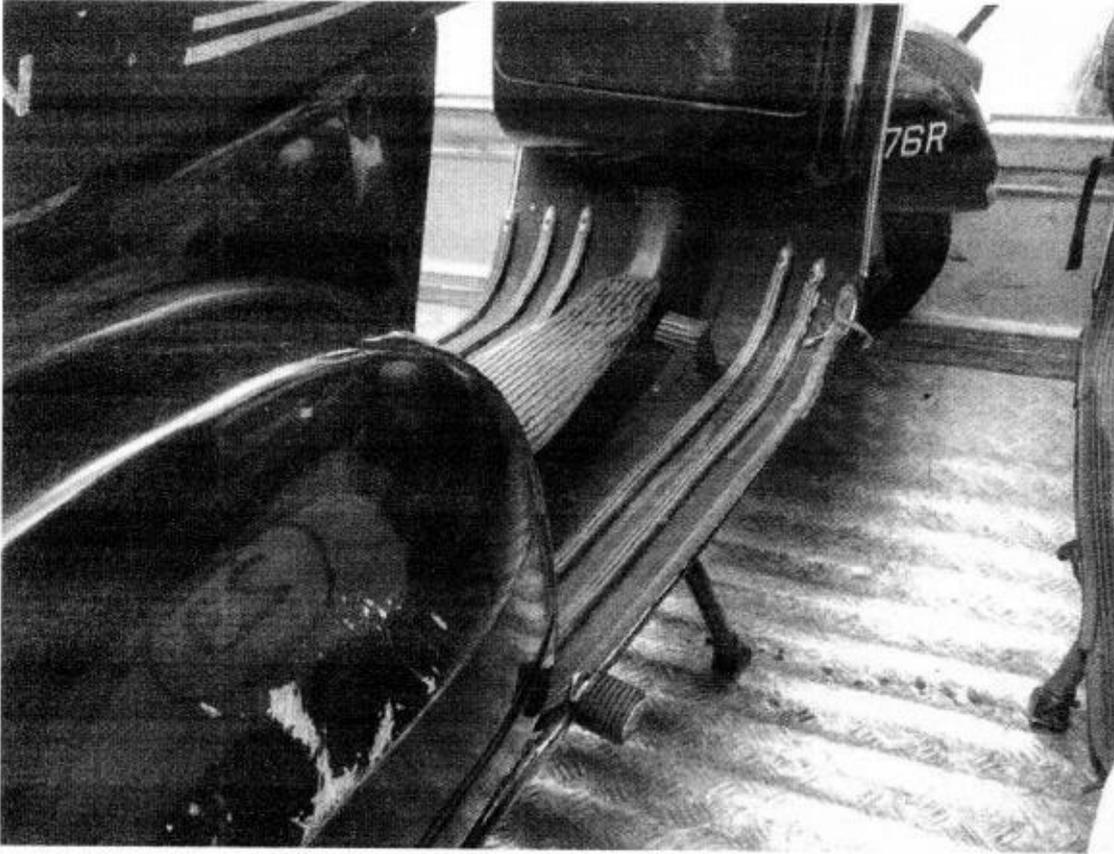
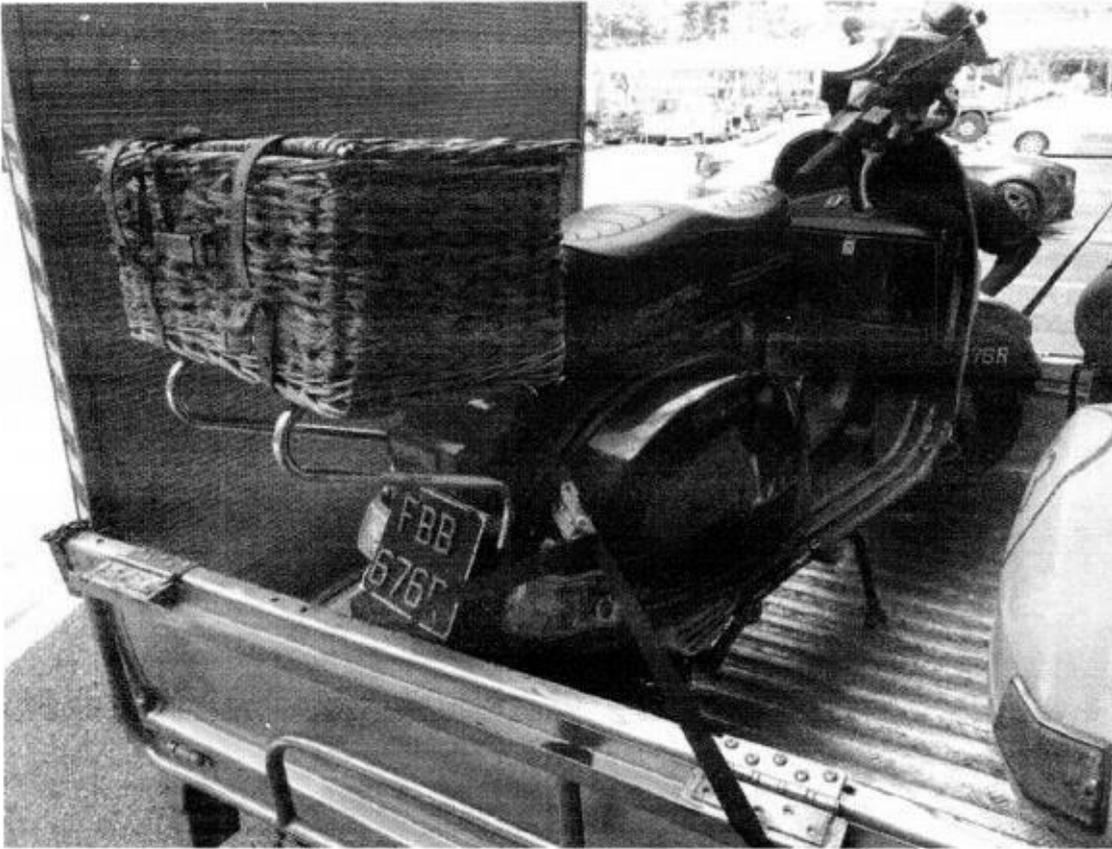
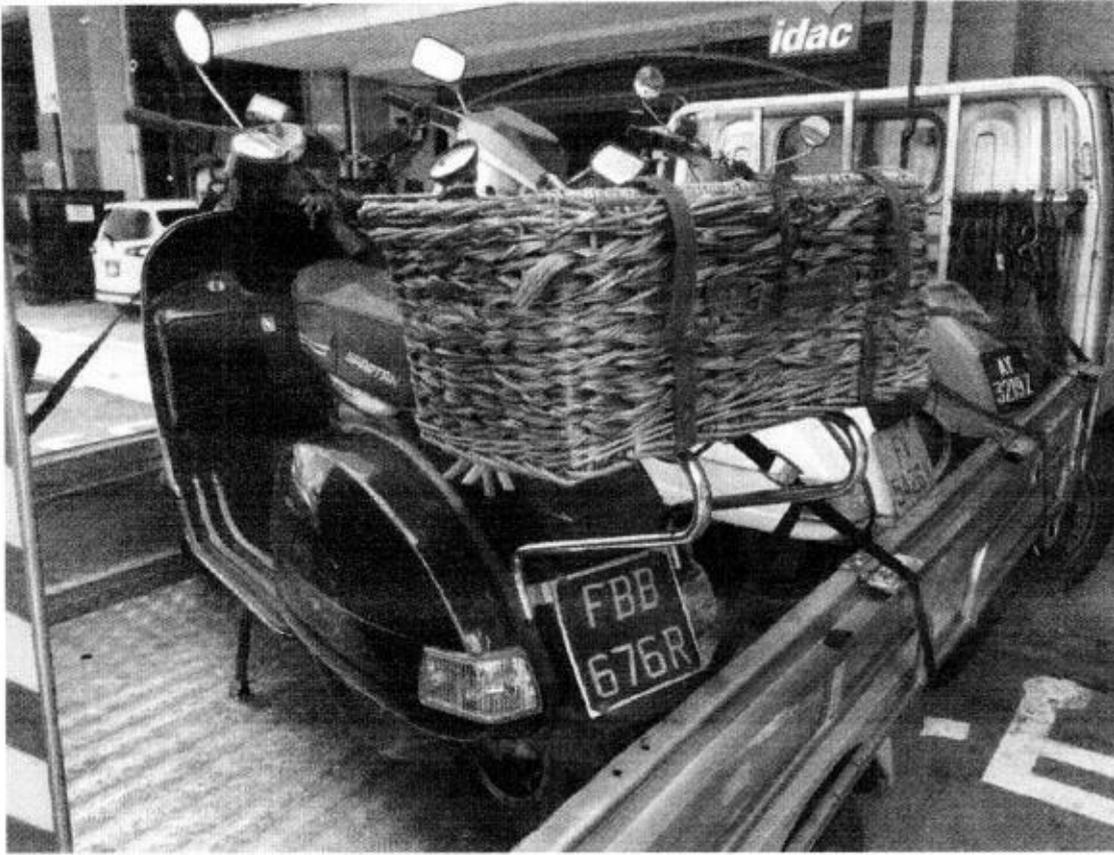
The U/C / Chassis frame / Body Structure affected due to collision.

Accident Photo

No.	Qty	Part No.	Particulars	Condition	Repairer's	Amount
1	1		*FRONT STEERING FORK ASSY	Bent	785.00 FL	*785.00 FL
2	1		*FRONT MUDGUARD	Buckled	95.00 FL	*95.00 FL
3	1		*SET FRONT FORK BEARING W/CORE	Necessary	68.00 FL	*68.00 FL
4	1		*71Y WHEEL COVER	Bent	38.50 FL	*38.50 FL
5	1		*RH SIDE SIDE COWL	Buckled	125.00 FL	*125.00 FL
6	1		*SET FLOOR RAIL NET	Cut	78.00 FL	*78.00 FL
7	1		*SET REAR SIGNAL RH	Cracked	48.50 FL	*48.50 FL
8	1		*FORK LINK COVER	Missing	22.50 FS	*22.50 FS
9	1		*HORN EMBLEM	Missing	6.00 FS	*6.00 FS
10	1		*FRT SHIELD BEADING	Cut	28.00 FS	*28.00 FS
11	2		*FRONT STICKER PLATE	Necessary	18.00 FS	*18.00 FS

No	Particulars	Lab.Type	Repairer's	Amount
Labour Items				
1	KNOCK RH SIDE COWL, RH FLOORBOARD EDGE.	New	180.00	100.00
2	JACK BODY ALIGNMENT & STOPPER.	New	150.00	80.00
3	TRANSPORT TO IDAC.	New	80.00	35.00
4	LABOUR CHARGES.	New	280.00	180.00
5	SPRAY WHOLE SCOOTER.	New	800.00	300.00
Gross Labour Cost (S\$)			1,490.00	695.00
