ASSIGNMENT (Office)

Final repair bill for Honda Vezel SLR 8339 J

THIRD PARTY SURVEY ACCIDENT HAPPENED ON 7 Nov 2018

ADJUSTMENT ON REPAIR COST FOR VEHICLE NO. SLR 8339J

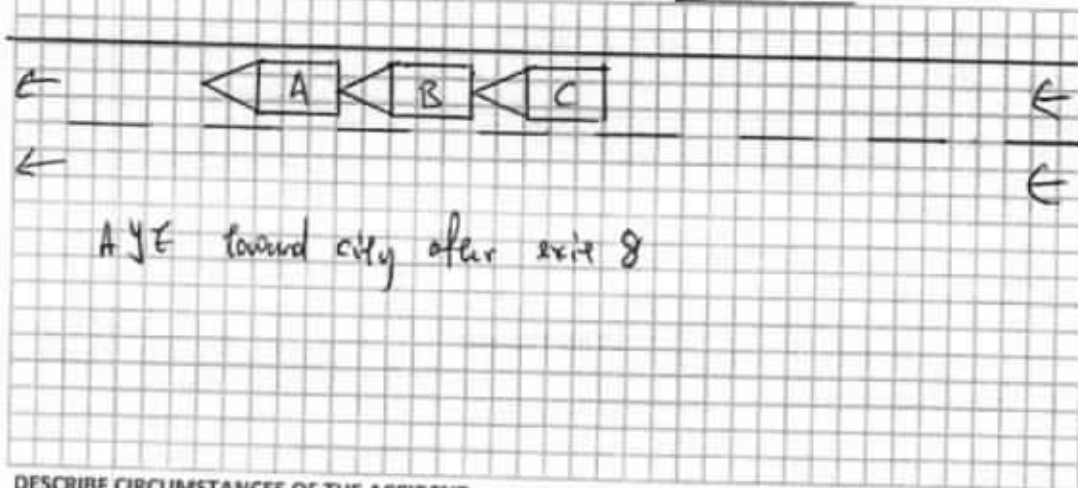
SKETCH PLAN

Date of Accident: 07-Nov-2018 Time: 08.30AM Location: AYE towards City After Exit 8
 My Vehicle A: SLR8339J Vehicle B: SLP5714P Vehicle C: SKH8808L

DESCRIBE CIRCUMSTANCES OF THE ACCIDENT

On 7th Nov 2018 at around 8.30am, I am driving Vehicle A SLR8339J along aye towards city after exit 8
When vehicle B SLP5714P knocked into my rear!
After when I aligned I realized it is a chain collision involving 3 cars with Vehicle C SKH8808L
I have in car video
Note: Please take note that your insurer have 14 days timeframe for you to submit Own Damage Claim under your own comprehensive policy. Please check with your policy for more information.
