CS3/MCA19000931/Gqd3-1

ACCIDENT INVOLVING SJM 2556M & SGW 2685G ALONG BEDOK RESERVOIR
ROAD NEAR BLOCK 627 ON 15 MAY 2018 X 12-01-19

VEHICLE DAMAGE INSPECTION REPORT

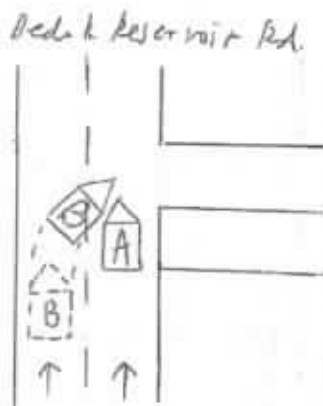
SKETCH PLAN

A = JM 25567
B = SGW 26856

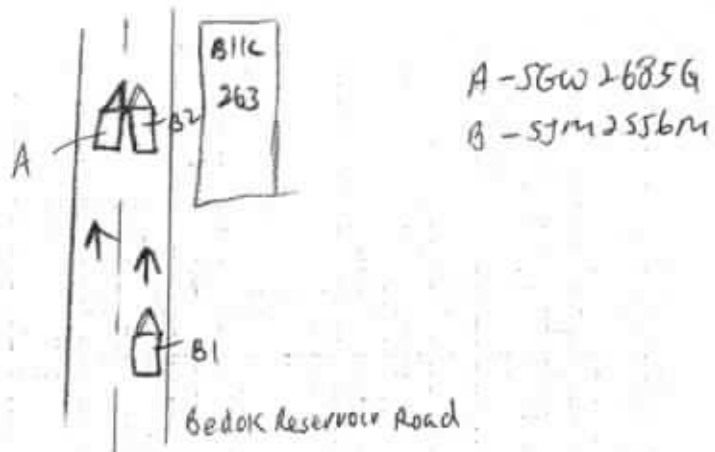
SKETCH PLAN

I was travelling along Bedok Reservoir Road on the inner lane. As I wanted to filter into the 1st lane I "on" my right signal. As I check my right wing mirror and my blind spot and that it was very safe to make my change. As I was slowly entering into the 1st lane, suddenly this vehicle B SJM 2556M came in a very fast speed and side swipe my right side portion and rip off my vehicle front bumper. We went down and exchange our particulars and took some photos of the damage.
