FW: REQUEST CLAIM NUMBER

REPAIR ESTIMATE

## ADJUSTMENT ON REPAIR COST FOR VEHICLE NO. SHC 8671A

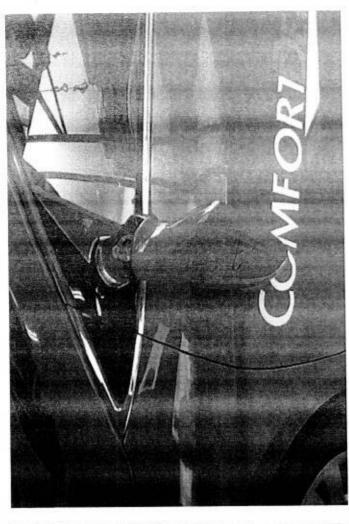
4.		Description	on of Da	images	
3	THE VEHICLE SU	STAINED DAMAGES AT THE N/S ETAILS.	MIRROF	₹.	
5.		Genera	Inform	ation	
	Accident Date	01/04/2019	Inspec	tion Date	01/04/2019
	Survey held at	COMFORTDELGRO ENGINEER	RING PT	ELTD	
		59 LOYANG DRIVE SINGAPORE 508969			
5a.		R	emarks		CONTRACTOR OF THE PARTY OF THE
		ON WAS CONDUCTED ON A"WIT CE TO YOUR INSTRUCTIONS, W			
5b.		Estimate	Days of	Repair	
	ESTIMATED NOR	MAL PERIOD FOR REPAIR:		1 Working Days

Qty	Description of Parts	Condition	Estimate By Workshop (\$)	Our Adjusted (\$)
	REPLACEMENT OF PARTS			
1	140VC MIRROR ASSY - O/S REA	BROKEN	670.50	670.50
	LESS 20% DISCOUNT		-134.10	-134.10
			536.40	536.40
	LABOUR			
	PANEL BEATING.	NOT NECESSARY	100.00	
	SPRAY PAINT CHARGE.		100.00	100.00
	CHECK ALL LIGHTING.		30.00	30.00
			230.00	130.00
	GRAND TOTAL		766.40	666.40

RECOMMENDED COST OF LUMP SUM REPAIRS	550.0
(TO ITS PRE-ACCIDENT CONDITION) (CONFIRMED)
