REF: NS/INC/19005865/K19d3n2

1. Policy Particulars :- THIRD PARTY CLAIM				
Insured Veh.	FBF 830R	Veh. Inspected	SHA 3277Z	
Policy No.	5069150719-04	Coverage (\$)	0.00	
Claim No.	MT/1039478-001	Excess (\$)	0.00	
Assign From		Assign Date	02/04/2019

4. Description of Damages				
THE VEHICLE SUSTAINED DAMAGES AT THE O/S FRONT PORTION. DAMAGES SEE DETAILS.				
5. General Information				
Accident Date	01/04/2019	Inspection Date	02/04/2019	
Survey held at	COMFORTDELGRO ENGINEERING PTE LTD 59 LOYANG DRIVE SINGAPORE 508969			
5a. Remarks				
A)THE INSPECTION WAS CONDUCTED ON A"WITHOUT PREJUDICE" BASIS. B)IN ACCORDANCE TO YOUR INSTRUCTIONS, WE HAVE NOT AUTHORISED REPAIRS.				
5b. Estimate Days of Repair				
ESTIMATED NORMAL PERIOD FOR REPAIR:		3 Working Days

ADJUSTMENT ON REPAIR COST FOR VEHICLE NO. SHA 3277Z

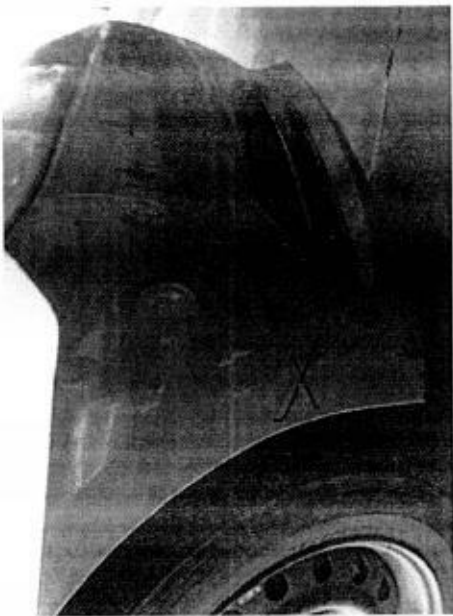
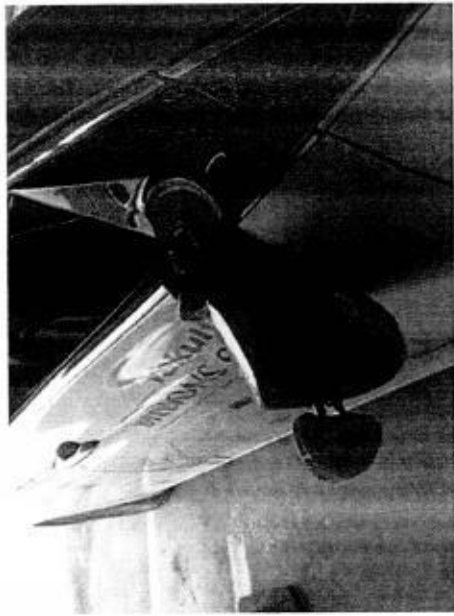
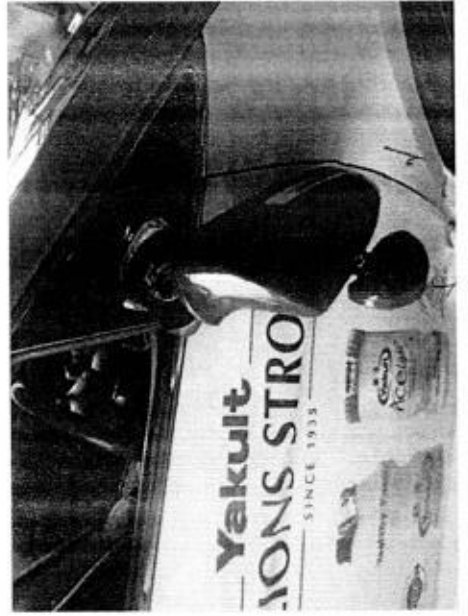
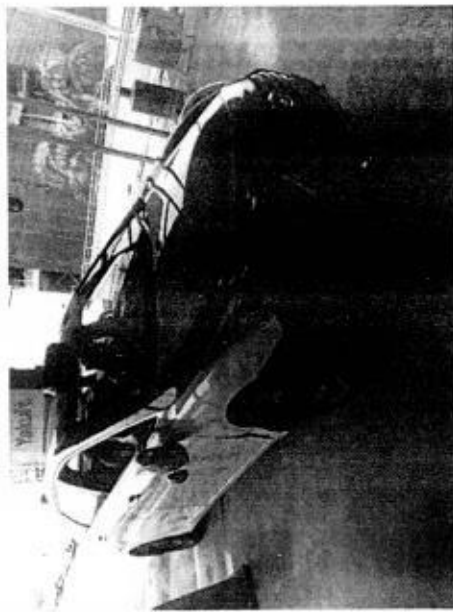
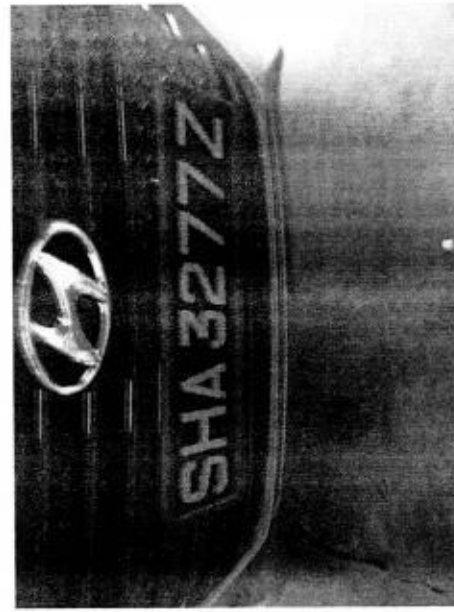
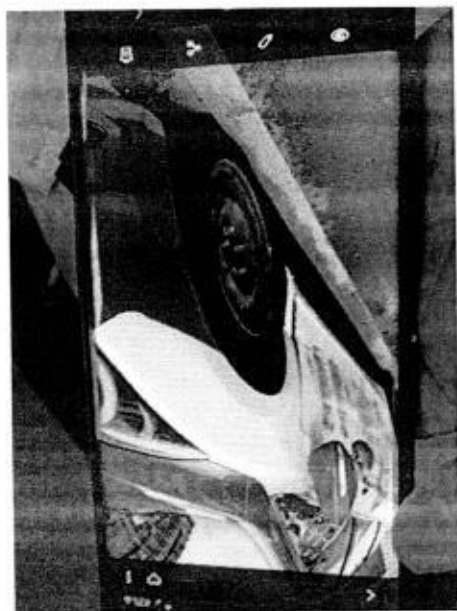
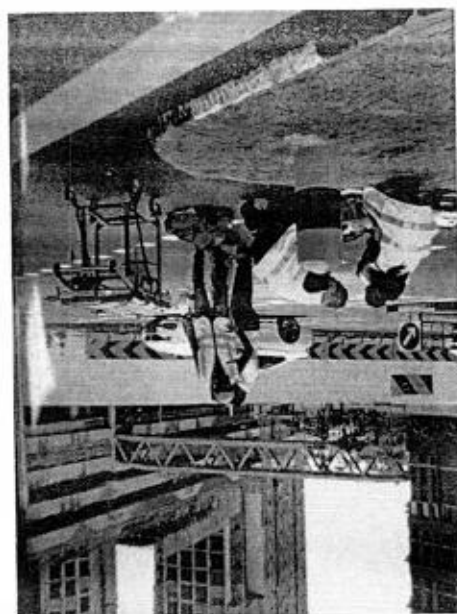
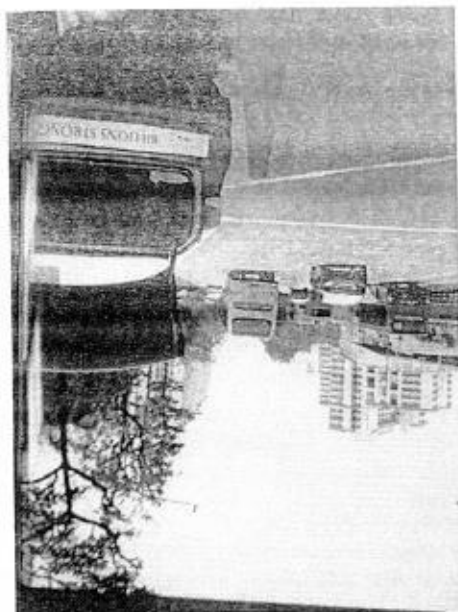
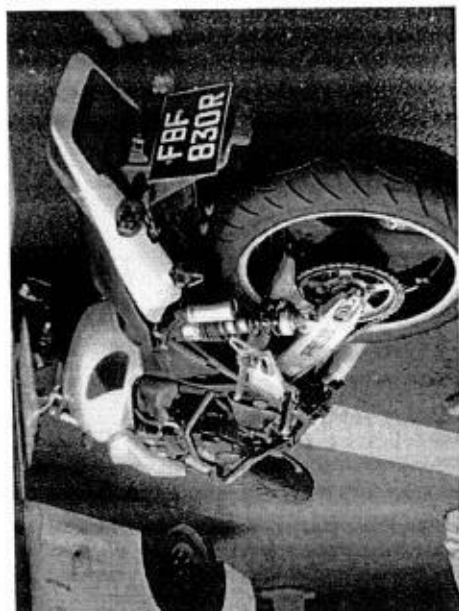
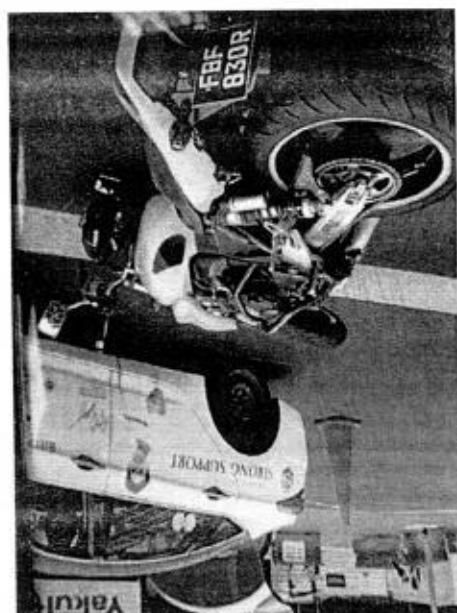
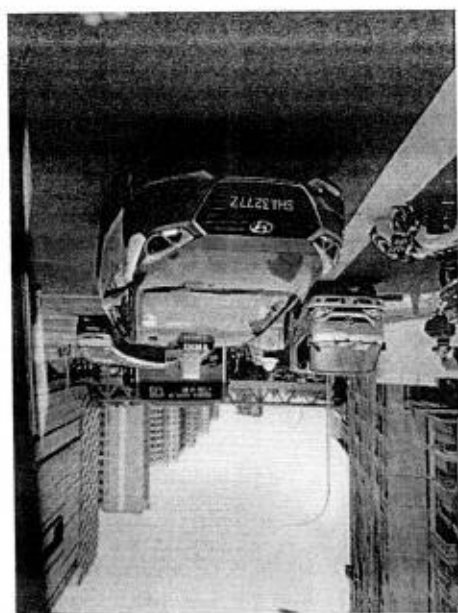
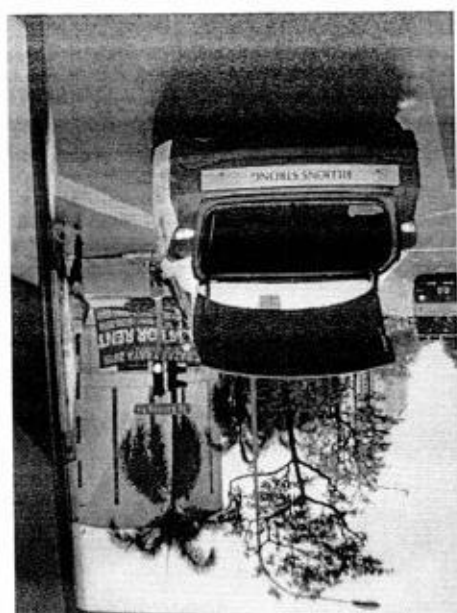
Qty	Description of Parts	Condition	Estimate By Workshop (\$)	Our Adjusted (\$)
	<u>REPLACEMENT OF PARTS</u>			
1	FRONT FENDER (RH)	BUCKLED	663.00	663.00
1	FRONT FENDER SHIELD (RH)	SERVICEABLE	174.90	-
1	FRONT FENDER RETAINER	SERVICEABLE	24.60	-
1	FRONT DOOR (RH)	BENT	2,256.40	2,256.40
1	FRONT DOOR MIRROR ASSY (RH)	BROKEN	670.00	670.00
1	FRONT WHEEL HUB CAP (RH)	SERVICEABLE	107.10	-
1	FRT RH WHEEL RIM	BENT	325.30	325.30
	LESS 20% DISCOUNT		-844.26	-782.94
			3,377.04	3,131.76
	<u>SPECIAL NETT ITEMS</u>			
1	FRONT FENDER ADVERTISEMENT LOGO (RH)(SN)	NECESSARY	100.00	100.00
1	FRONT DOOR COMFORT LOGO (RH)(SN)	NECESSARY	75.00	75.00
1	FRONT DOOR ADVERTISEMENT LOGO (RH)(SN)	NECESSARY	100.00	100.00

RECOMMENDED COST OF LUMP SUM REPAIRS (TO ITS PRE-ACCIDENT CONDITION) (CONFIRMED)			3,500.00
--	--	--	----------
