NTUC INCOME INSURANCE CO-OPERATIVE LTD		Ref: NS/INC19005957/K1qd3n2	
73 BRAS BASAH ROAD

1. Policy Particulars :- THIRD PARTY CLAIM			
Insured Veh.	SGN 1129A	Veh. Inspected	SHC 7116T
Policy No.	5087498276-01	Coverage (\$)	0.00
Claim No.	MT/1038897-002	Excess (\$)	0.00
Assign From		Assign Date	03/04/2019

4. Description of Damages			
THE VEHICLE SUSTAINED DAMAGES AT THE O/S FRONT PORTION.			
DAMAGES SEE DETAILS.			
5. General Information			
Accident Date	03/04/2019	Inspection Date	03/04/2019
Survey held at	COMFORTDELGRO ENGINEERING PTE LTD 59 LOYANG DRIVE SINGAPORE 508969		
5a. Remarks

ADJUSTMENT ON REPAIR COST FOR VEHICLE NO. SHC 7116T

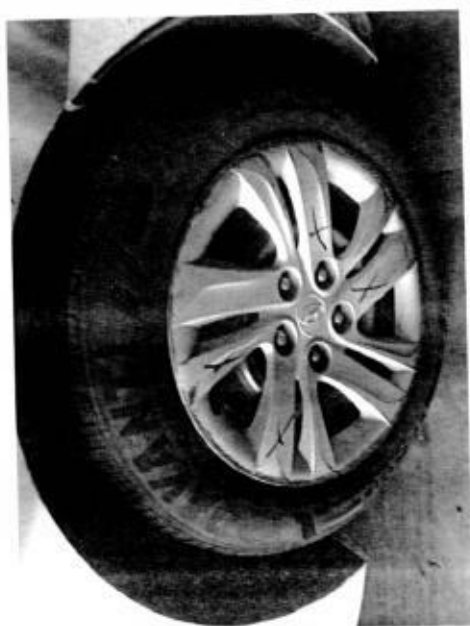
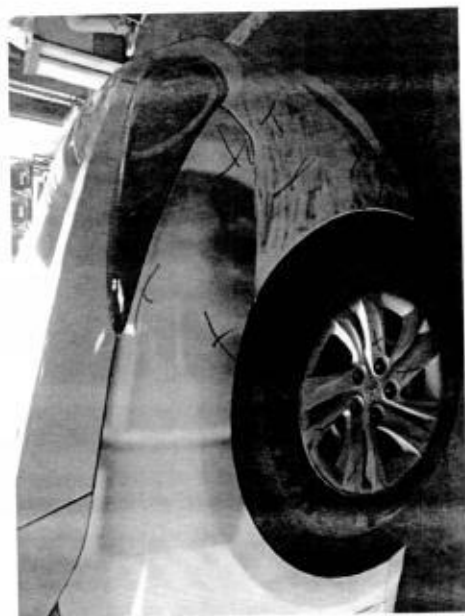
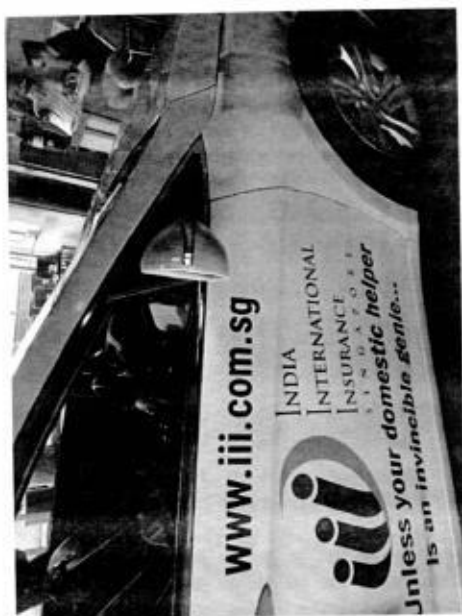
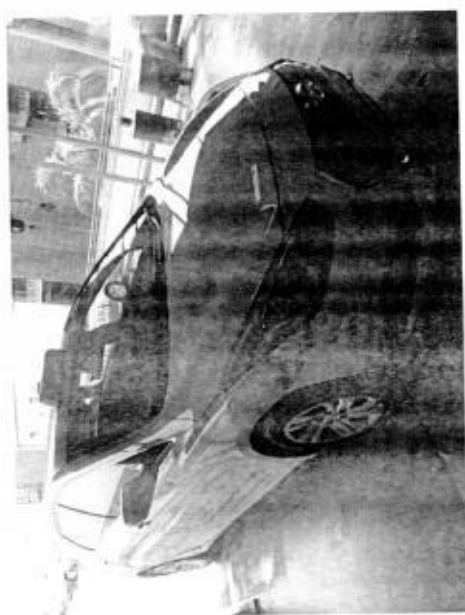
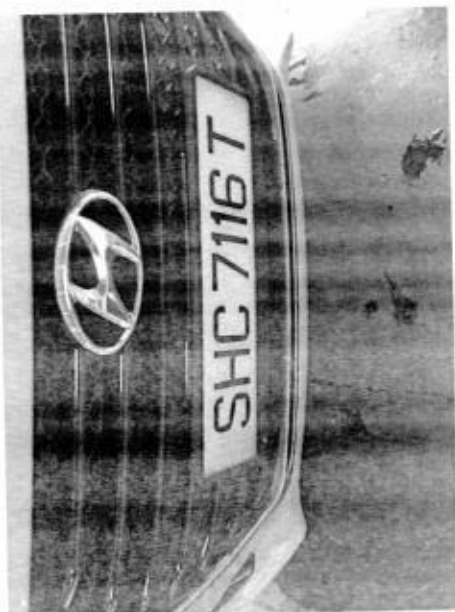
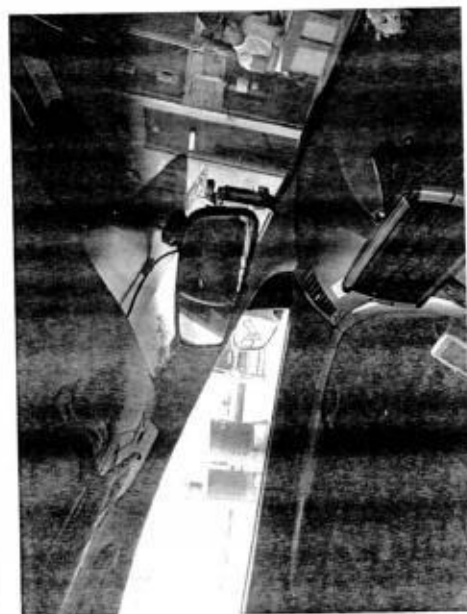
The U/C + Chassis frame / Body Structure affected due to collision.

Qty	Description of Parts	Condition	Estimate By Workshop (\$)	Our Adjusted (\$)
<u>REPLACEMENT OF PARTS</u>				
1	FRONT BUMPER COVER	DEFORMED	1,052.20	1,052.20
1	FRONT BUMPER SPONGE	SERVICEABLE	99.20	-
1	FRONT BUMPER REINFORCEMENT	SERVICEABLE	402.10	-
1	FRONT BUMPER GRILLE (RH)	SERVICEABLE	93.60	-
1	FRONT BUMPER GRILLE AIRDUCT (RH)	SERVICEABLE	26.20	-
1	FRONT BUMPER BRACKET TOP (RH)	SERVICEABLE	22.40	-
1	FRONT BUMPER BRACKET (RH)	CRACKED	24.60	24.60
1	HEADLAMP SUPPORT TOP COVER	SERVICEABLE	222.60	-
1	HEADLAMP SUPPORT PANEL ASSY	SERVICEABLE	907.40	-
1	HEADLAMP (RH)	SERVICEABLE	1,388.00	-
1	FRONT FENDER (RH)	DENTED	663.00	663.00
1	FRONT FENDER SHIELD (RH)	SERVICEABLE	174.90	-
1	WIPER CONTAINER	SERVICEABLE	61.90	-
1	WIPER CONTAINER MOTOR	SERVICEABLE	75.00	-
1	FRONT WHEEL HUB CAP (RH)	GRAZED	107.10	107.10
	LESS 20% DISCOUNT		-1,064.04	-369.38
			4,256.16	1,477.52
<u>SPECIAL NETT ITEMS</u>				
1	FRONT FENDER ADVERTISEMENT LOGO (RH)(SN)	NECESSARY	100.00	100.00

100.00	100.00
<u>LABOUR</u>				
	PANEL BEATING.		800.00	400.00
	SPRAY PAINTING CHARGE.		500.00	400.00
	WIRING CHARGE.	NOT NECESSARY	50.00	-
	TUFF KOTE.		50.00	20.00
	FRT WHEEL ALIGNMENT.	NOT NECESSARY	120.00	-
	REMOVE/REFIX AIRCON & REFILL GAS.	NOT NECESSARY	150.00	-
			1,670.00	820.00
GRAND TOTAL			6,026.16	2,397.52

RECOMMENDED COST OF LUMP SUM REPAIRS (TO ITS PRE-ACCIDENT CONDITION) (CONFIRMED)			1,900.00
--	--	--	----------
