Insured Vehicle No : GBD4301K

: SGJ3215S

## VEHICLE DAMAGE INSPECTION REPORT

NISSAN SUNNY, 1.6 EX (A) 07/07/2006 (Man. Year: 2006)

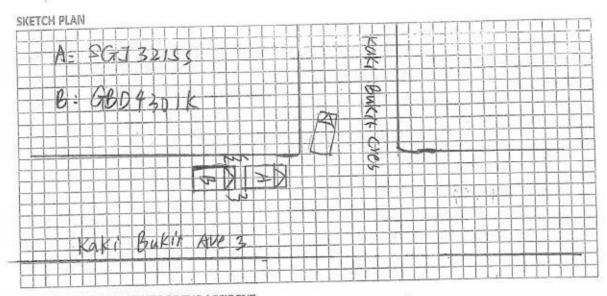
### Sketch Plan Pg. 2

On 04/04/2019 at about 08:00hrs, I was driving along the junction of Kaki Bukit Ave 3 & Kaki Bukit Cres, the front car slow down, I follow suit, suddenly I felt an impact from behind, I realized the lorry B: GBD4301K had hit onto the my car's rear portion.
