REF: NS/INC 190062191 & 15d302

4. Description of Damages

THE VEHICLE SUSTAINED DAMAGES AT THE O/S FRONT PORTION. DAMAGES SEE DETAILS.

ADJUSTMENT ON REPAIR COST FOR VEHICLE NO. SHC 8855L

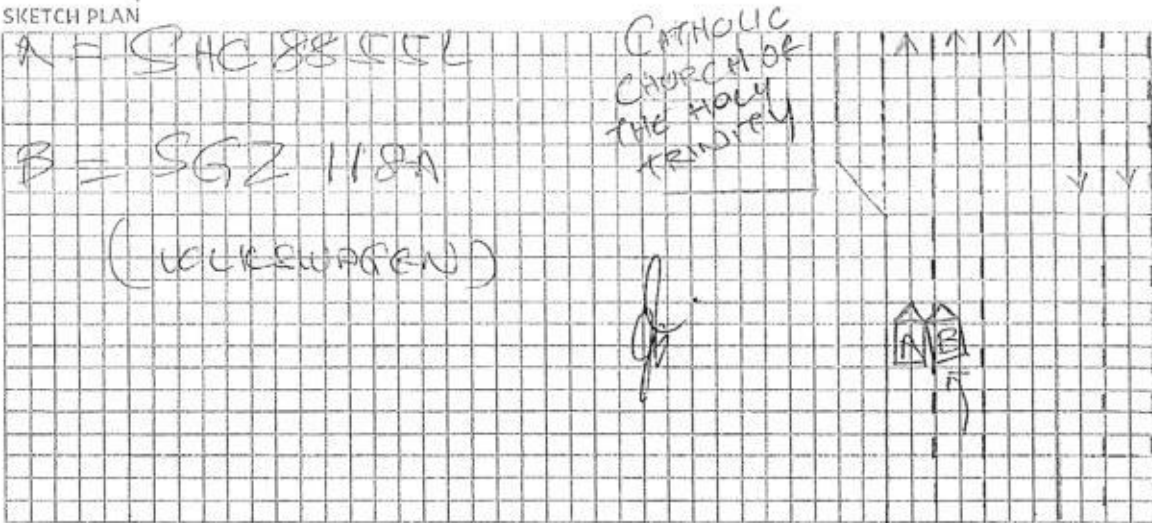
SKETCH PLAN

On the 06/04/2019 at about 13:10hrs, I was driving along Tampines Ave 2 towards PIE direction.

As I was driving suddenly vehicle SGZ118A encroached onto my lane and collided onto my right front and right wing mirror.

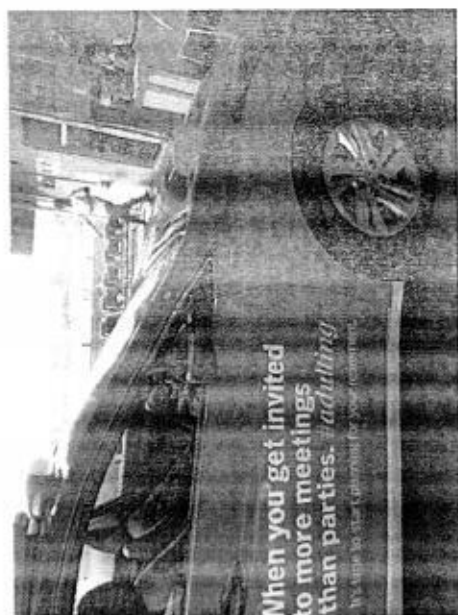
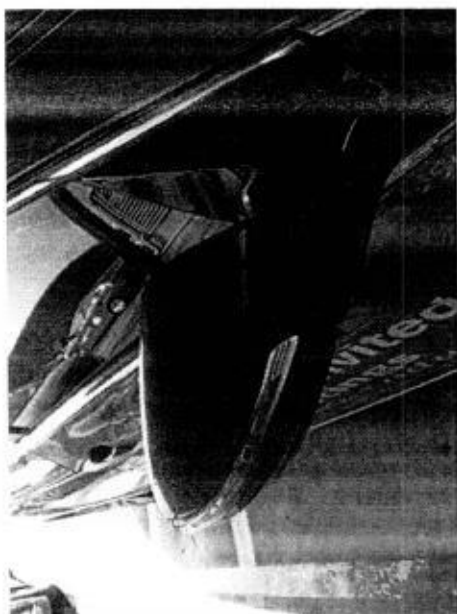
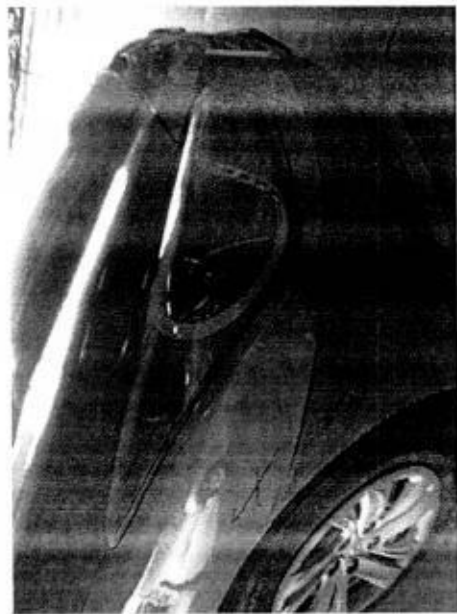
The U/C / Chassis frame / Body Structure affected due to collision.

Qty	Description of Parts	Condition	Estimate By Workshop (\$)	Our Adjusted (\$)
<u>REPLACEMENT OF PARTS</u>				
1	FRONT BUMPER COVER	TO REPAIR SEE LABOUR	544.50	-
1	FRONT BUMPER BRACKET TOP (RH)	SERVICEABLE	22.40	-
1	FRONT BUMPER BRACKET (RH)	SERVICEABLE	24.60	-
1	FRONT WHEEL HUB CAP (RH)	GRAZED	107.10	107.10
1	RH WING MIRROR (NPA)	TO REPAIR SEE LABOUR	-	-
	LESS 20% DISCOUNT		-139.72	-21.42

558.88	85.68
<u>SPECIAL NETT ITEMS</u>				
1	FRONT FENDER ADVERTISEMENT LOGO (RH)(SN)	NECESSARY	100.00	100.00
			100.00	100.00
<u>LABOUR</u>				
	PANEL BEATING.INCLUSIVE OF THE REPAIR OF FRONT BUMPER COVER AND RH WING MIRROR.		400.00	200.00
	SPRAY PAINTING CHARGE-FENDER/BUMPER.		600.00	450.00
	TUFF KOTE.	NOT NECESSARY	50.00	-
	FRT WHEEL ALIGNMENT.	NOT NECESSARY	80.00	-
			1,130.00	650.00
GRAND TOTAL			1,788.88	835.68
RECOMMENDED COST OF LUMP SUM REPAIRS (TO ITS PRE-ACCIDENT CONDITION) (CONFIRMED)				650.00
