To Inspect Vehicle No: YN3561H Insured: GX83014

Remark: The veh had commenced its repair at the time of inspection.

ESTIMATED COST OF REPAIR FOR ISUZU NMR85UH5A 3.0 MT (2012) YN3561H

VEHICLE DAMAGE INSPECTION REPORT

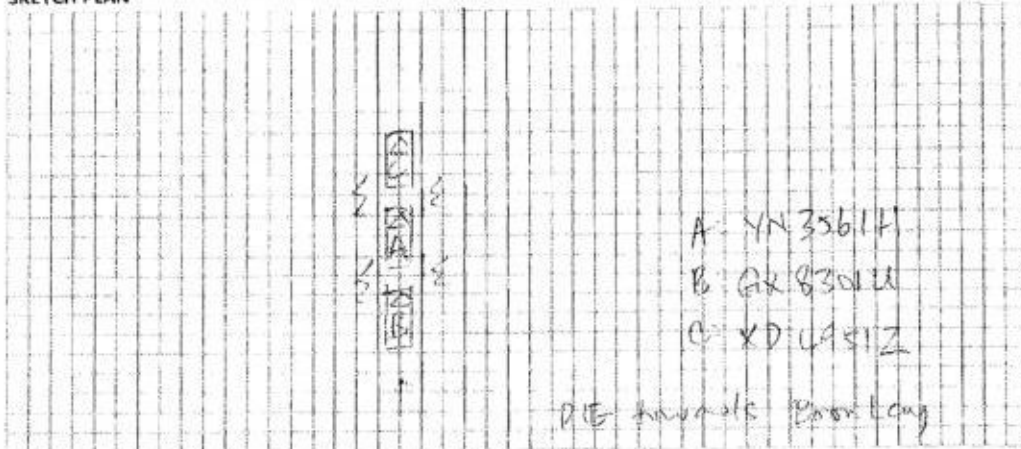
SKETCH PLAN

I WAS coming to a stop as Vehicle C brake. Suddenly Vehicle B collided into my rear and pushing me forward to hit Vehicle C. I have some discomfort and will be seeing doctor.
