NTUC INCOME INSURANCE CO-OPERATIVE LTD Ref: NS/INC19006397/K1qd3n2				
73 BRAS BASAH ROAD #05-01 NTUC TRADE UNION HOUSESINGAPORE 189556			Date: 06-05-2019

4. Description of Damages				
THE VEHICLE SUSTAINED DAMAGES AT THE N/S FRONT PORTION. DAMAGES SEE DETAILS.				
5. General Information				
Accident Date	04/04/2019	Inspection Date	08/04/2019	
Survey held at	COMFORTDELGRO ENGINEERING PTE LTD 59 LOYANG DRIVE SINGAPORE 508969			
5a. Remarks				
A)THE INSPECTION WAS CONDUCTED ON A"WITHOUT PREJUDICE" BASIS. B)IN ACCORDANCE TO YOUR INSTRUCTIONS, WE HAVE NOT AUTHORISED REPAIRS.				
5b. Estimate Days of Repair				
ESTIMATED NORMAL PERIOD FOR REPAIR:		3 Working Days

ADJUSTMENT ON REPAIR COST FOR VEHICLE NO. SHC 956G

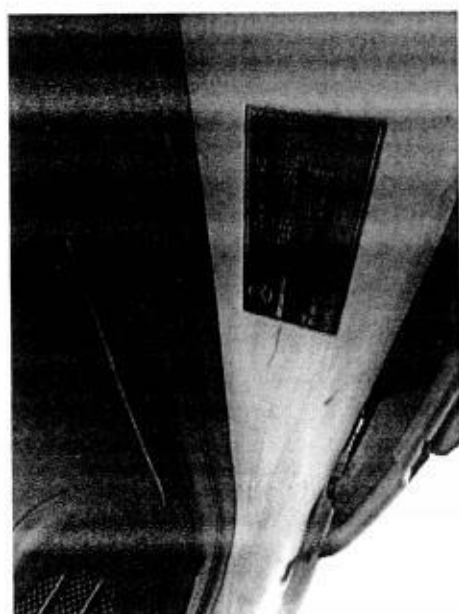
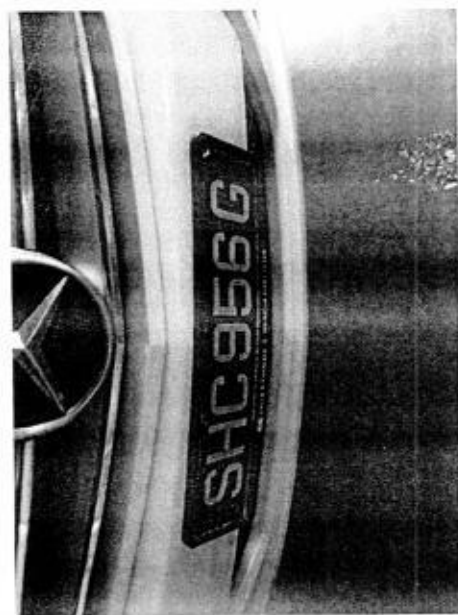
The UIC / Chassis frame / Body Structure affected due to collision.

Qty	Description of Parts	Condition	Estimate By Workshop (\$)	Our Adjusted (\$)
REPLACEMENT OF PARTS				
1	HEAD LAMP ASSY, LH	GRAZED	3,620.00	3,620.00
1	FENDER, FRT/LH	DENTED	1,320.00	1,320.00
1	FRONT BUMPER (NPA)	TO REPAIR SEE LABOUR	-	-
	LESS 20% DISCOUNT		-988.00	-988.00
			3,952.00	3,952.00
LABOUR				
	PANEL BEATING. INCLUSIVE OF THE REPAIR OF FRONT BUMPER.		400.00	200.00
	SPRAY PAINTING CHARGE -FENDER/BUMPER.		600.00	400.00
	WIRING CHARGE.		30.00	20.00
	TUFF KOTE.		50.00	20.00
			1,080.00	640.00
GRAND TOTAL			5,032.00	4,592.00
RECOMMENDED COST OF LUMP SUM REPAIRS (TO ITS PRE-ACCIDENT CONDITION)(CONFIRMED)				3,650.00
