ACCIDENT INVOLVING SLT 2564D & SHD 4832ZZ ALONG CTE ON 22.12.18

Statement Of Claim On Veh No: SLT 2564D

SYNOPSIS OF DAMAGES

ADJUSTMENT ON REPAIR COST FOR VEHICLE NO. SLT 2564D

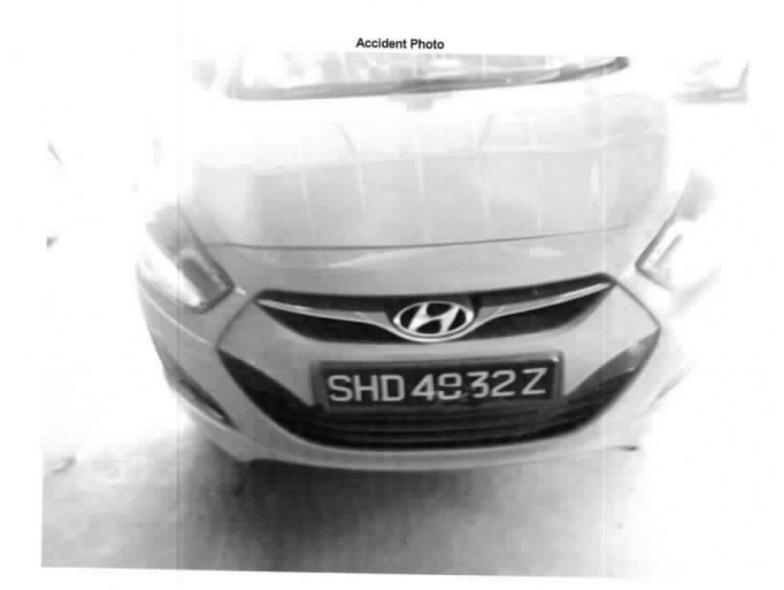
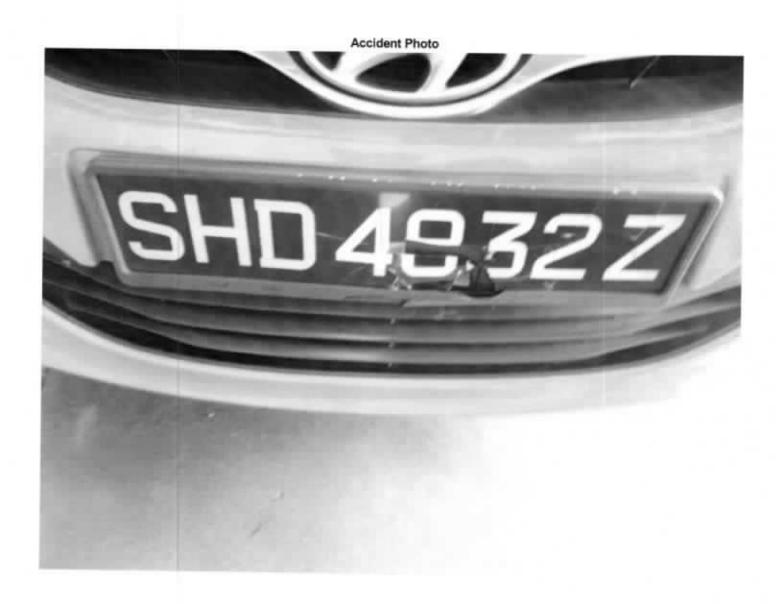
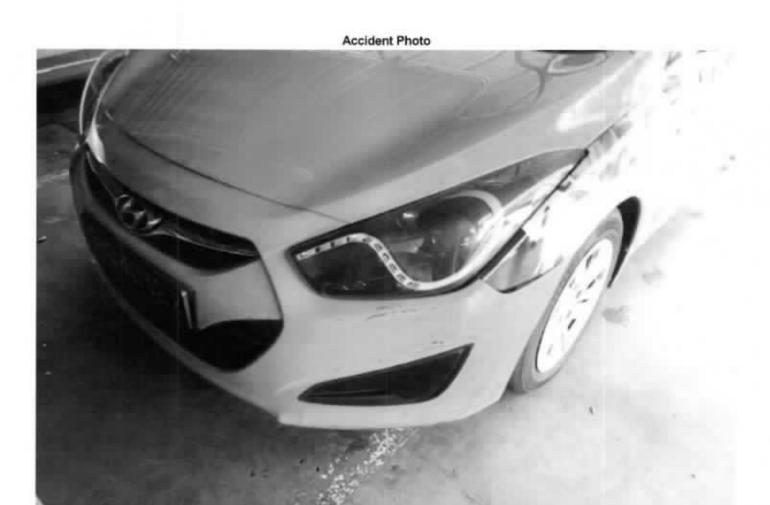
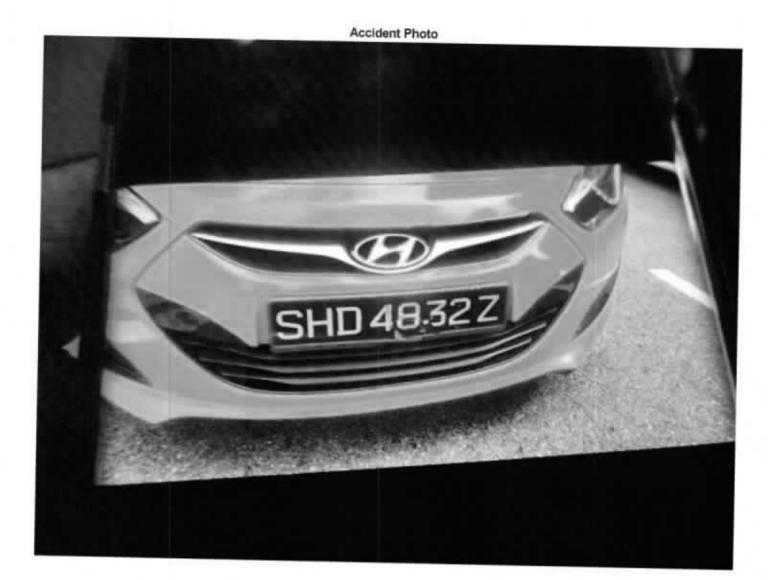
Accident Photo

4.		Descr	iption of Damages		
	THE VEHICLE SU	STAINED DAMAGES AT THE	REAR PORTION.		
	DAMAGES SEE D	ETAILS.			
5.		Ger	eral Information	CONTROL OF	
	Accident Date	22/12/2018	Inspection Date	27/12/2018	
	Survey held at	HENDON AUTOMOTIVE			
		280 WOODLANDS IND PAR #01-11 SINGAPORE 75732			
5a.		STATE OF STREET	Remarks		
		ON WAS CONDUCTED ON A CE TO YOUR INSTRUCTION			
5b.		Estim	ate Days of Repair	PER	
	ESTIMATED NORMAL PERIOD FOR REPAIR: 6 Working Days

RECOMMENDED COST OF LUMP SUM REPAIRS	3,800.00
(TO ITS PRE-ACCIDENT CONDITION)

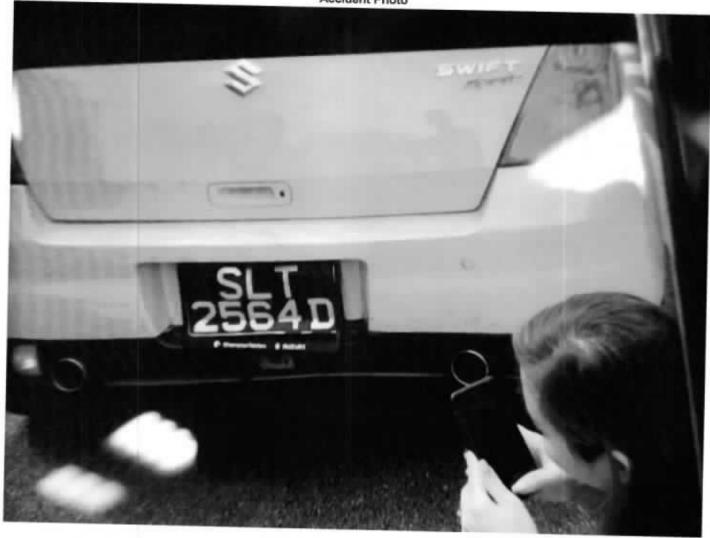
I then step out of my vehicle and made a check on my vehicle damaged. My vehicle exhaust pipe was shifted, the rear bumper clip was lose and my vehicle registration plate number was dented. In addition, the plate number holder was lose and the grill to rear had fallen apart.

At the time of survey, we noted that the vehicle has sustained an impact damages on the rear portions.
