Report Reference : TP / 18038-05/AY / 2018

THIRD PARTY SURVEY

ACCIDENT HAPPENED ON 15 May 2018

VEHICLE DAMAGE INSPECTION REPORT

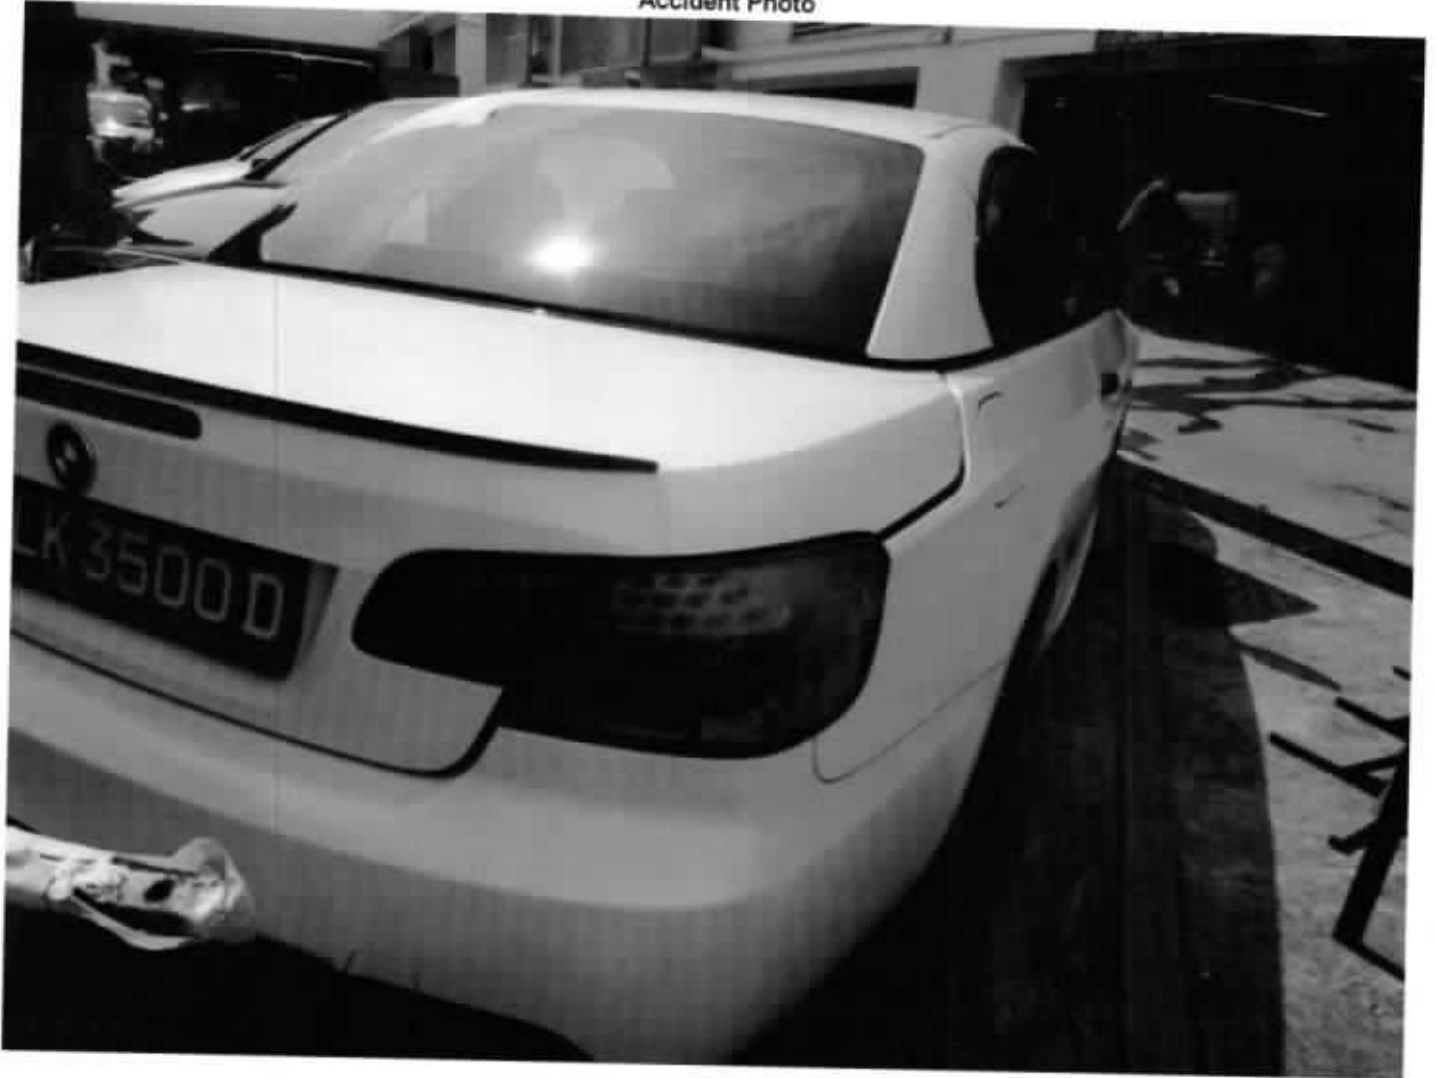
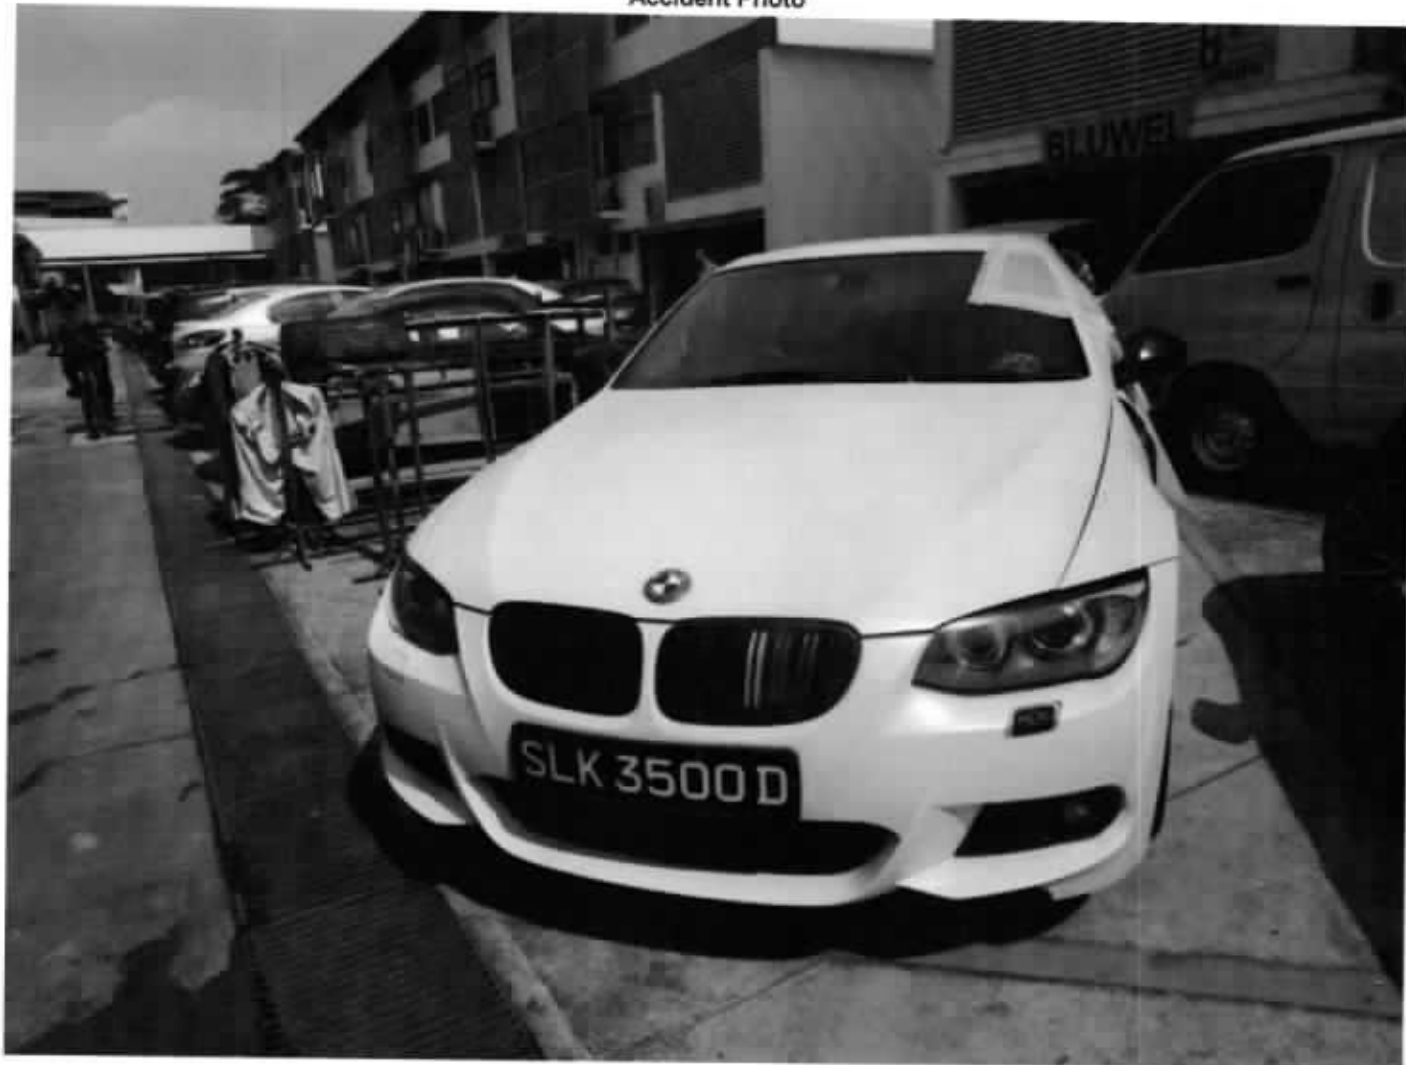
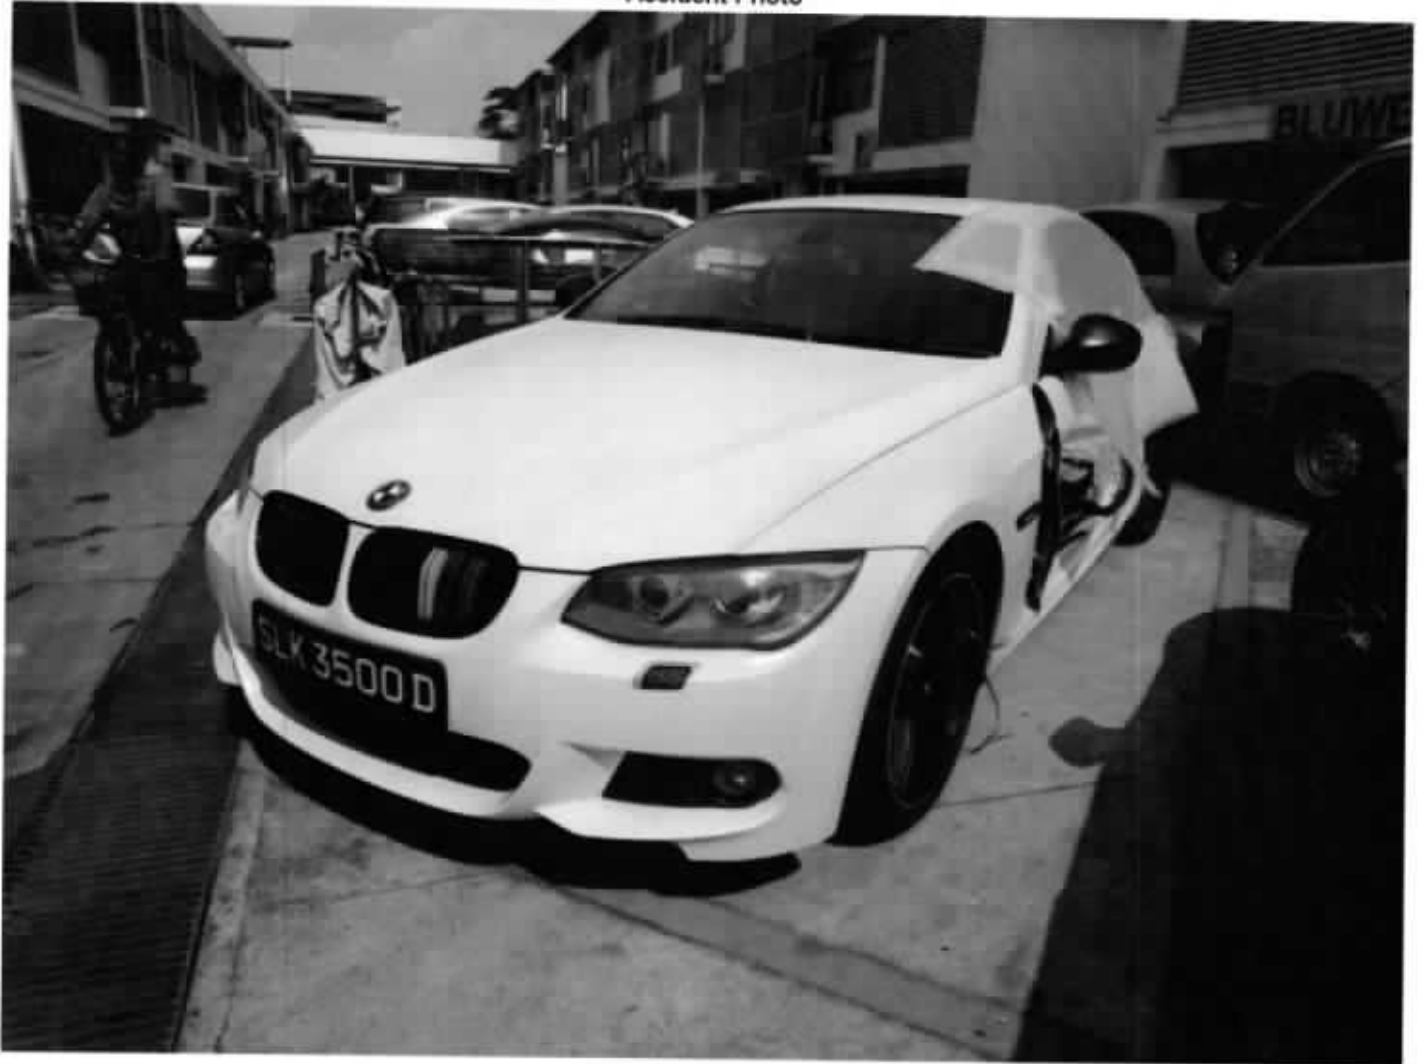
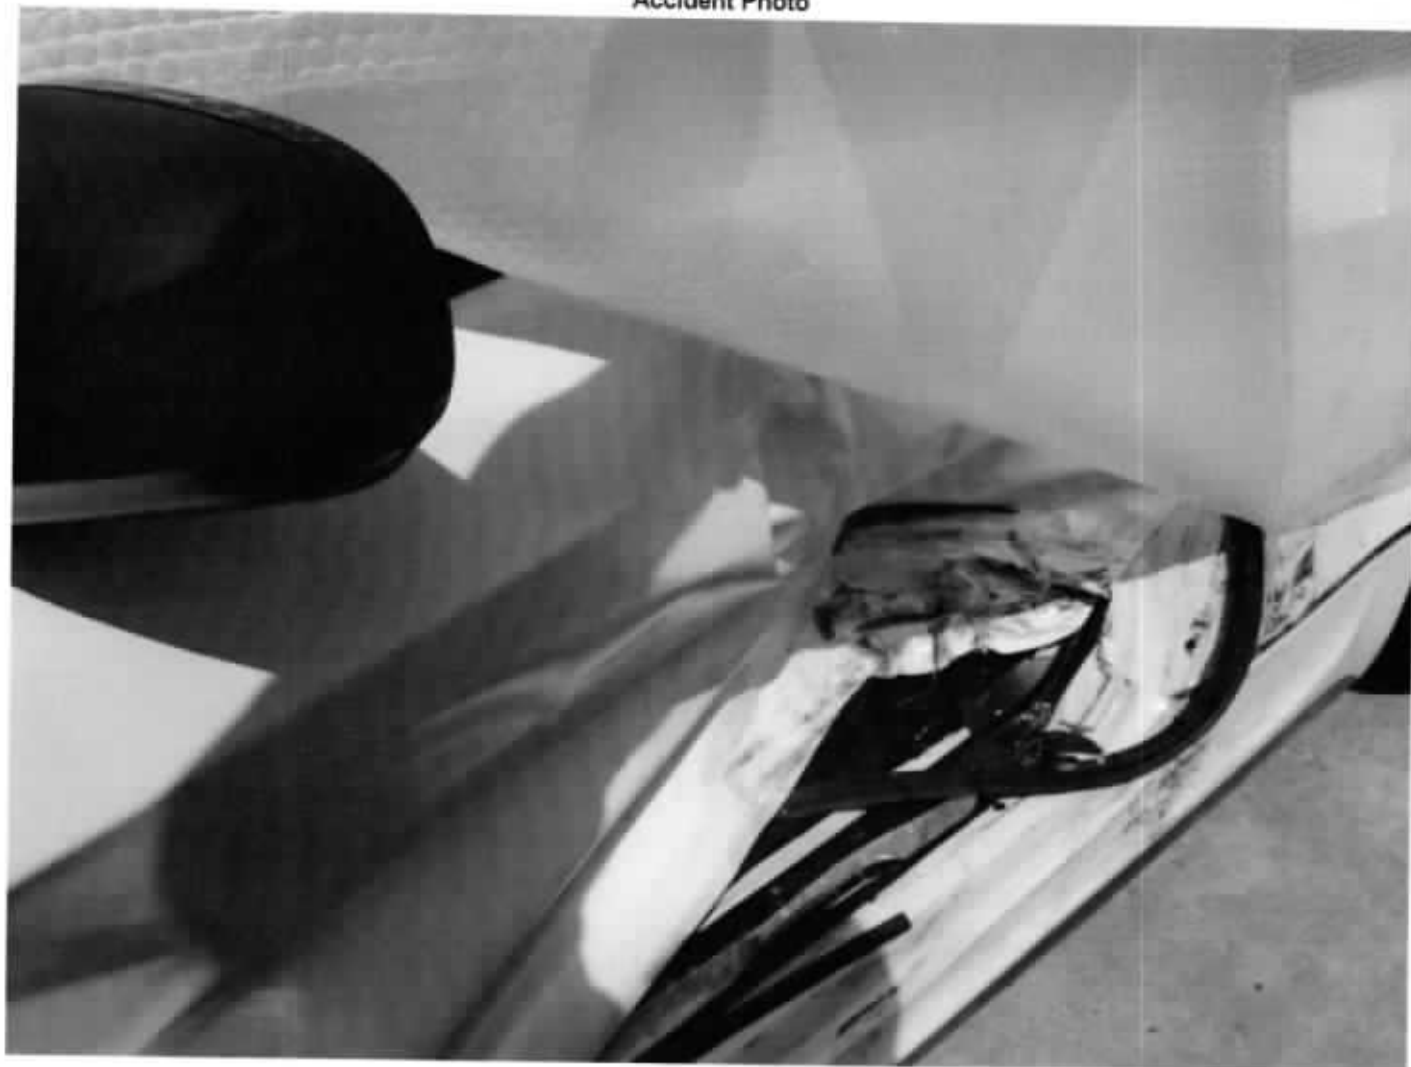
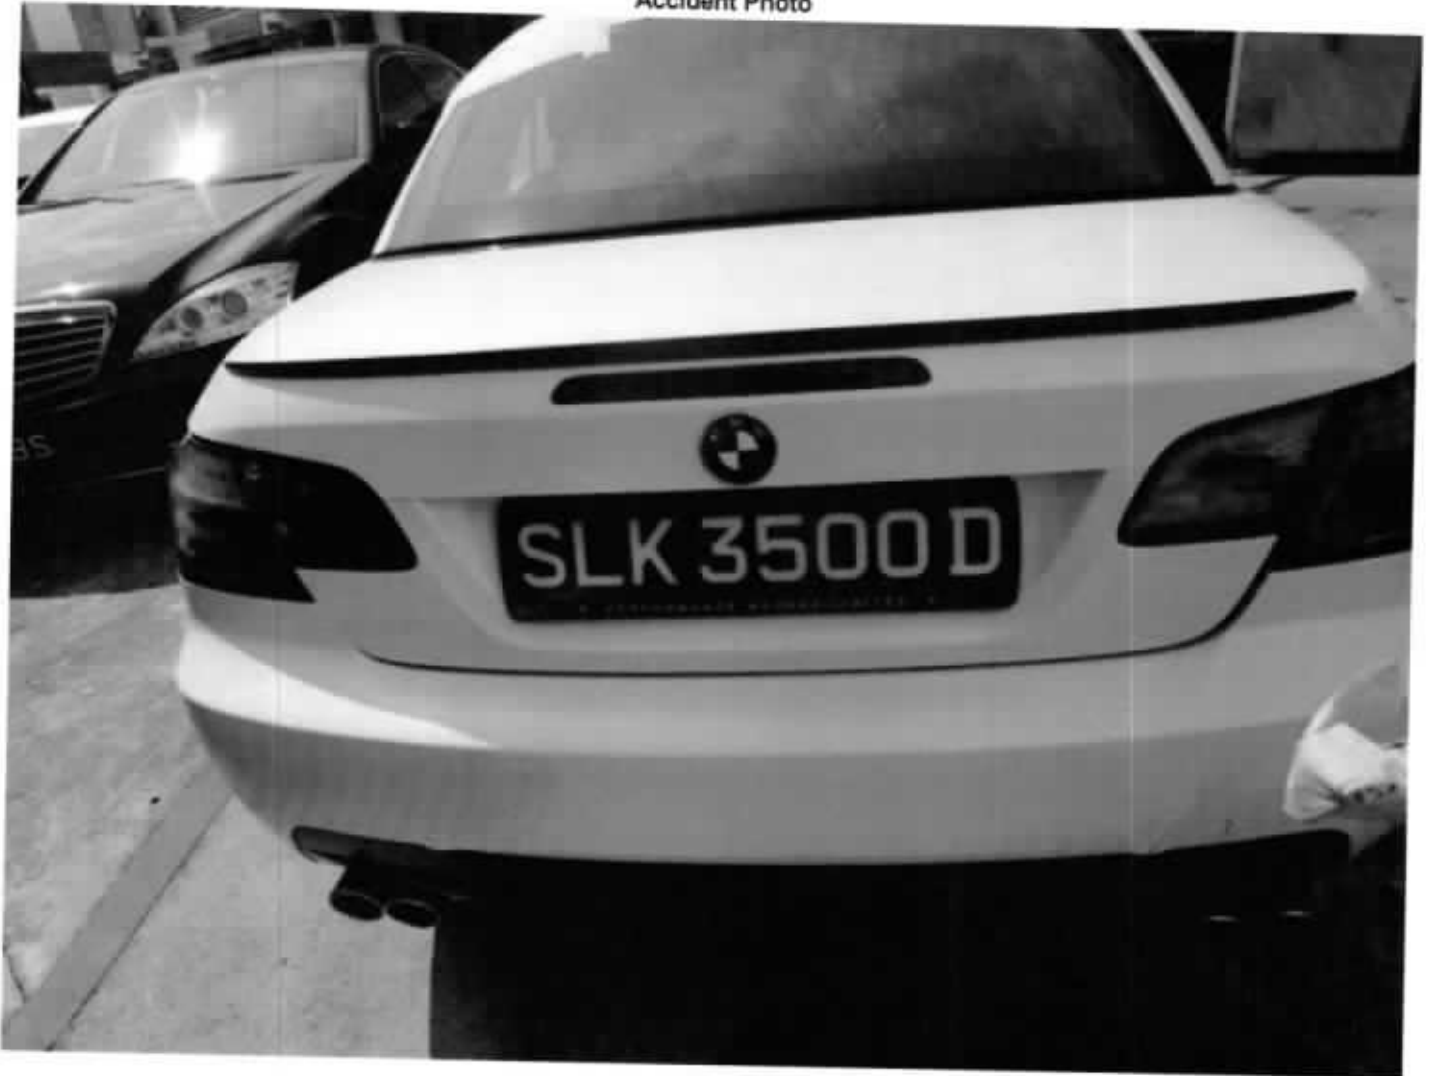
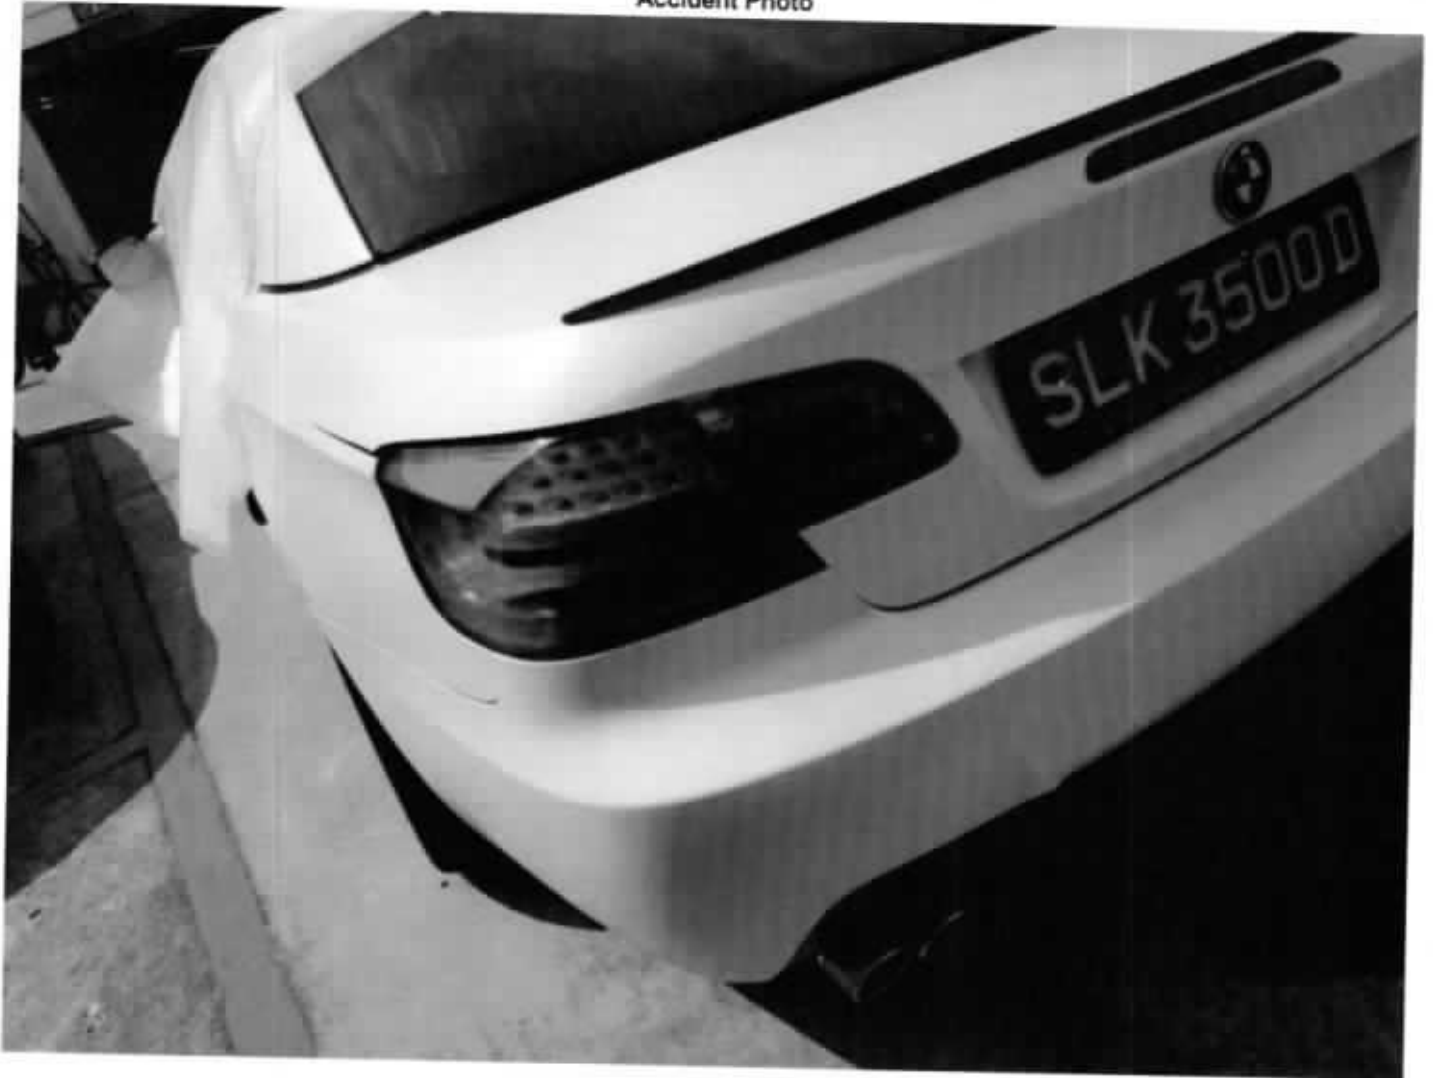
Accident Photo

At the time of inspection, we noted that the vehicle has sustained an impact damages on the n/s portion(s). For more detail of the damages, please see photograph attached.
