ASSIGNMENT

Veh No: SMF1077L Yr Regn: 2018 Oct  
 Type: M.Cam / M.Cycle / Bus / Van / Lorry / Taxi / Prime Mover /  
 Truck / Trailer or  
 Make: Audi A3 Sedan c.c. 1395  
 Colour: White A/C: Insured / Std / Nil / NA  
 Sp. Reading: 7765 T/Radio: Insured / Std / Nil / NA  
 Eng/No: \_\_\_\_\_  
 C/No: WAUZZZ8V6J1077661  
 Gen. Cond: Good / Fair / Poor / Burnt  
 Steering: In order / Jammed / Leaked / Burnt or  
 Brake: In order / Jammed / Leaked / Burnt or  
 Modi: Nil / S/Rim / STD A/Rim or  
 Tyre Size: F: 205/55R16  
 R: 205/55R16  
BS / DUN / EXNOVA / GY / FS / LIZA / MIC / OHTSU / PIR / SUMI /  
 TOYO / YOKO or

Estimate : Accident Repairs  
Workshop : Ubi Road 1  
Contact No : 6366 2323  
Fax No : 6841 1183  
Reference : PA/OD/0472/2019/DY  
Date : 11-Apr-19

### VEHICLE DAMAGE INSPECTION REPORT

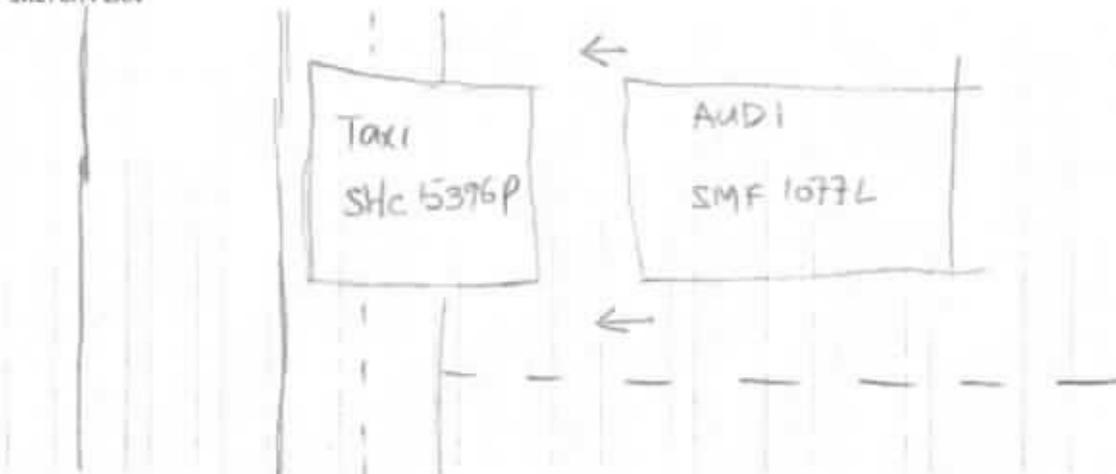
SKETCH PLAN

On 9 April 2019 at around 2:10 pm, I was driving on the rightmost lane along Beach Road heading West towards City Hall. There was a red Trans Cab taxi (vehicle no. SHC 5396P) travelling in front of my vehicle.

As we approached the junction at Ophir Road, the traffic light turned amber. At this point, the taxi was very near the stop line and still travelling at the same speed or before. Just moments before reaching the stop line the brake lights of the taxi came on. However, due to the speed at which it was travelling, the taxi continued to move ahead past the stop line. It only came to a complete halt when the taxi was already partially in the pedestrian crossing ahead, with only the rear wheels still on the stop line.

Due to the speed at which the taxi was travelling it ~~appeared~~ <sup>was clear</sup> that the vehicle ~~could~~ <sup>could not</sup> have stopped in time to stop before the stop line, and I had expected it to maintain its speed to clear the junction before the light turned red.

While driving, I had kept a safe distance between my vehicle and the taxi, but as I did not expect the taxi to brake so suddenly so close to the stop line, I was

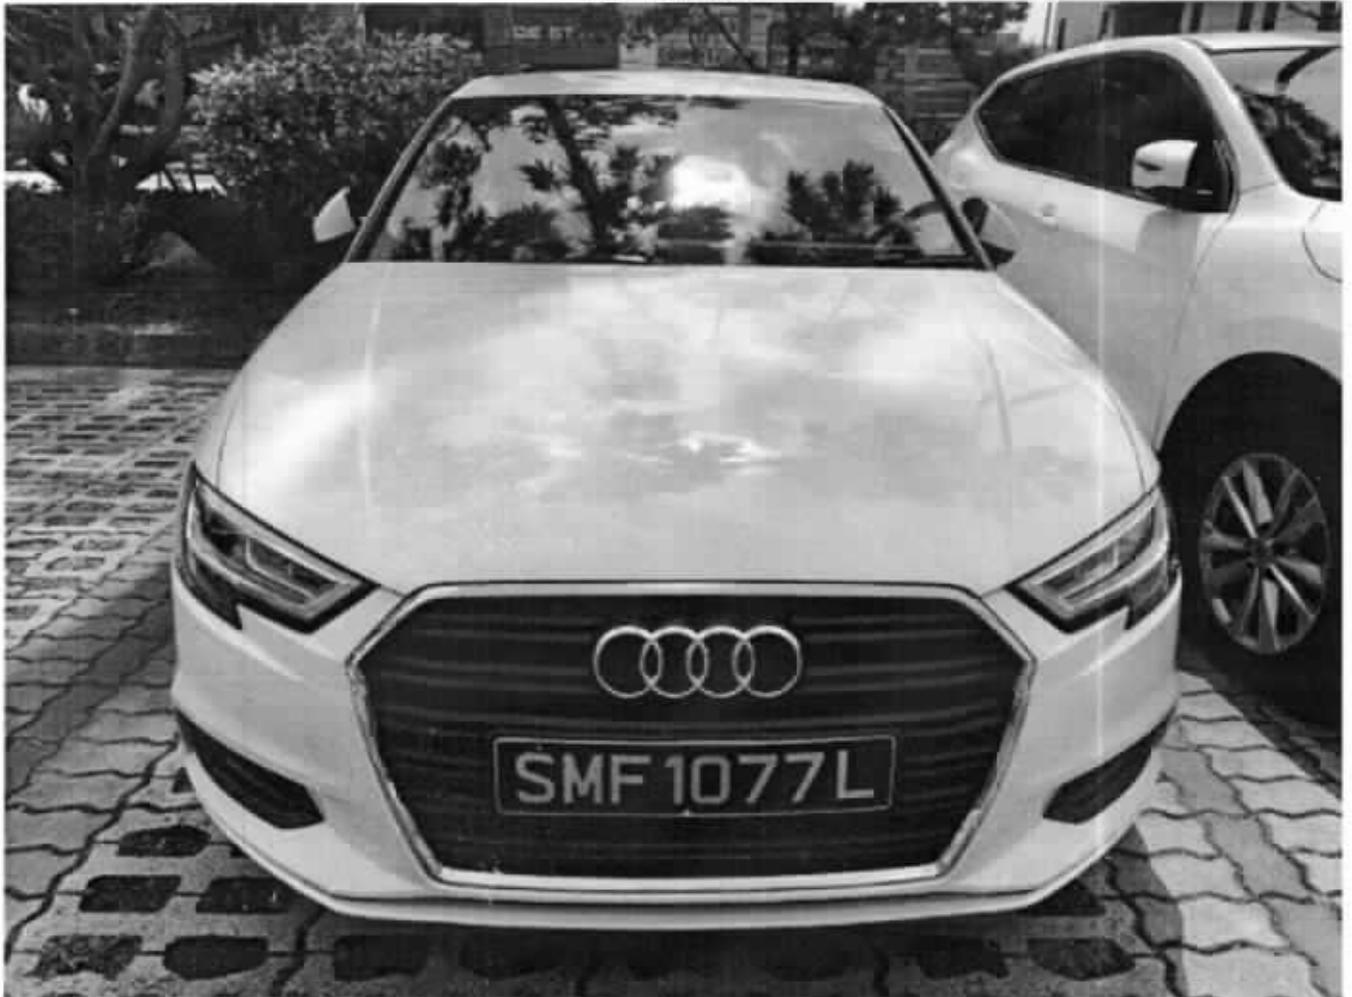
Accident Photo

The U/C / Chassis frame / Body Structure affected due to collision.

No.	Qty	Part No.	Particulars	Condition	Repairer's	Amount
1	1		*FRONT BUMPER COVER	Deformed	1,667.00 FS	*1,333.60 FS
2	1		*FRONT BUMPER FIXING PARTS	Not Necessary	170.00 FS	*- FS
3	1		*FRONT BUMPER GRILLE	Not Necessary	134.00 FS	*- FS
4	1		*CLOSING ELEMENT - LH	Not Necessary	445.00 FS	*- FS
5	1		*CLOSING ELEMENT - RH	Not Necessary	270.00 FS	*- FS
6	1		*COVER TRIM FOR CLOSING ELEMENT - LH	Not Necessary	135.00 FS	*- FS
7	1		*COVER TRIM FOR CLOSING ELEMENT - RH	Not Necessary	135.00 FS	*- FS
8	1		*FRONT RADIATOR GRILLE	Cracked	1,176.00 FS	*940.80 FS
9	1		*CLOSING ELEMENT	Cracked	158.00 FS	*126.40 FS
10	1		*SIDE REINFORCEMENT	Not Necessary	660.00 FS	*- FS
11	1		*FOAM FILLER PIECE	Not Necessary	157.00 FS	*- FS
12	1		*COVER FOR FOAM FILLER PIECE	Not Necessary	111.00 FS	*- FS
13	1		*STICKER FOR AIR CONDITIONER	Necessary	6.00 FS	*5.12 FS
14	1		*CAUTION STICKER	Necessary	12.00 FS	*9.76 FS
15	1		*LED HEADLIGHT - LH	Not Necessary	5,458.00 FS	*- FS

16	1		*LED HEADLIGHT - RH	Not Necessary	5,458.00 FS	*- FS
17	1		*FRONT NUMBER PLATE	Necessary	40.00 FS	*40.00 FS
18	1		*SUNDRIES	Not Necessary	500.00 FS	*- FS
19	1		*RADIATOR AIR GUIDE LH	Cracked	17.12 FS	*17.12 FS
20	1		*RADIATOR AIR GUIDE RH	Cracked	17.12 FS	*17.12 FS

No	Particulars	Lab.Type	Repairer's	Amount
<b>Labour Items</b>				
1	TO REMOVE AND REINSTALL FRONT WIRE HARNESS FOR HEADLIGHTS, HORNS, OUTSIDE TEMPERATURE SENSOR HEADLIGHT WASHER ASSY	New	360.00	360.00
2	TO DISMANTLE AND RENEW FRONT BUMPER AND BOTH HEADLIGHTS. TO REPAIR BONNET. RE-ORGANISE CRASH MANAGEMENT COMPONENTS. REINSTALL ALL PARTS REMOVED	New	2,100.00	500.00
3	TO RESPRAY FRONT BUMPER AND BONNET	New	1,500.00	1,100.00
4	TO CARRY OUT DIAGNOSTIC CHECK	New	192.00	192.00
<b>Gross Labour Cost (S\$)</b>			<b>4,152.00</b>	<b>2,152.00</b>
