## ASSIGNMENT (Office)

To Inspect Vehicle No: SG C 2711U

Remark: The veh had commenced its  
repair at the time of inspection.

## VEHICLE DAMAGE INSPECTION REPORT

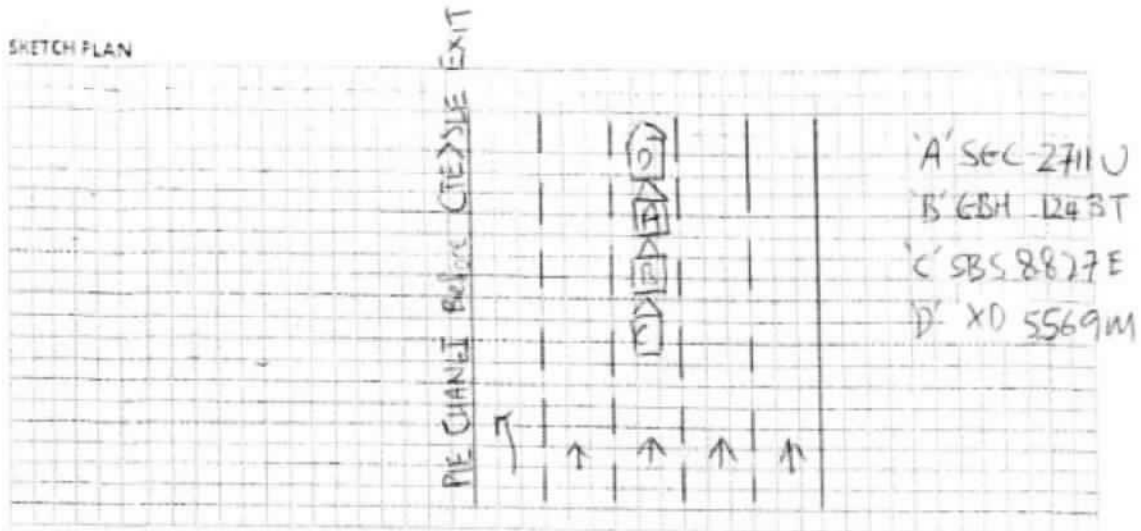
## SKETCH PLAN

On the stated date, time and location I vehicle A was travelling along the stated venue. As the front vehicle stopped, I stopped. After about 40 seconds of stopping, I felt a huge impact from causing me to propel forward the rear. Within the 40 seconds of stopped time I witness vehicle B from the rear had also come to a complete stopped. My vehicle suffered damages from rear and the front. So there is a total of 4 cars chain collision.

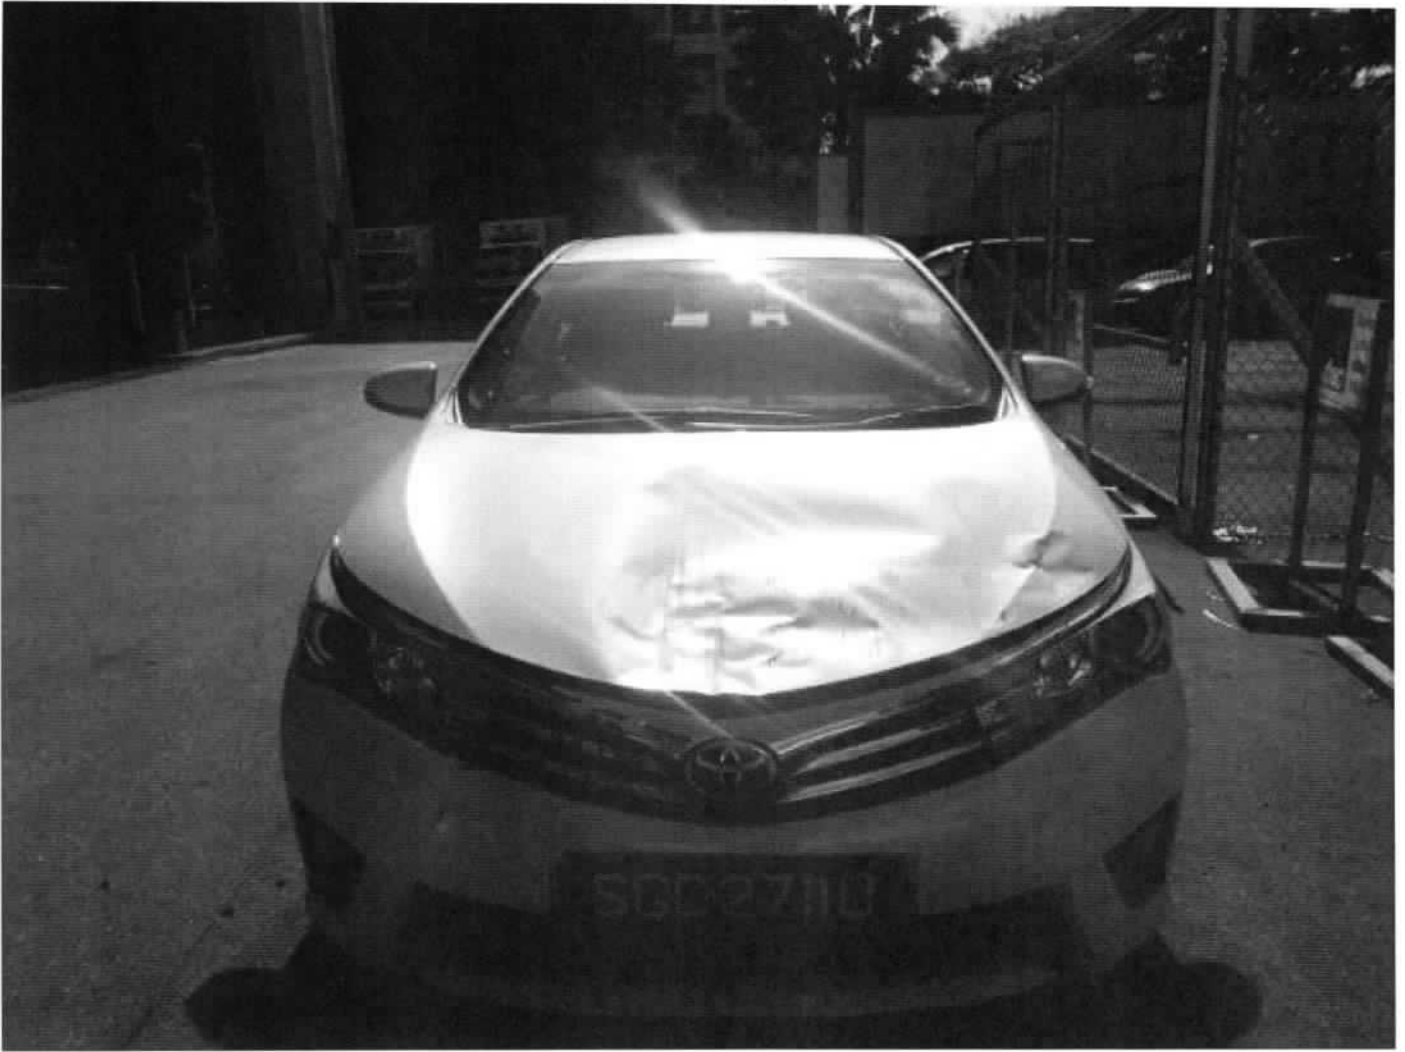
Accident Photo

The U/C / Chassis frame / Body Structure affected due to collision.
