VEHICLE ASSESSMENT REPORT

Ref. No : YBL/1808/FBE8893
Date : 30 November 2018

Vehicle No.	: FBE 8893 L	Date of Accident	: 06 August 2018
Make	: Yamaha	Date of Assignment	: 13 August 2018
Model	: YZF-R15	Date of Inspection	: 13 August 2018
Year	: 2010	Date of Re-inspn.	: 30 August 2018
Chassis No	: ME120P022A2005727	Odometer	: 82643 km
Engine No	: Blocked	Color	: Black/red

VEHICLE DAMAGE INSPECTION REPORT

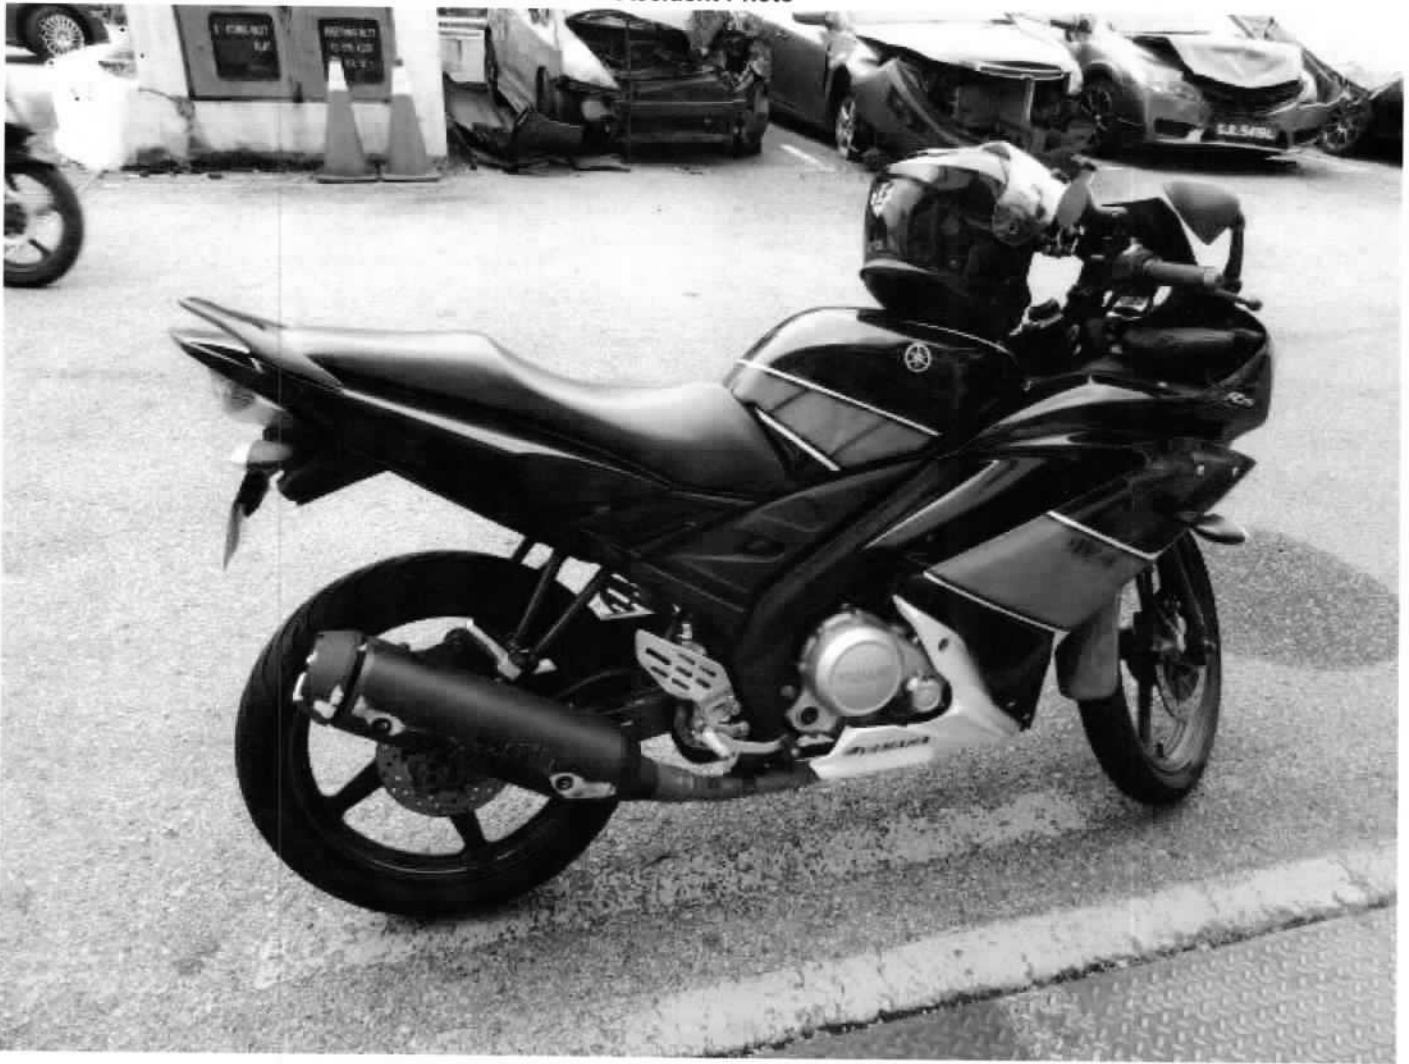
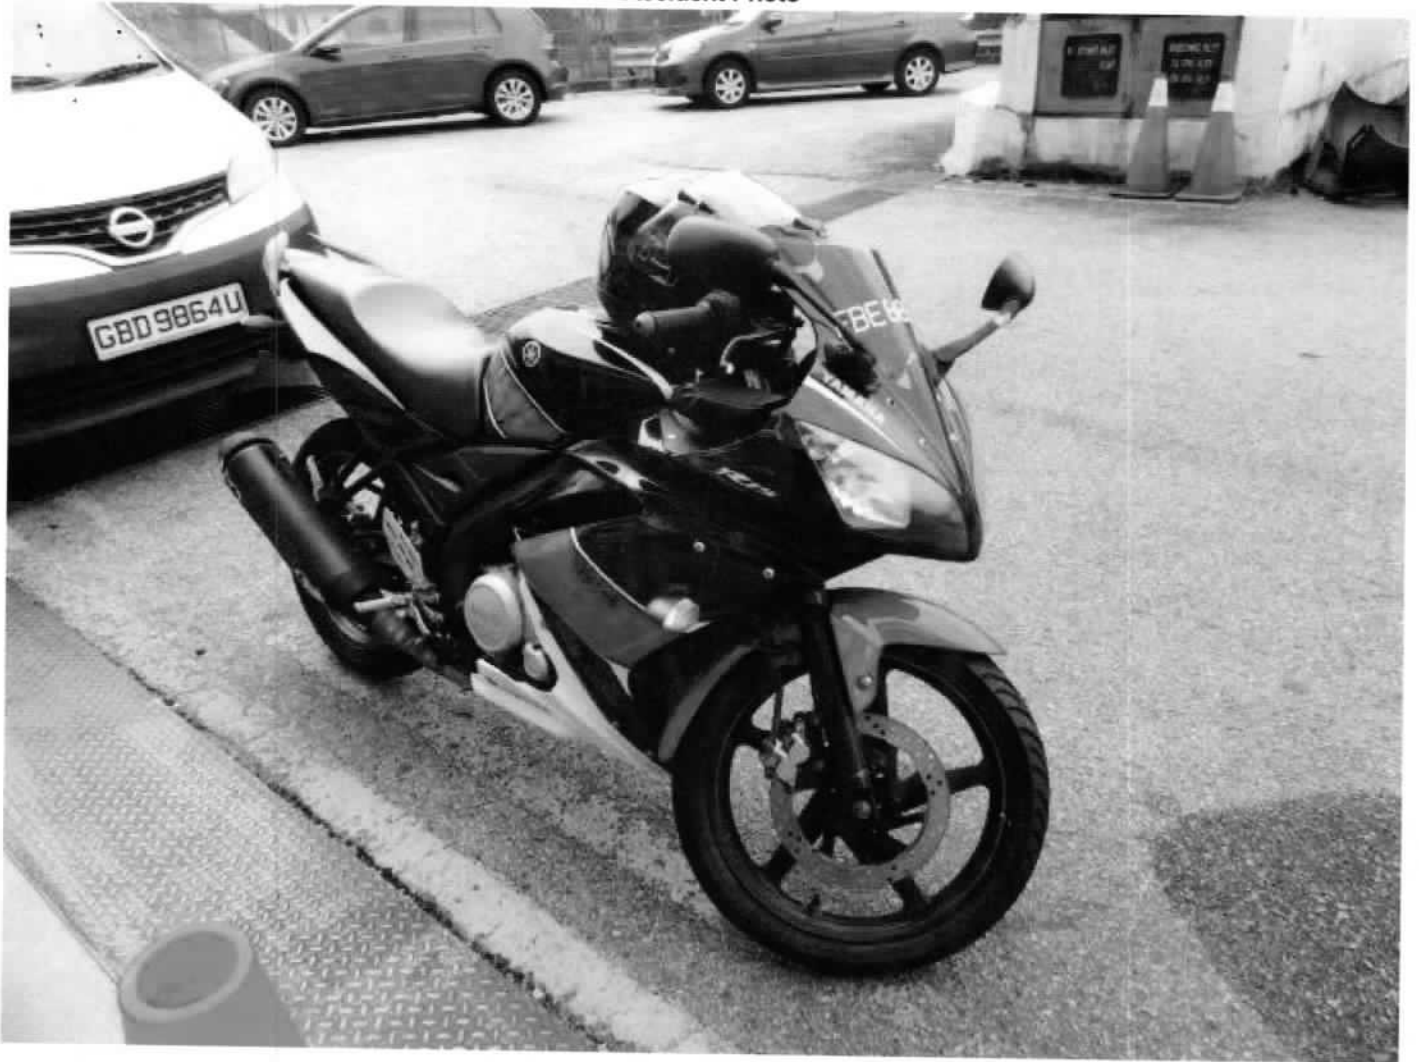
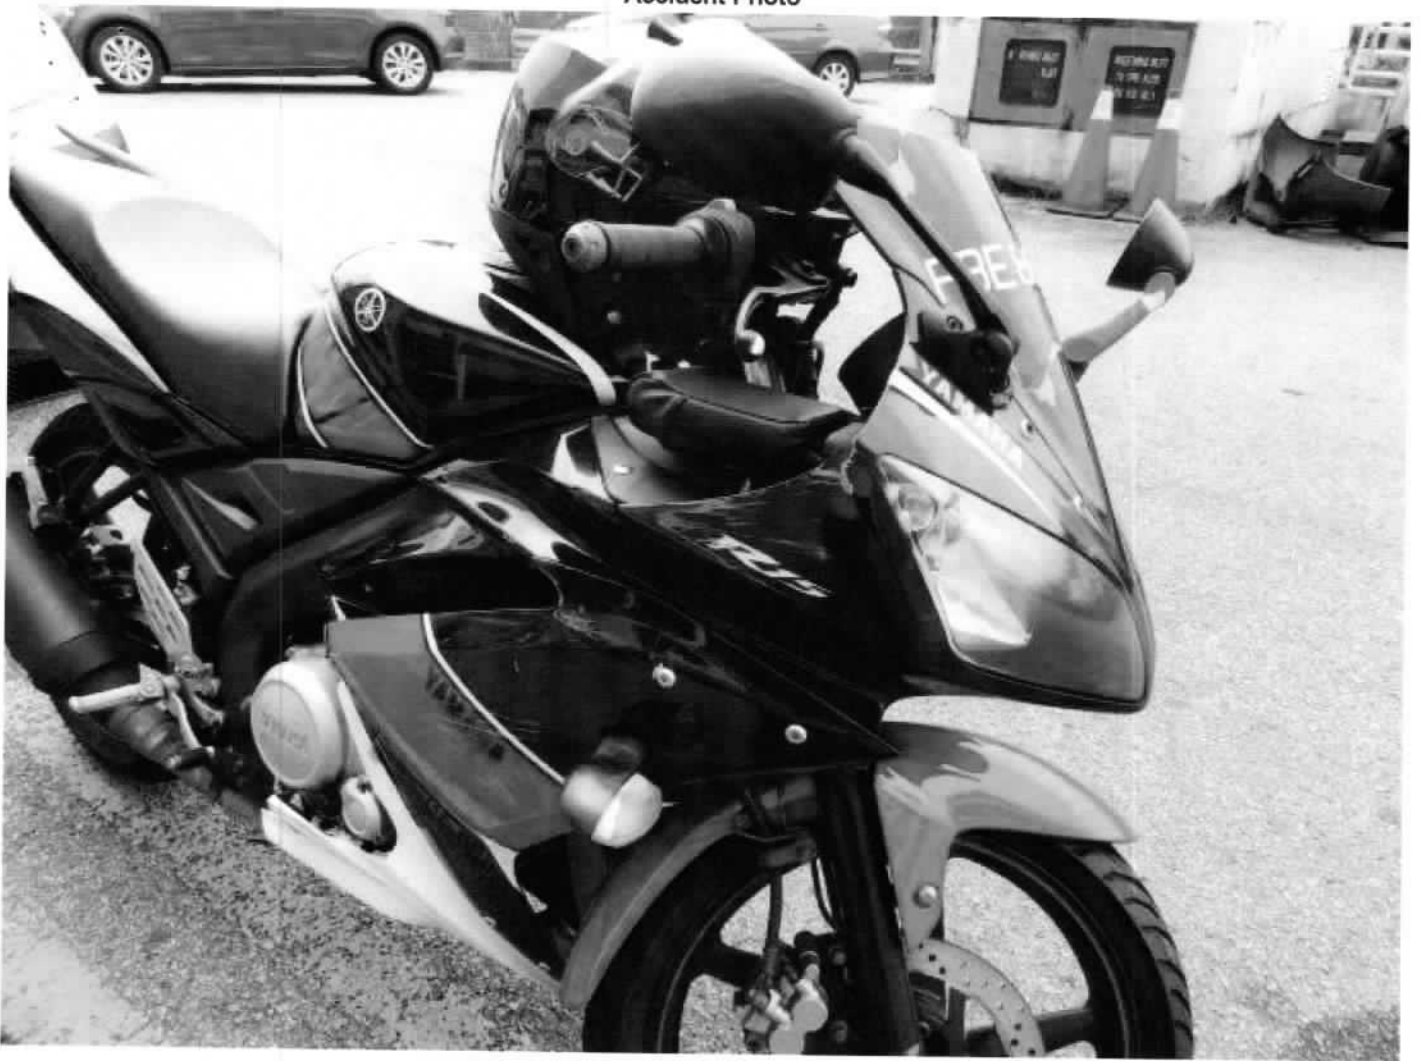
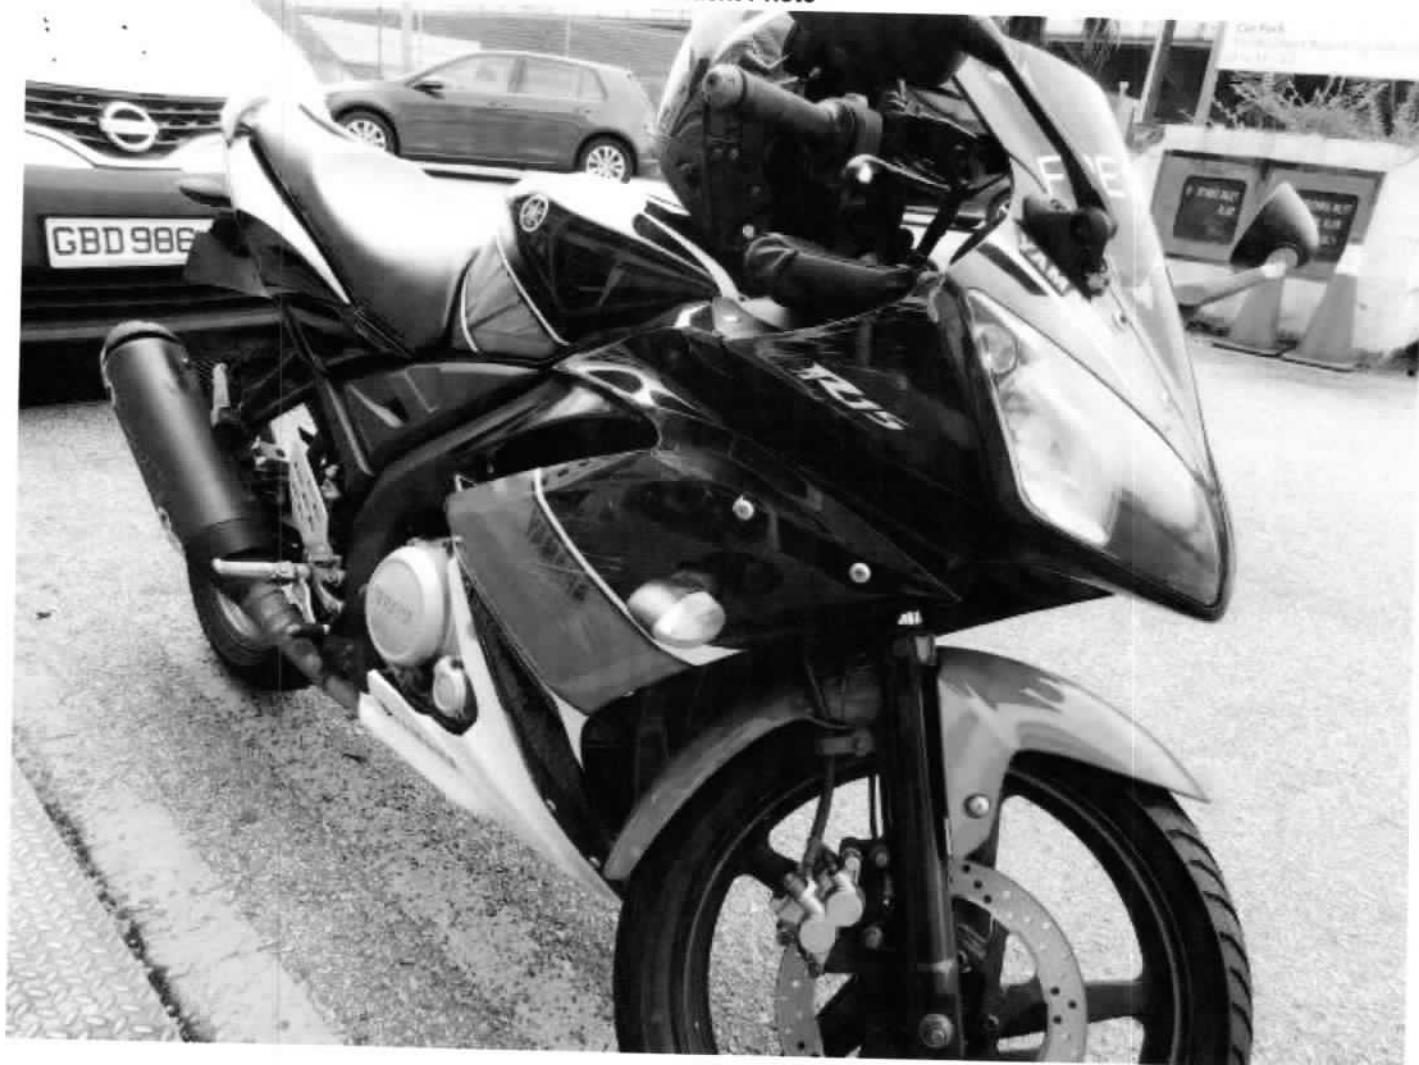
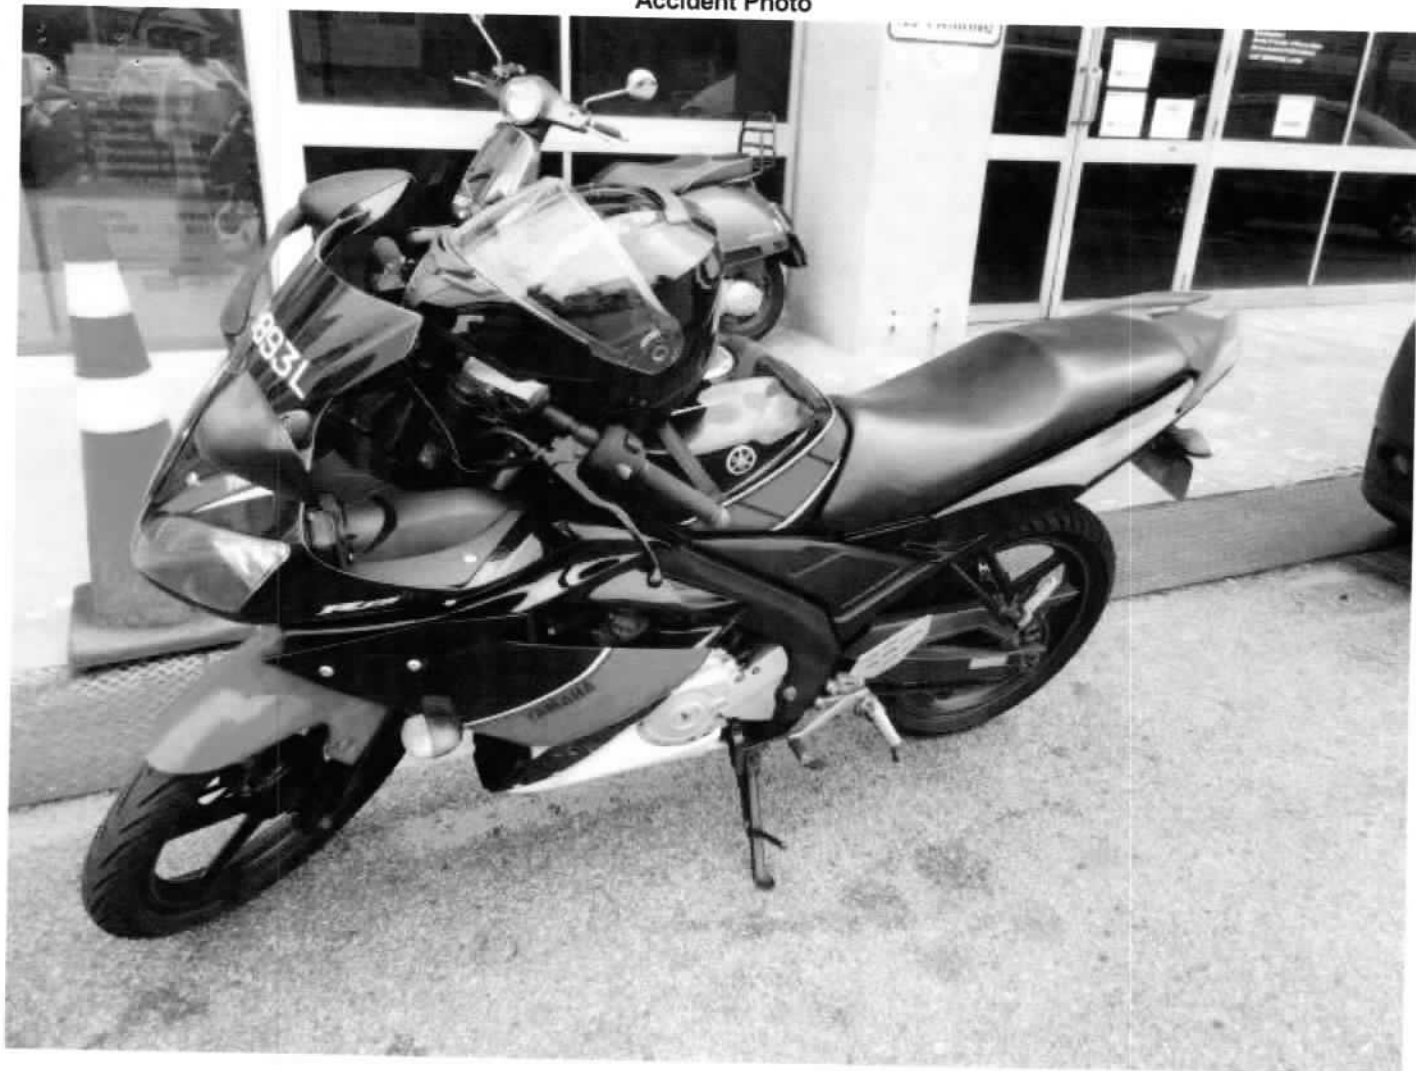
The motor cycle sustained damage at rear and right side.

<u>S/N</u>	<u>Description</u> <u>Material</u>	<u>Qty</u>	<u>Condition</u>	<u>Original</u> <u>Quotation</u>	<u>Revised</u> <u>Quotation</u>
1	Top cowling assy	1 pc	Grazed	290.00	290.00
2	Cowling screen	1 pc	Scratches	90.00	90.00
3	Cowling stay	1 pc	Bent	85.00	85.00
4	Handle bar	1 pc	Bent	80.00	80.00
5	Handle balancer	1 set	Grazed RH	50.00	25.00
6	Brake lever	1 pc	Cut	22.00	22.00
7	Mirror assy RH	1 pc	Grazed	75.00	75.00
8	Head lamp	1 pc	Cut/grazed	240.00	240.00
9	Front signal RH	1 pc	Grazed	60.00	60.00
10	Front fender	1 pc	Deformed	95.00	95.00
11	Front side fairing RH	1 pc	Grazed	185.00	185.00
12	Side fairing inner cover RH	1 pc	Cracked	105.00	105.00
13	Fuel tank	1 pc	Repair	640.00	S.N. 180.00
14	Front footrest RH	1 pc	Bent	45.00	45.00
15	Brake pedal	1 pc	Bent	58.00	58.00
16	Pillion footrest RH	1 pc	Usable	42.00	~
17	Rear seat bar	1 pc	Cut	48.00	48.00
18	Rear centre top cover	1 pc	Deformed	38.00	38.00
19	Rear side fairing @ \$185/-	2 pcs	Graze/deformed	370.00	370.00

20	Tail lamp	1 pc	Broken	115.00	115.00
21	Rear rim	1 pc	Warped	390.00	390.00
22	Rear mudguard	1 pc	Deformed	98.00	98.00
23	Rear number plate lamp	1 pc	Usable	55.00	~
24	Rear signal @ \$60/-	2 pcs	Grazed/cut	120.00	120.00
25	Exhaust protector	1 pc	Dented	108.00	108.00
26	Exhaust pipe assy	1 pc	Graze/dented	850.00	850.00
				4,354.00	3,592.00
			Less 10%	435.40	359.20
				3,918.60	3,232.80
	Add special nett from above				180.00
27	Front number plate	1 pc	Necessary	12.00	12.00
28	Rear number plate	1 pc	Bent	12.00	12.00
29	Rear number plate holder	1 pc	Bent	68.00	68.00
			Total parts	4,010.60	3,504.80

Revised Assessment : \$ 3,400.00 Lump sum.

<u>Labour & Misc</u>		
1) Transportation x 2	70.00	✓ 60.00
2) Front rim realign	80.00	40 60.00
3) Front fork realign	120.00	✓ 100.00
4) Chassis frame /swing arm realign	350.00	200 300.00
5) Workmanship	280.00	200 250.00
Total parts and labour charges	<u>4,910.60</u>	<u>4,274.80</u>
Final lump sum repair adjustment	600	<u>3,400.00</u>
