**RE: Road Traffic Accident on 5/12/2018
Kiralay Automobile Pte Ltd**

In accordance with your instructions received in this office on **12/12/2018**, we made arrangements to examine the vehicle on **12/12/2018** at above-mentioned address. The following data was recorded:

VEHICLE DAMAGE INSPECTION REPORT

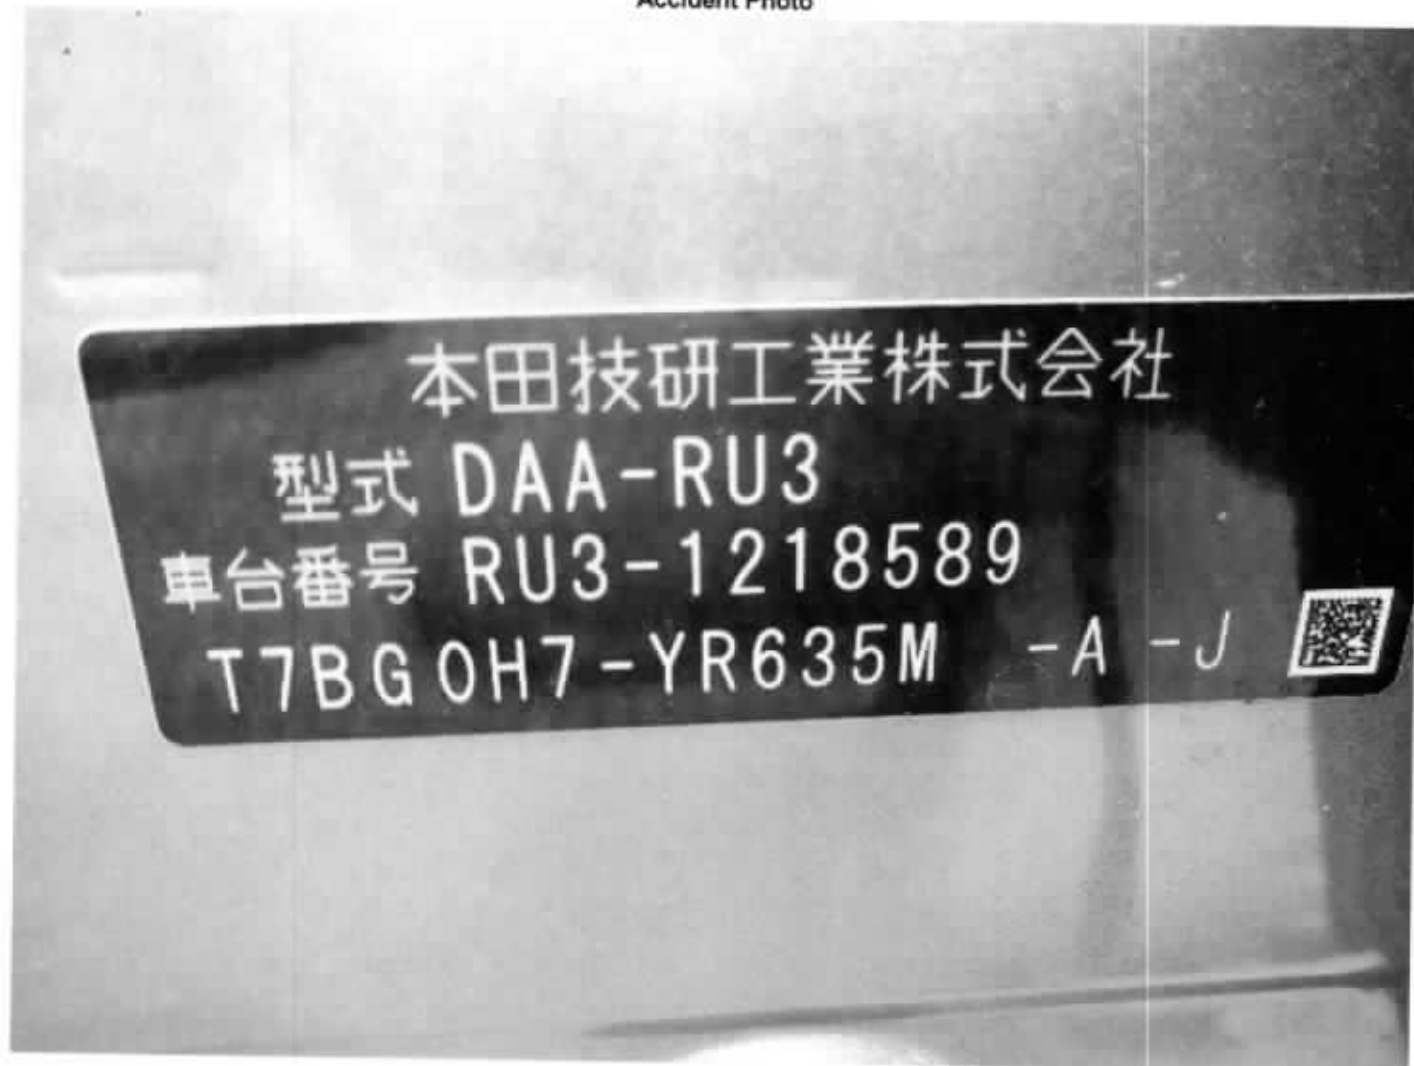
Accident Photo

MY CAR SLM4565A WAS PARKED IN A PARKING LOT . UPON COLLECTION OF MY CAR , THE DRIVER'S OF GBD3616J HAD APPROACHED ME AND INFORMED ME THAT HIS VAN HAD COLLIDED ONTO THE FRONT PORTION (RH) OF MY CAR WHILE HE WAS REVERSING.
