Certificate of Insurance

RMG TOURS PTE. LTD.
C/o 10 Hoe Chiang Road #13-03A Keppel Towers Singapore 089315
ACCIDENT INVOLVING GBG 6748B & **YP 5816A** AT SIN MING INDUSTRIAL ESTATE
SECTION A BEFORE TURN INTO SECTOR B ON 26.02.2019

VEHICLE INSPECTION REPORT

VEHICLE DAMAGE INSPECTION REPORT

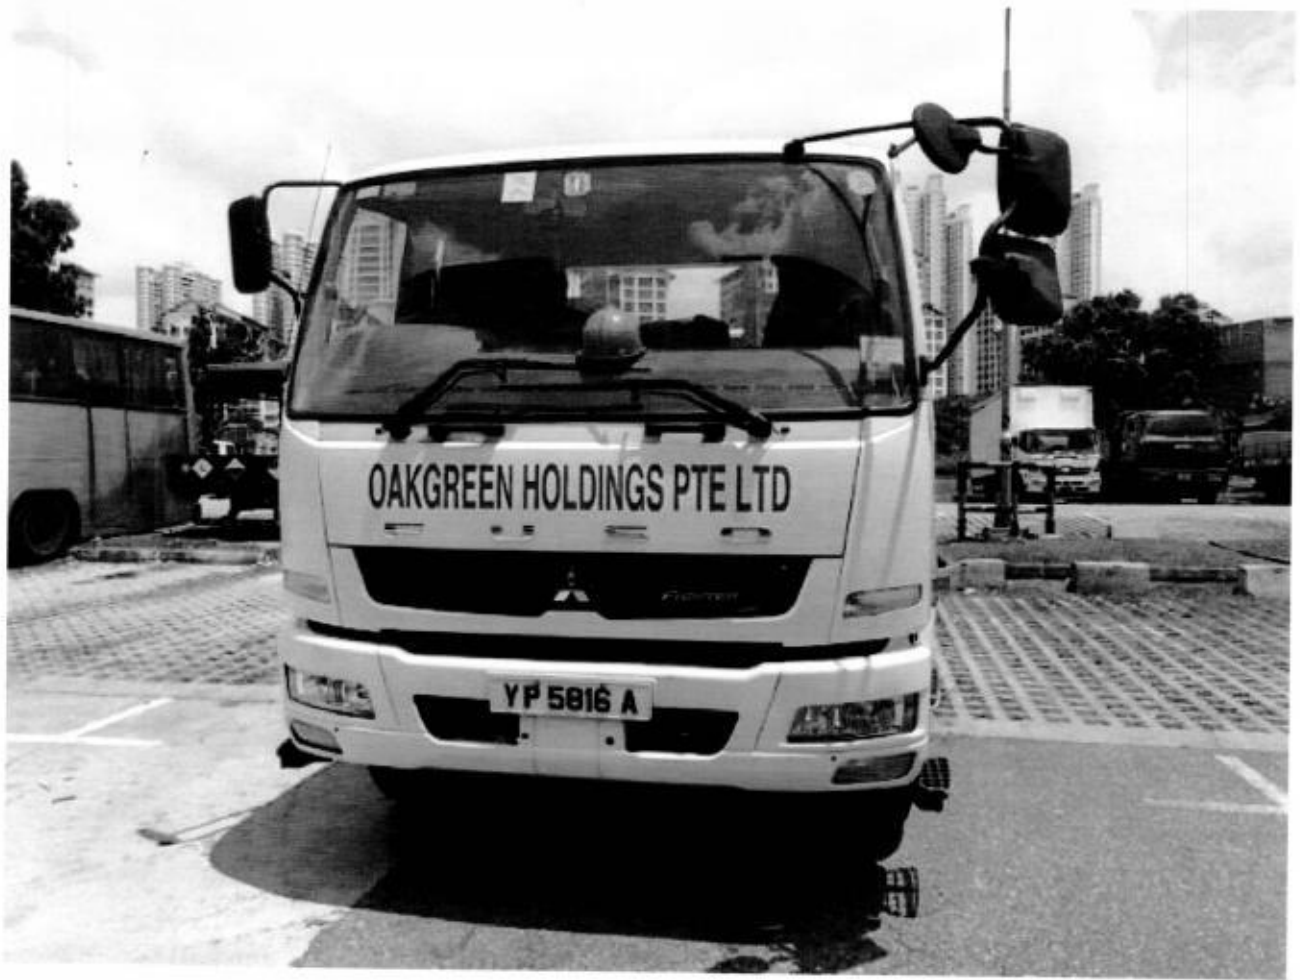
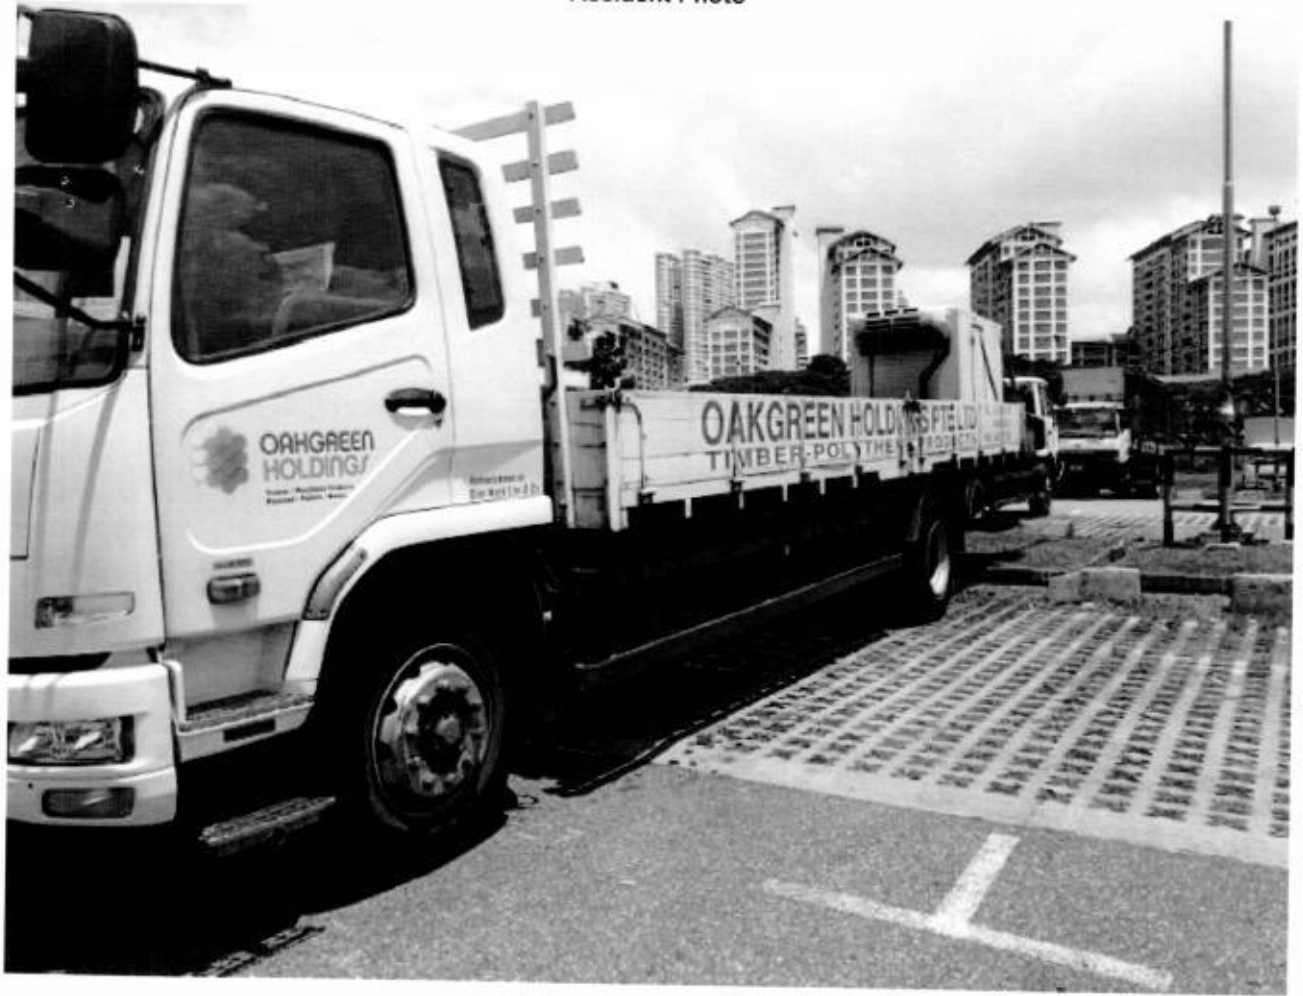
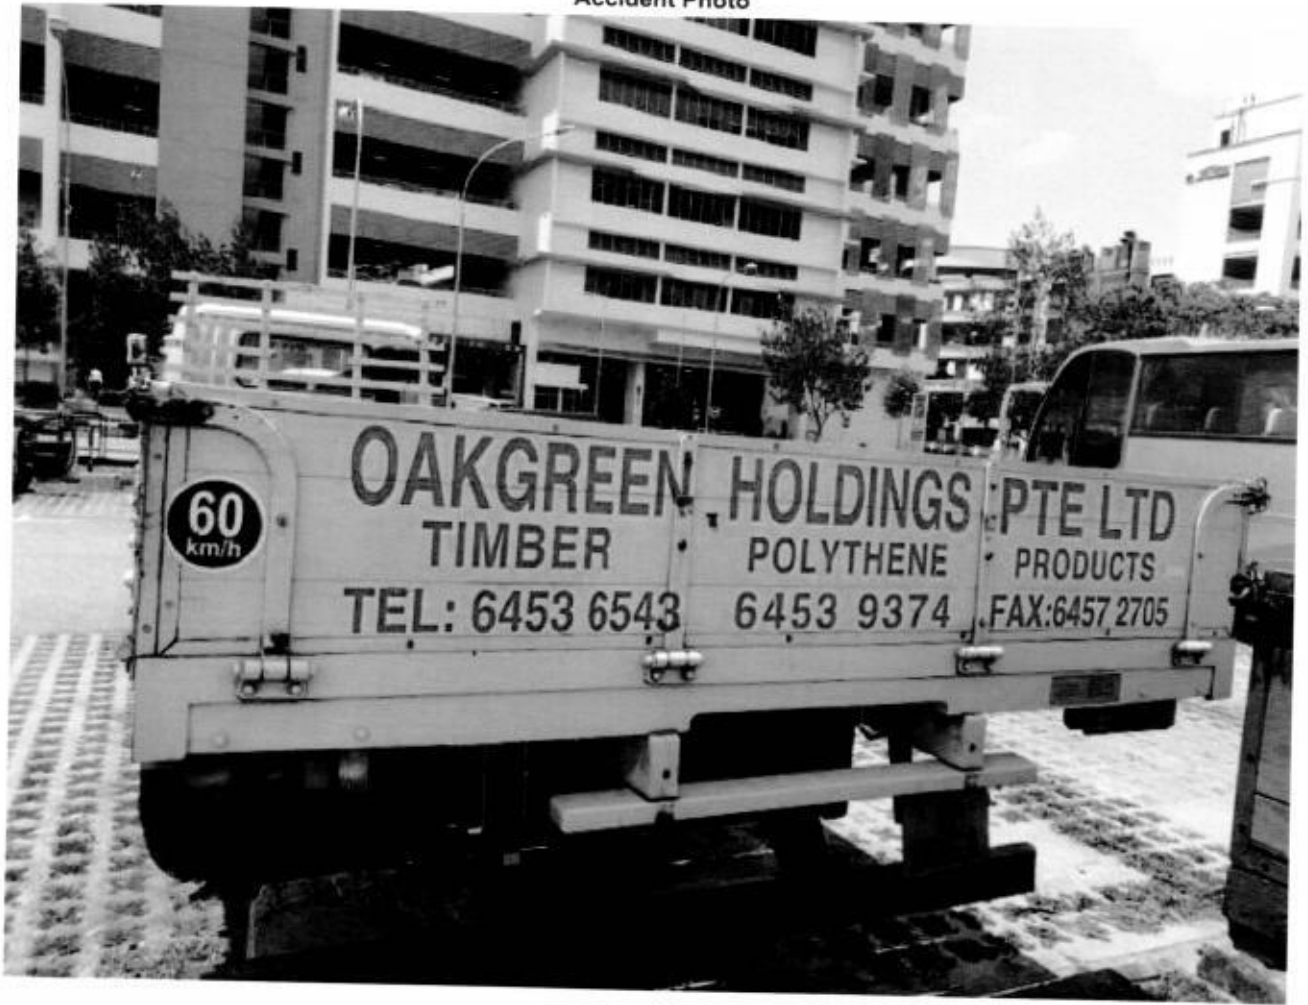
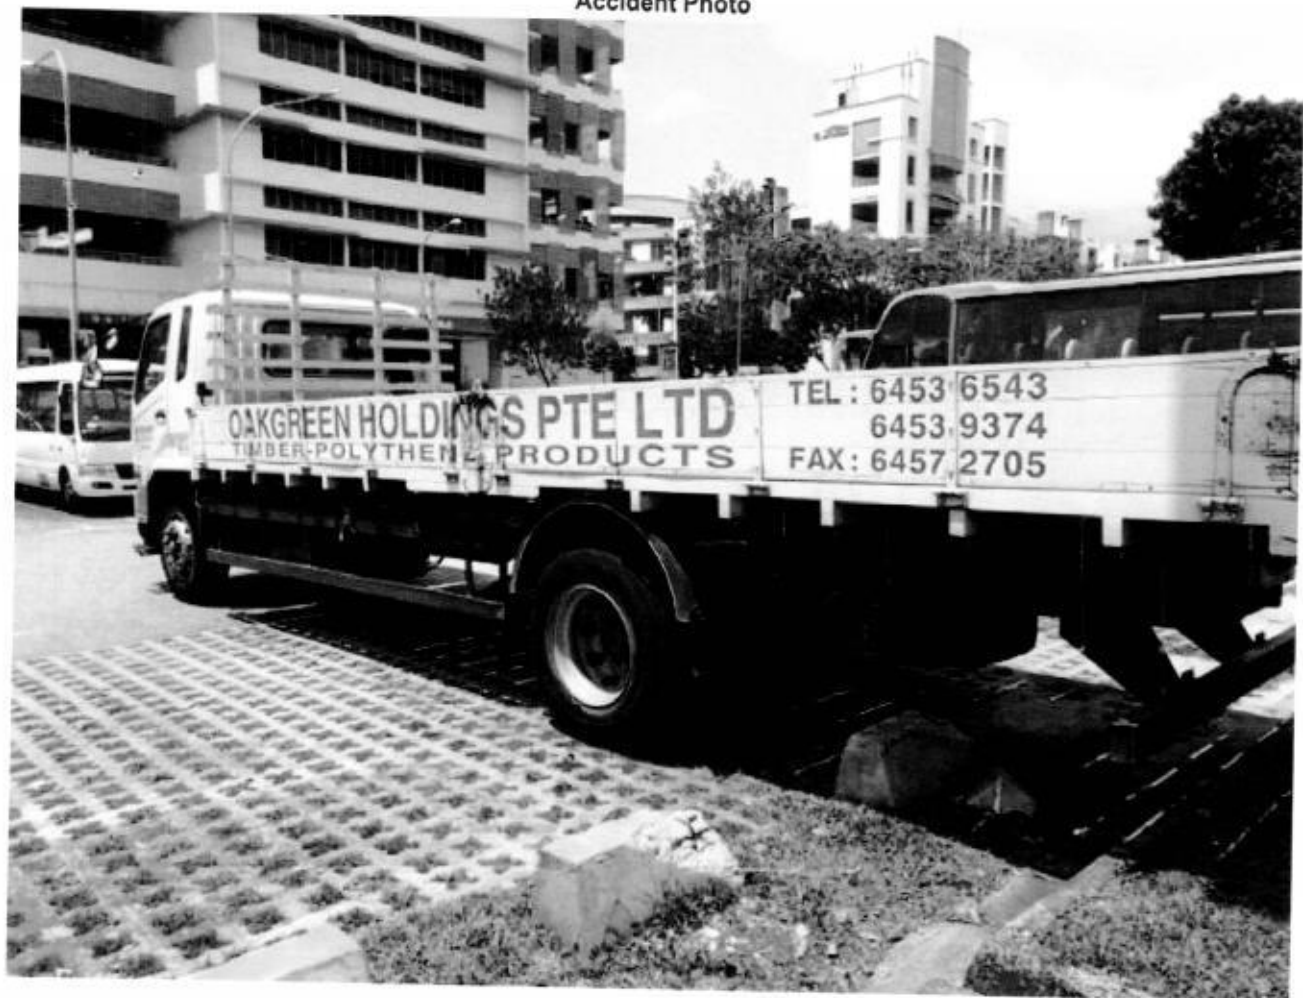
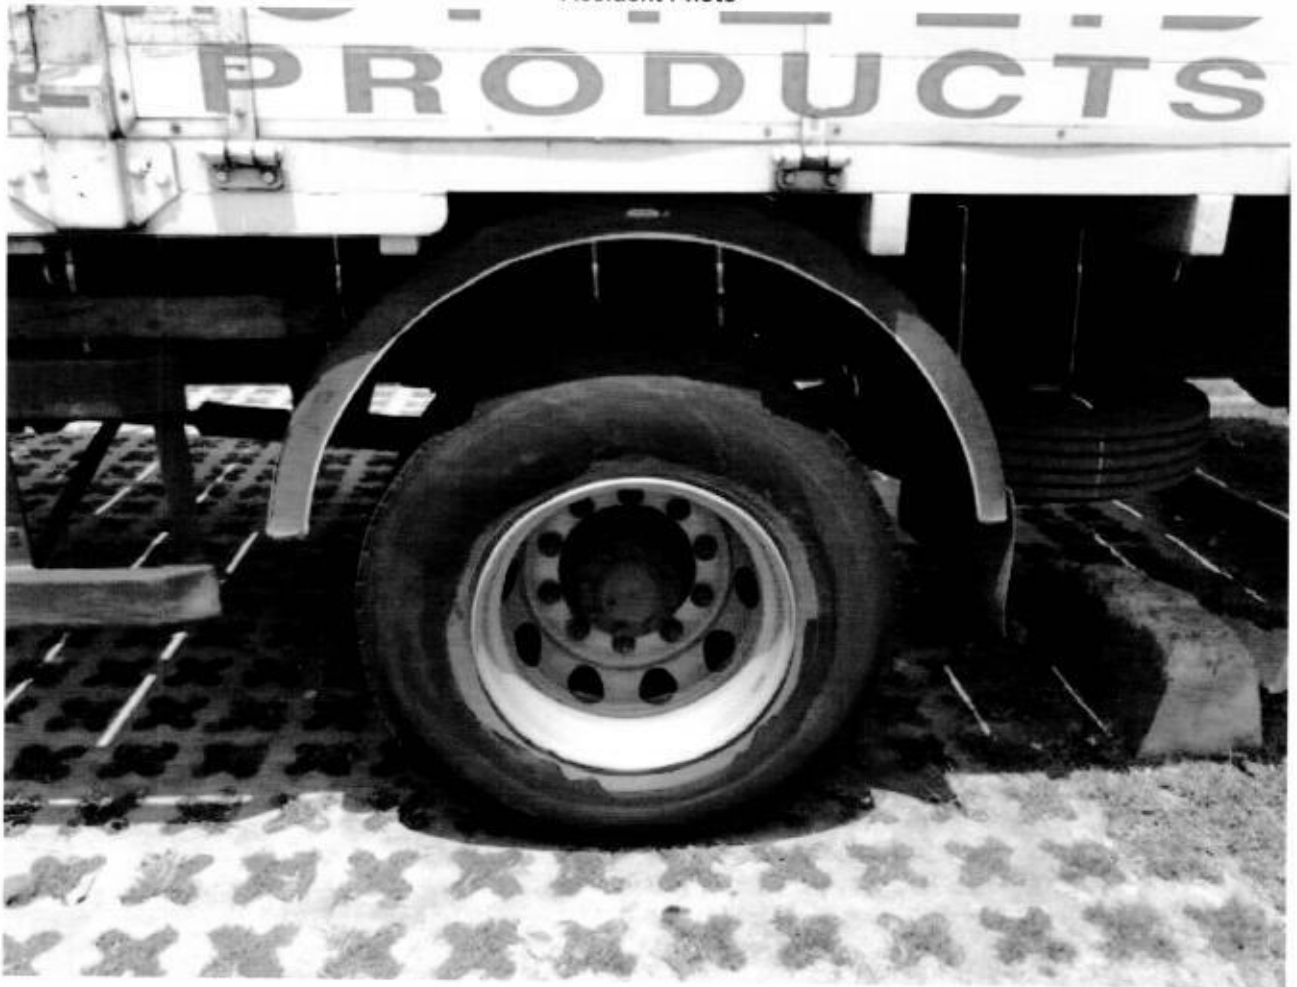
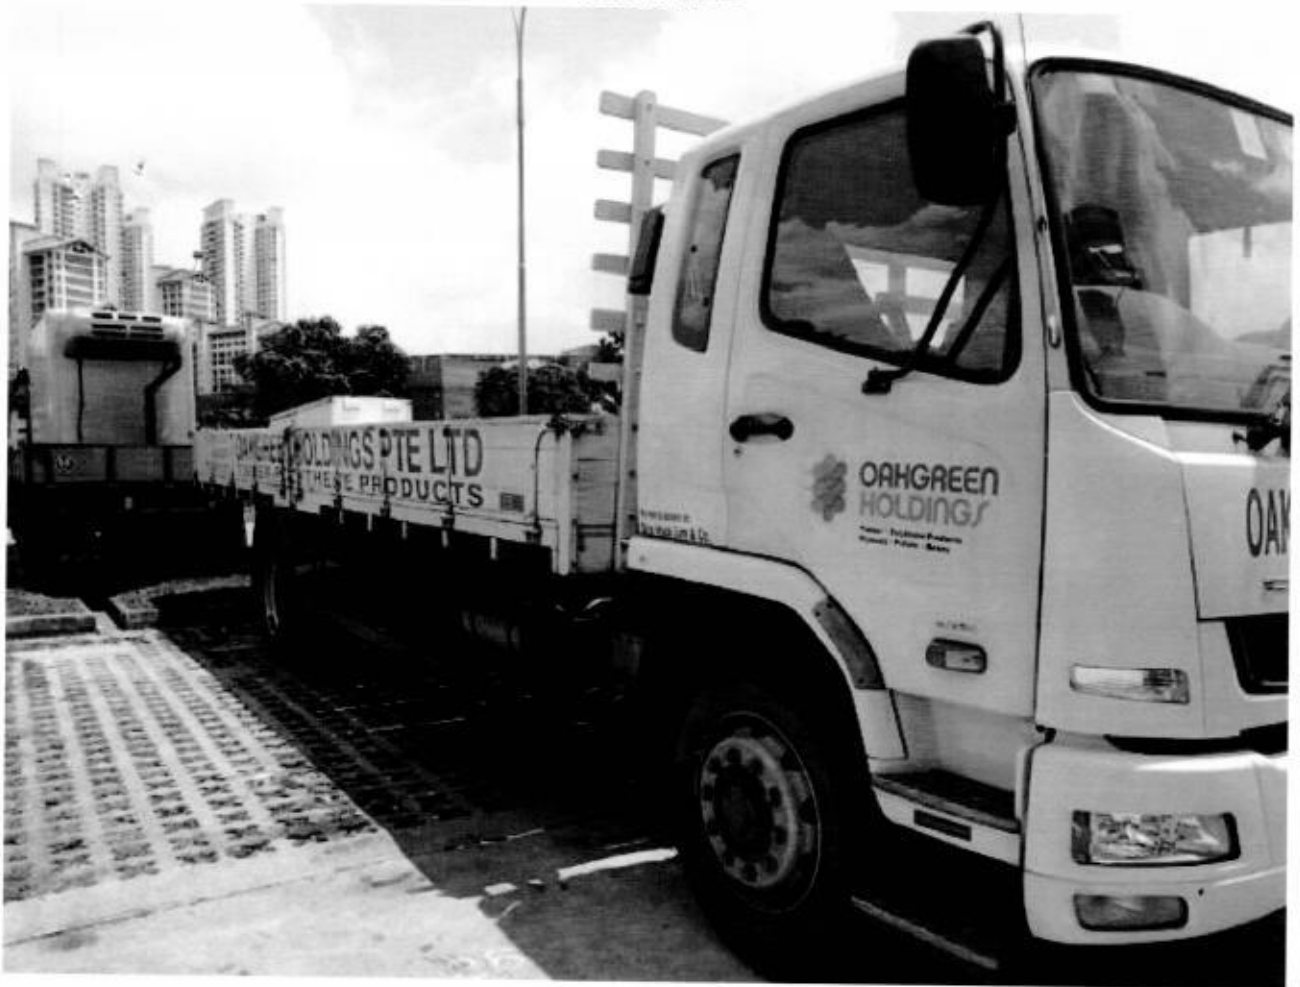
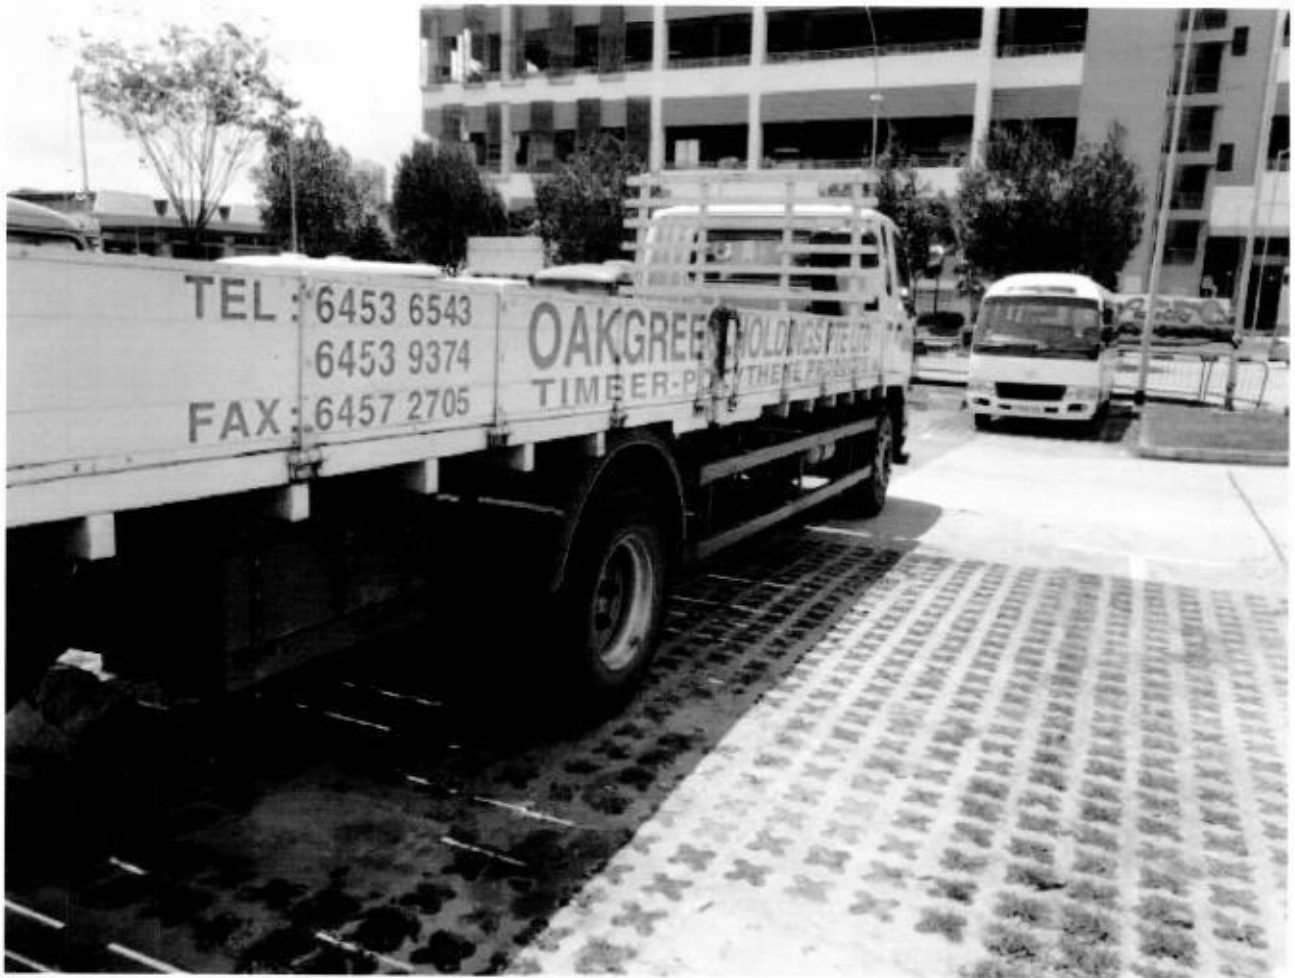
Accident Photo

The vehicle sustained an impact on the R/H front portion.

The front bumper, support panel, bonnet, R/H fender, door were dented/distorted.
The R/H front undercarriage were also affected.

The repairer has agreed to undertake repairs at our revised amount of \$6,500.00 lump sum corresponding to supply of parts, labour charges and spray-painting. However, we have not given instruction to authorize the repairs.
