To Inspect Vehicle No: SJW 1386R

The U/C / Chassis frame / Body Structure affected due to collision.

**PRE-REPAIR INSPECTION REQUEST – SJW1386R vs SJD6659X (OI) on D.O.A.: 15/04/2019**

## VEHICLE DAMAGE INSPECTION REPORT

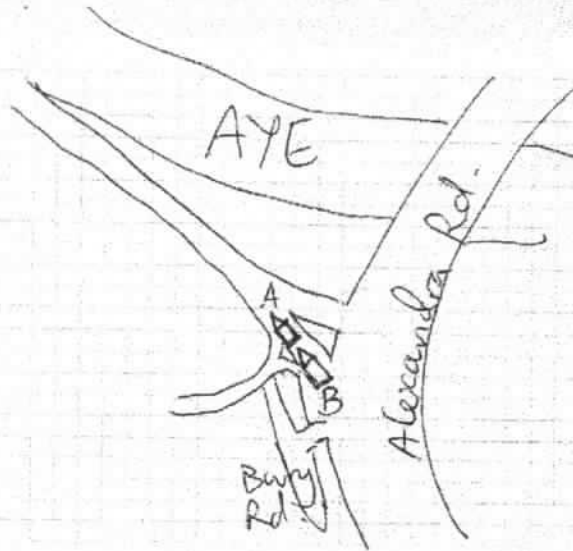
SKETCH PLAN

Type Of Accident COLLISION - HEAD TO REAR  
 Weather Conditions CLEAR  
 Road Surface DRY

Vehicle  
A: SJW 1386R  
Vehicle  
B: SJD 6659X
