## VEHICLE DAMAGE INSPECTION REPORT

Our File No: CS/CTI19006858/KTD3Q2

Claimant Vehicle  
No: SLV4941AInsured Vehicle  
No: SLV2883Y

Make &amp; Model: TOYOTA C-HR HYBRID, 1.8 S (A)

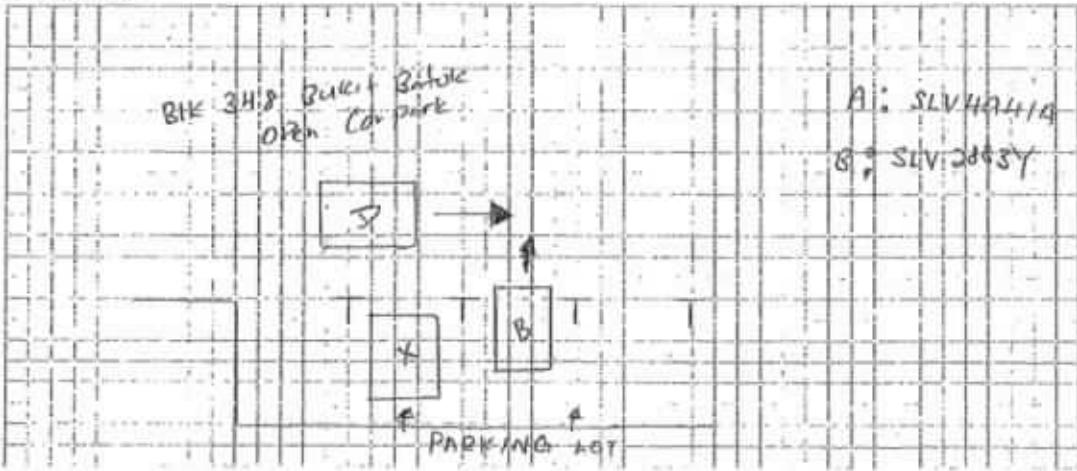
SKETCH PLAN

ON 11/04/2019 THURSDAY AT ABOUT 1705HRS, I WAS DRIVING AT THE DRIVEWAY OF BUKIT BATOK STREET 34, CAR PARK NO. BBU 25, I WAS TRAVELLING STRAIGHT ON THE DRIVEWAY, VEHICLE NO. SLV 2883Y DRIVE OUT FROM PARKING LOT WITHOUT CHECKING CLEARANCE THAT RESULT THIS ACCIDENT
