## Preliminary Advice

Insured Vehicle No	: SMD8988Y	Accident Date	: 17/04/2019
TP Vehicle No	: SLA4723Z	Assignment Date	: 07/05/2019
Make	: TOYOTA COROLLA ALTIS	Est. Duration of Repair	: 4 days
Date of Inspection	: 18/04/2019		
Inspection At	: Fastech Auto Pte Ltd (HQ) 1 Kaki Bukit Ave 6, #01-46/48/50 Autobay Singapore 417883

### Point of Impact / General Description of Damages

## VEHICLE DAMAGE INSPECTION REPORT

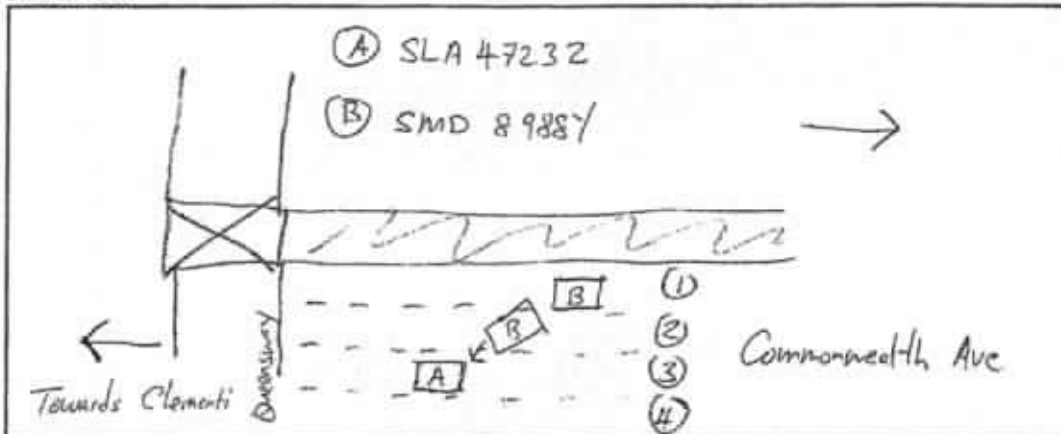
# Sketch Plan #2 Pg. 1

At approximately 12.10 PM, along Commonwealth Ave towards Clementi, I stopped as the traffic light is red.

Car (B) on lane one made a sharp left while changing lane failing to have proper lookout and knocked into Car (A) which is stationary. This hard knock caused severe pain to the neck and head.
