Work Order: R031202
 VIN: SGY6080P
 Year: 10
 Date: 16.4.19 16:03

Accident Claim for Vehicle No.SGY 6080 P , Involving Vehicle No.GBD 8545 Y.
A ident on 15 APRIL 2019, AT BLK 310 SHUNFU ROAD - FRONT OPEN AIR
CARPARK.

VEHICLE DAMAGE INSPECTION REPORT

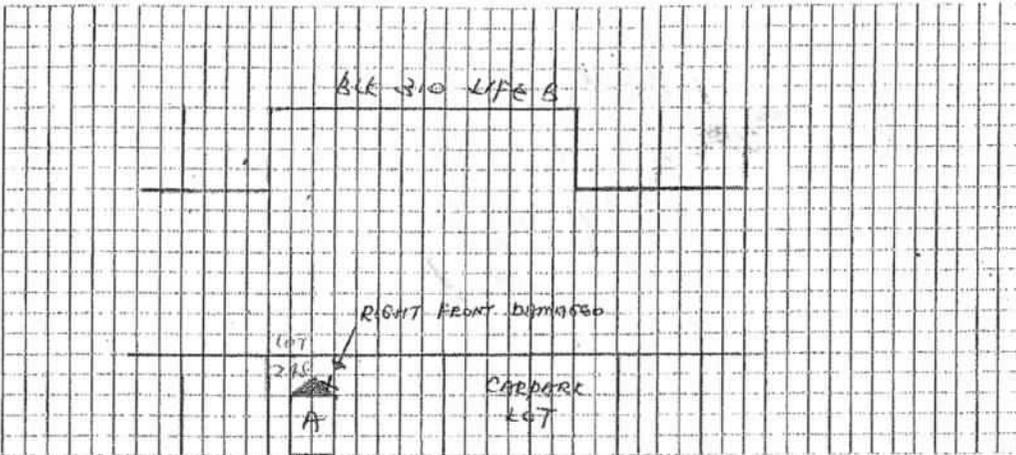
SKETCH PLAN

15/4/19 . I parked my car (PSY 6080 P) in front of my Block 210 SAMPAN ROAD LOT NO. 248. About 7.55 pm , my neighbour informed me that my car had damaged.

I check and found that one paper slip with phone number on the front windscreen wiper.
