Preliminary Advice

Insured Vehicle No	: SLT5075D	Accident Date	: 19/04/2019
TP Vehicle No	: SJZ2232D	Assignment Date	: 22/04/2019
Make	: TOYOTA WISH	Est. Duration of Repair	: 12.00
Date of Inspection	: 22/04/2019		
Inspection At	: CHEW MOTOR PTE LTD (KAKI BUKIT) (HQ) 1 KAKI BUKIT AVE 6, #01-43 BLK C @ AUTOBAY SINGAPORE 417883

VEHICLE DAMAGE INSPECTION REPORT

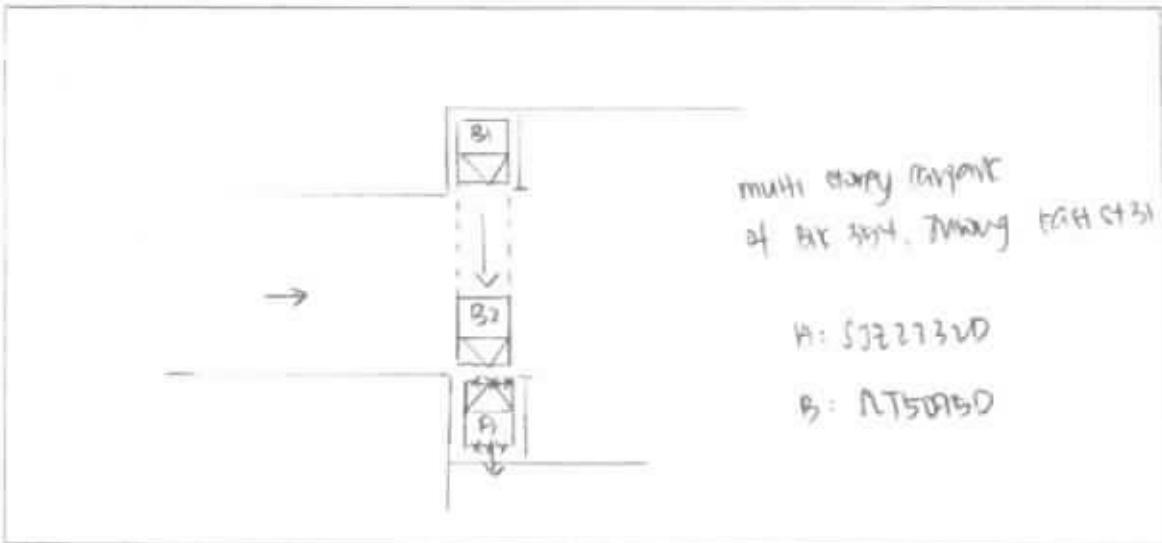
SKETCH PLAN

my vehicle was parked stationary at the multi story carpark of blk 354, along east st31

when i returned to my vehicle, i realised that my vehicle was hit on the front portion. due to the impact, my vehicle moved backwards and hit onto the pillar wall at the next.
