ACCIDENT INVOLVING SLP 4566G & SLJ 8828G AT JOHORE BAHRU CUSTOMS INTO SINGAPORE ON 20-01-2019

VEHICLE SURVEY REPORTS

Vehicle Registration No : SLP4566G
Make & Model : Toyota Corolla Axio 1.5X A
Vehicle Registration Date : 19/01/2008
Chassis No : NZE1416060587
Engine No : Blocked
Colour : Blue

VEHICLE DAMAGE INSPECTION REPORT

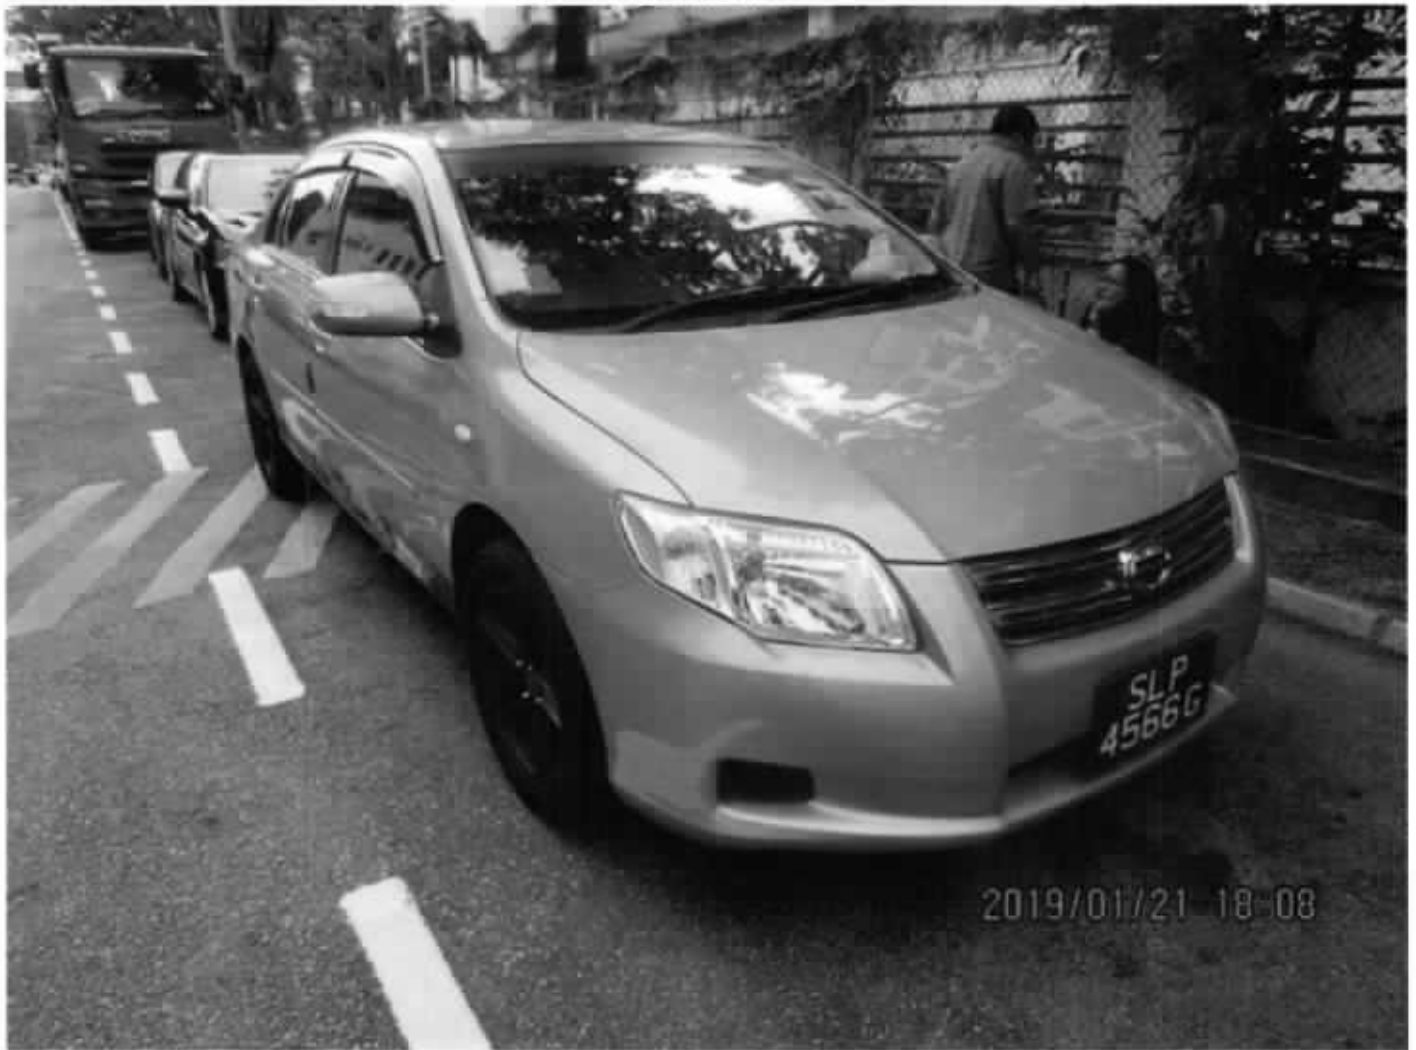
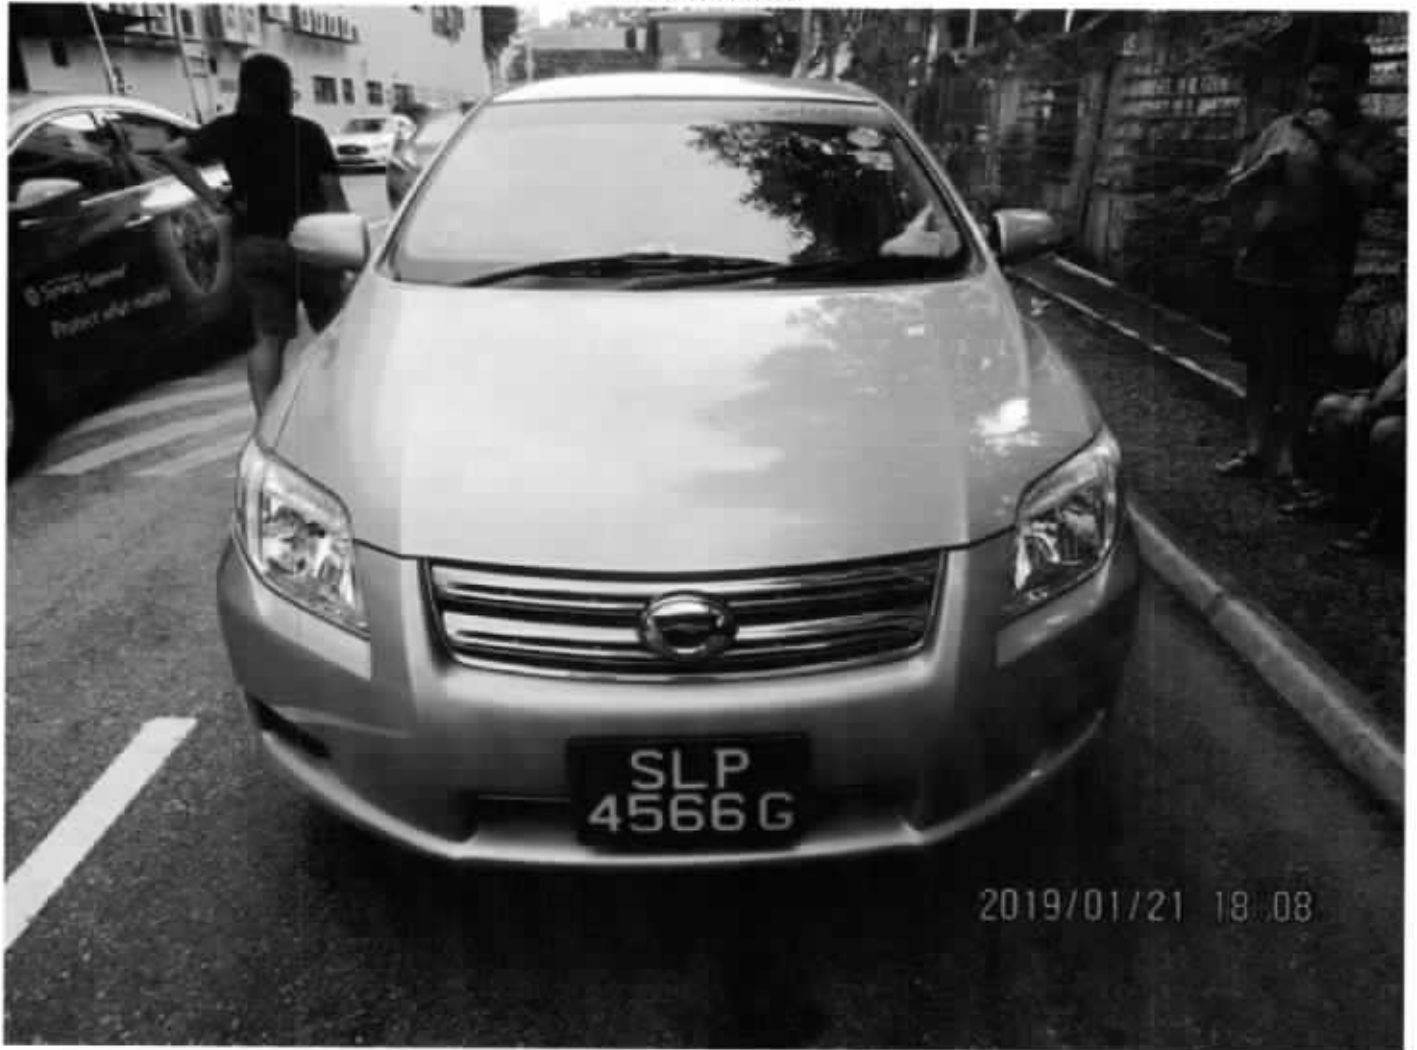
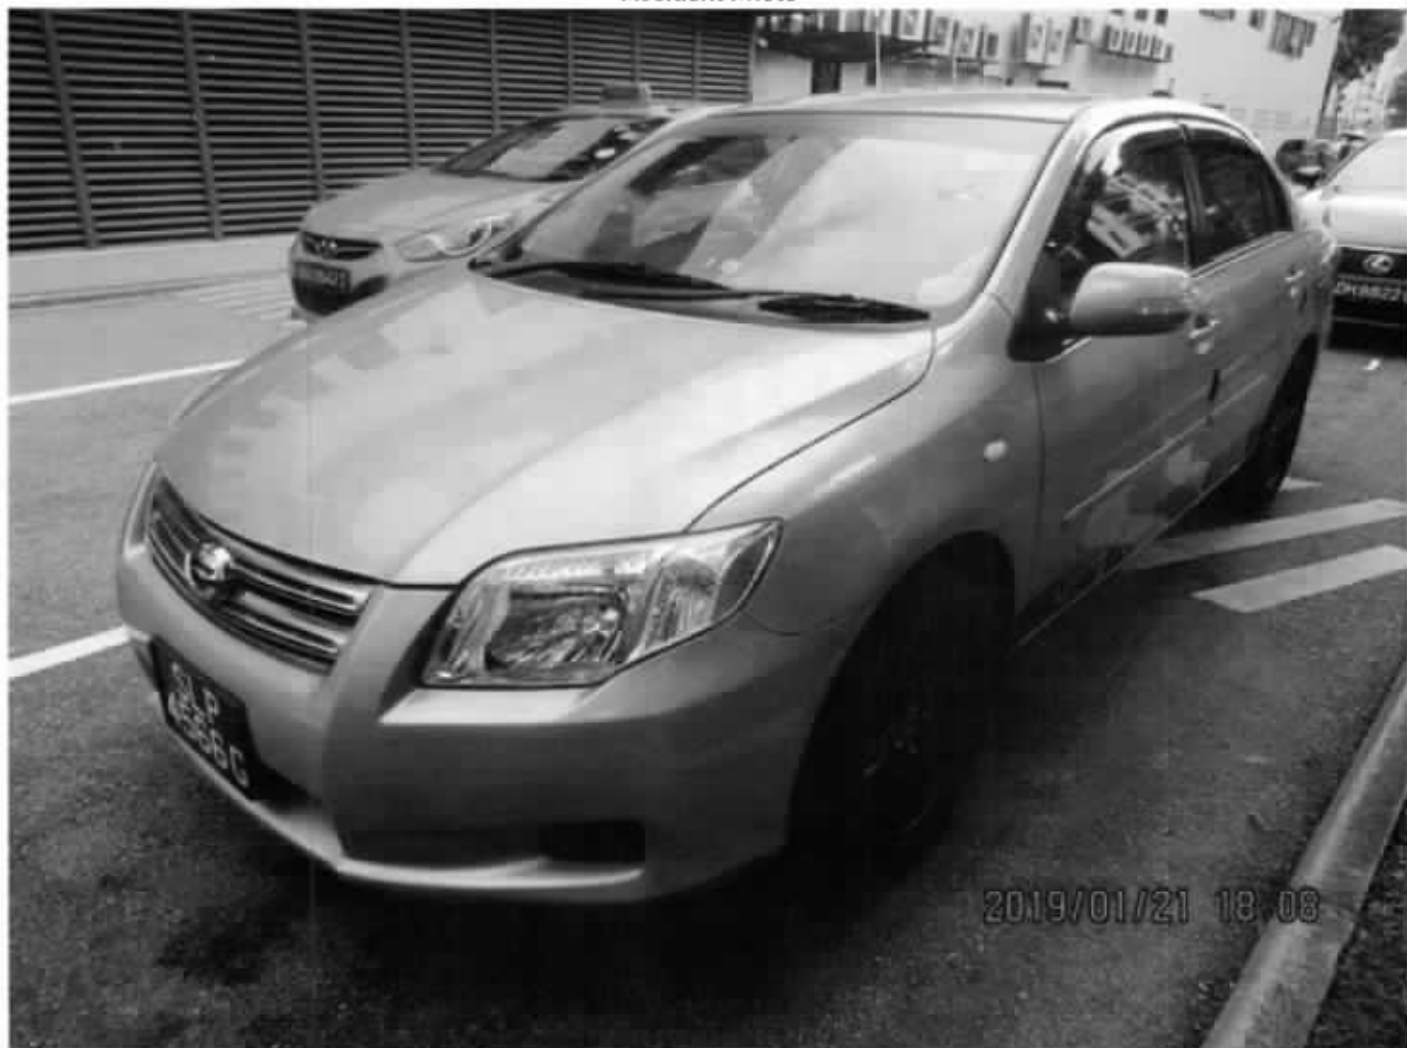
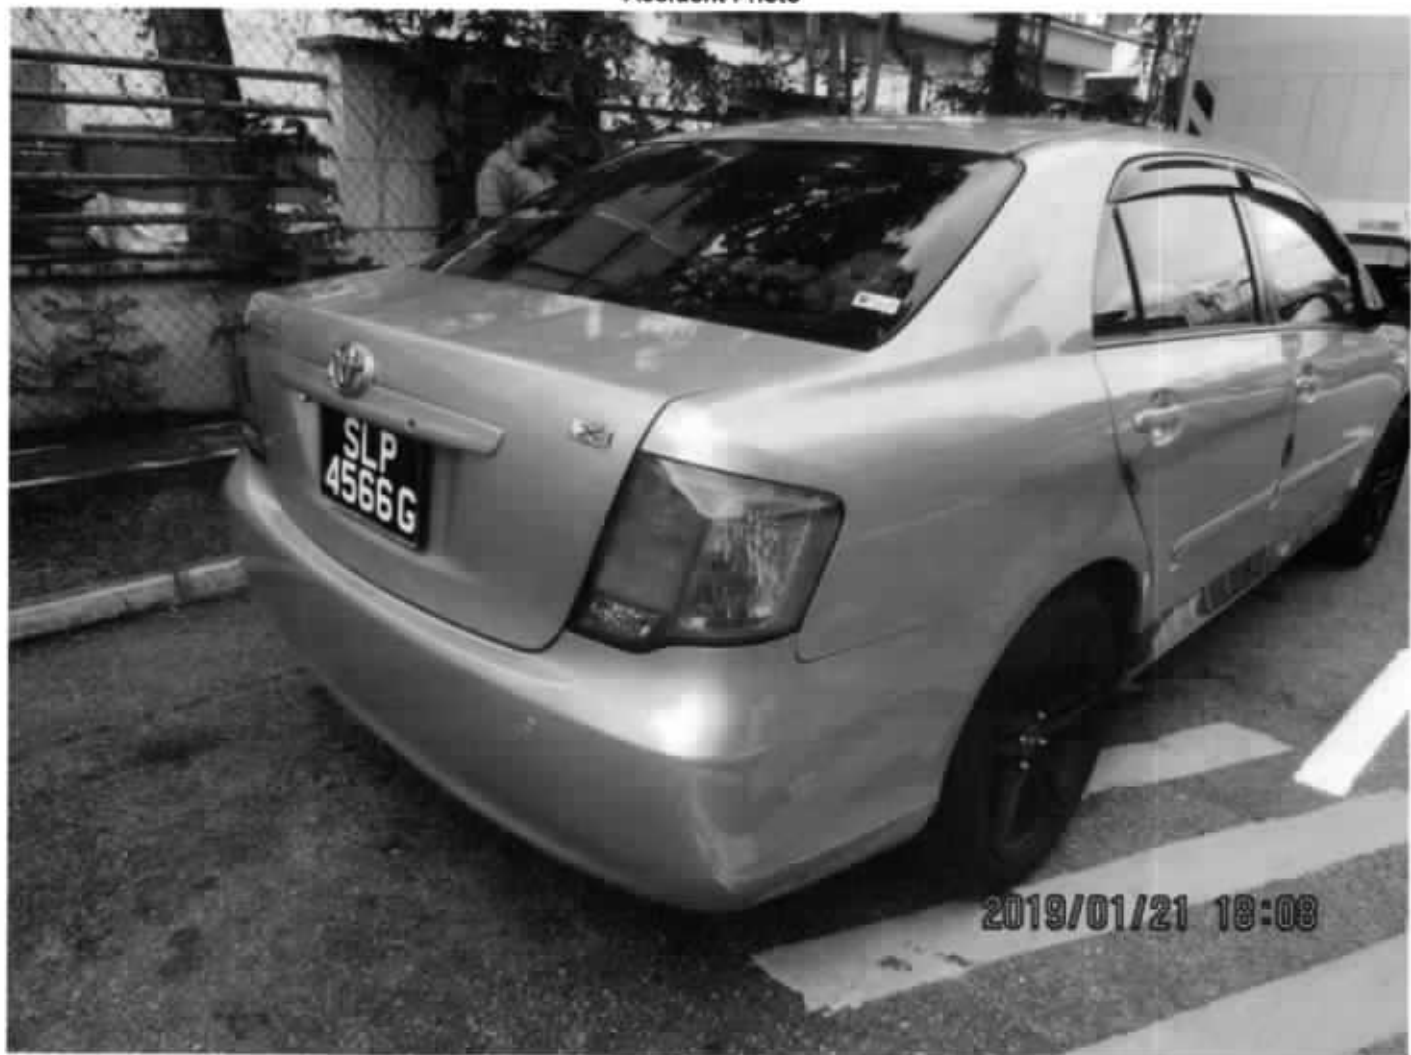
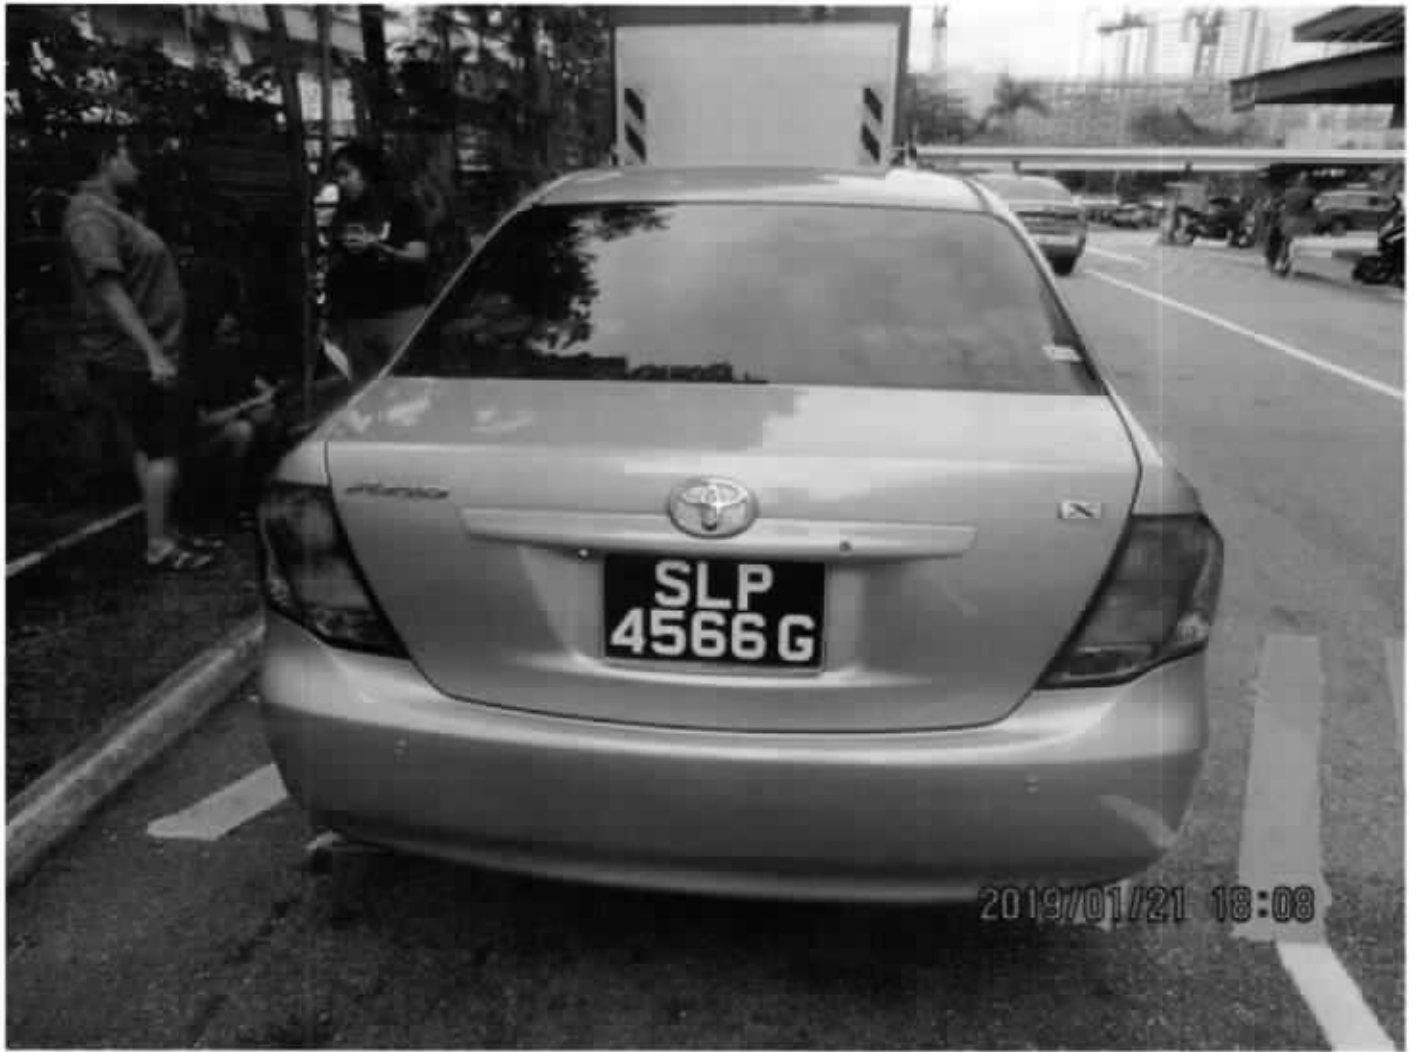
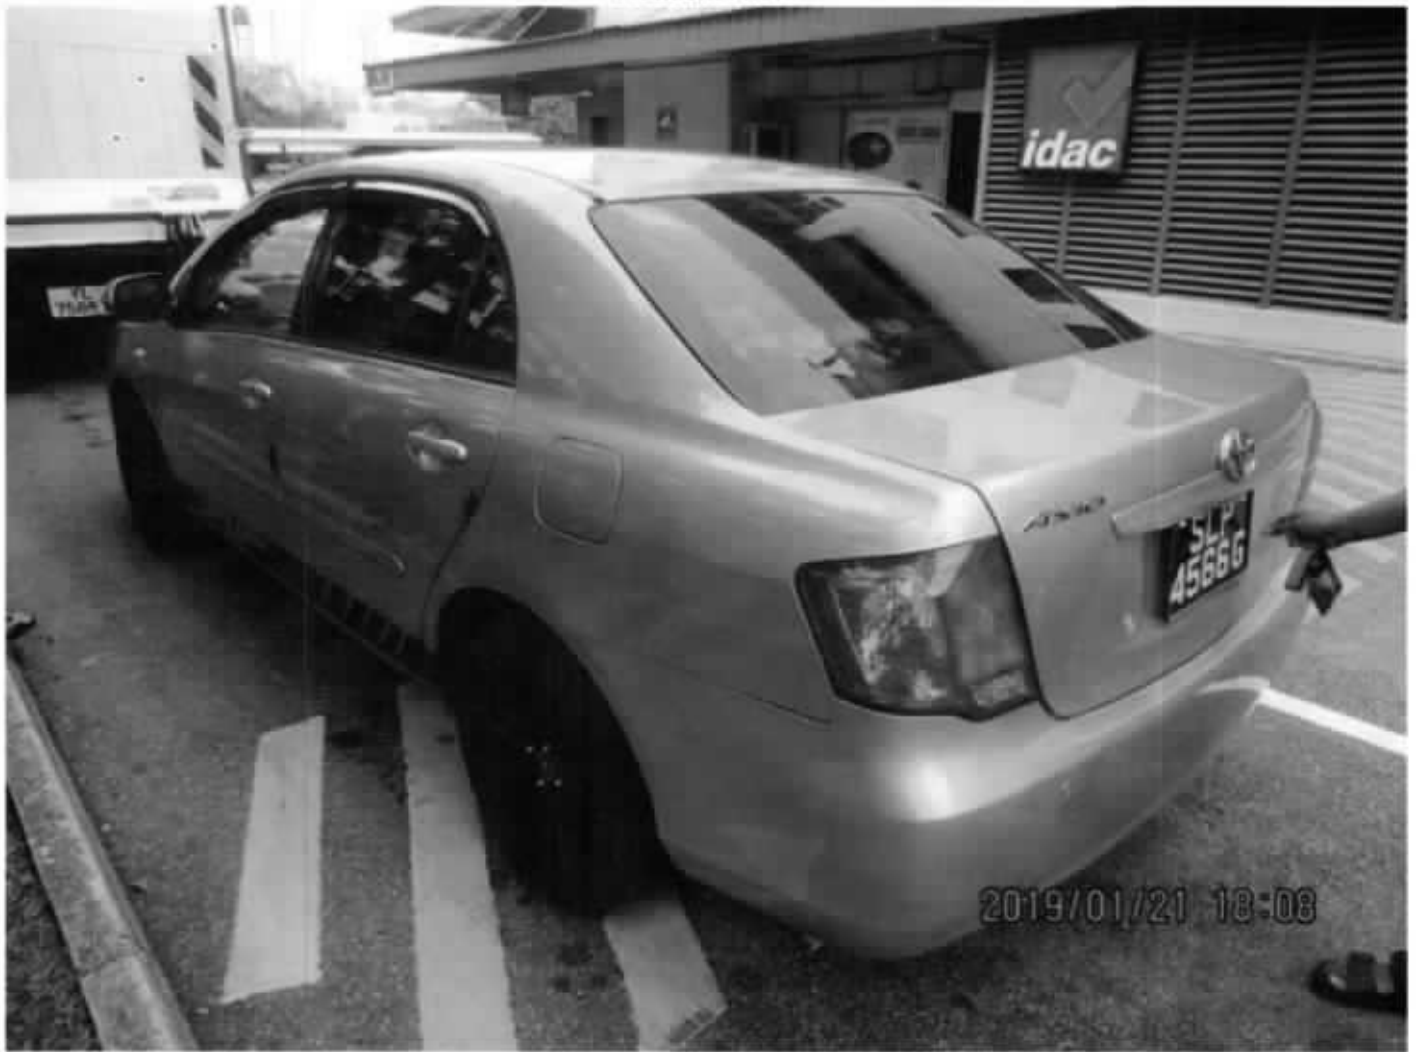
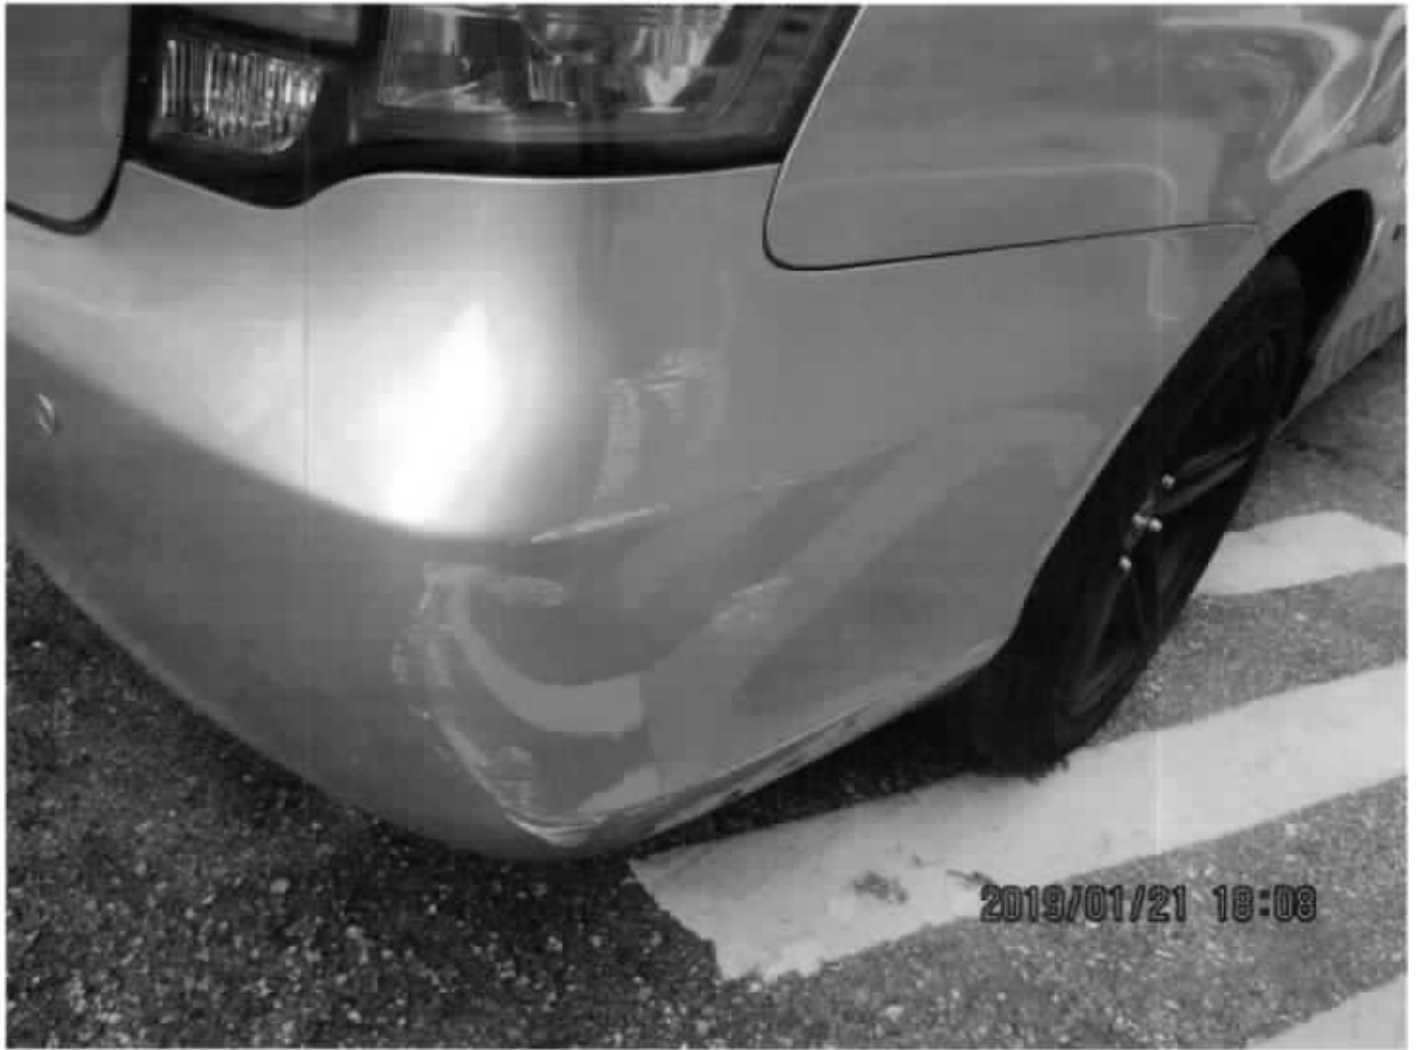
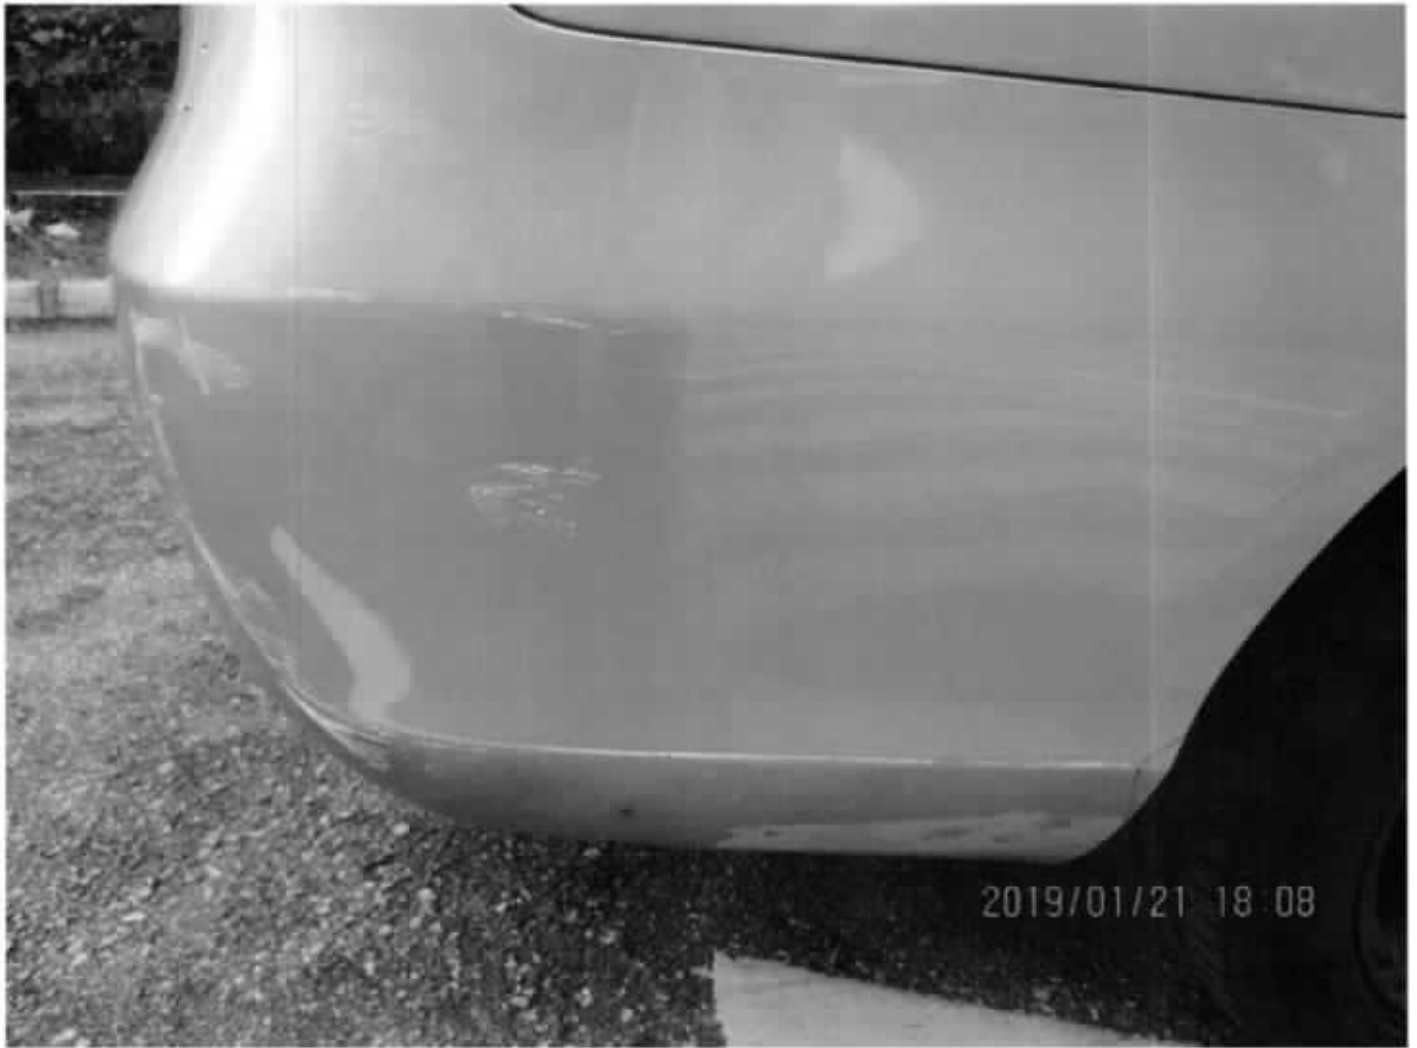
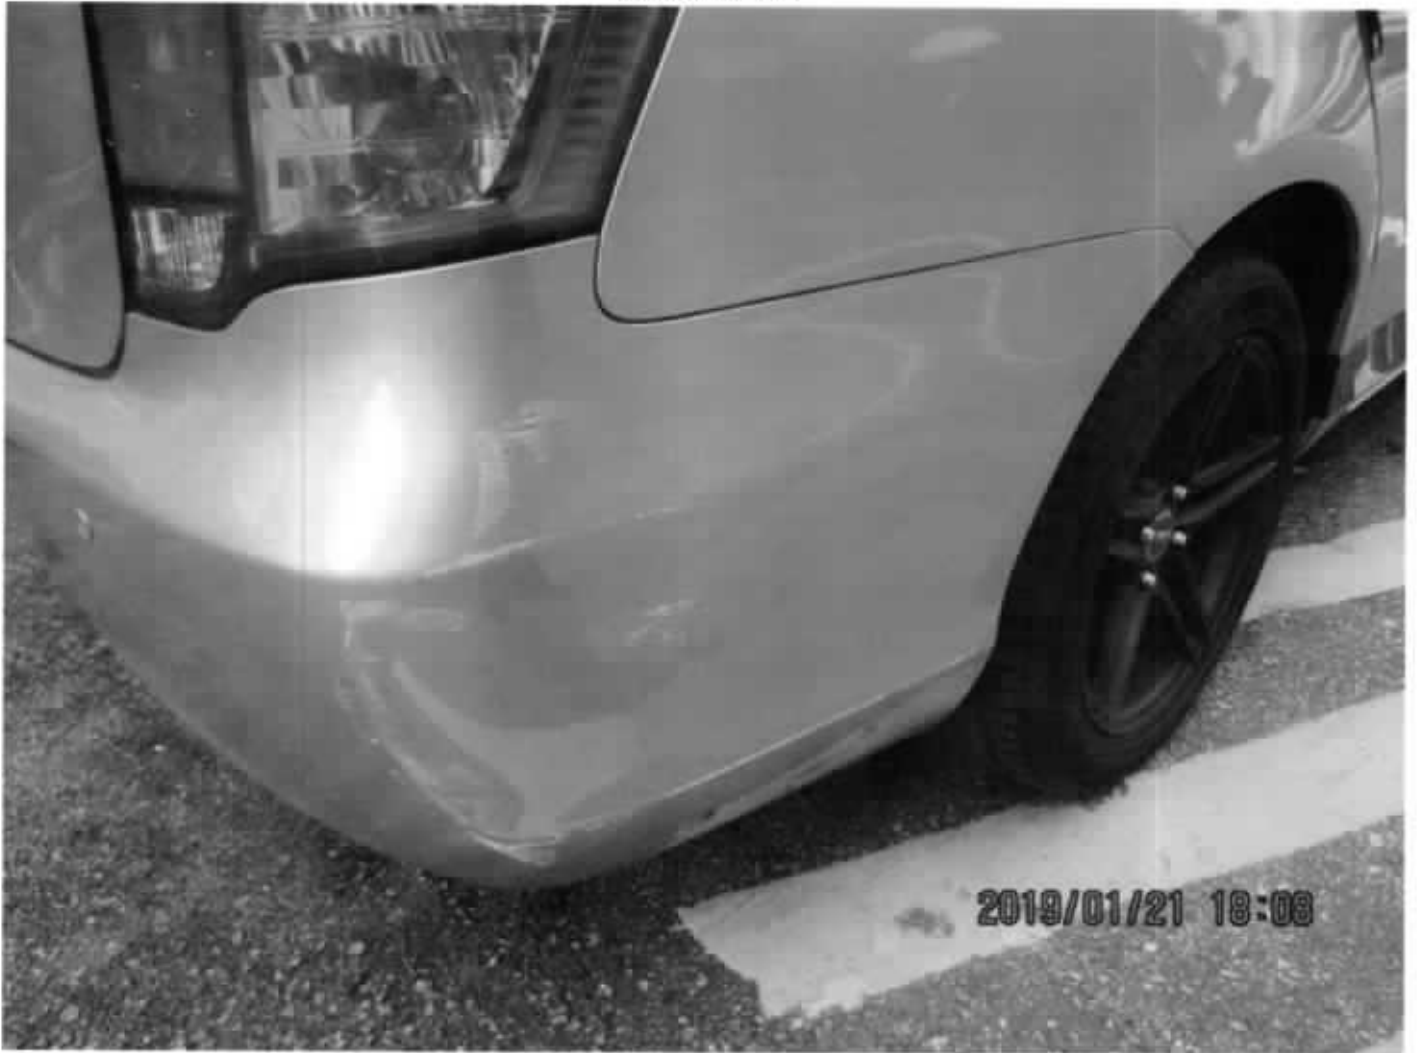
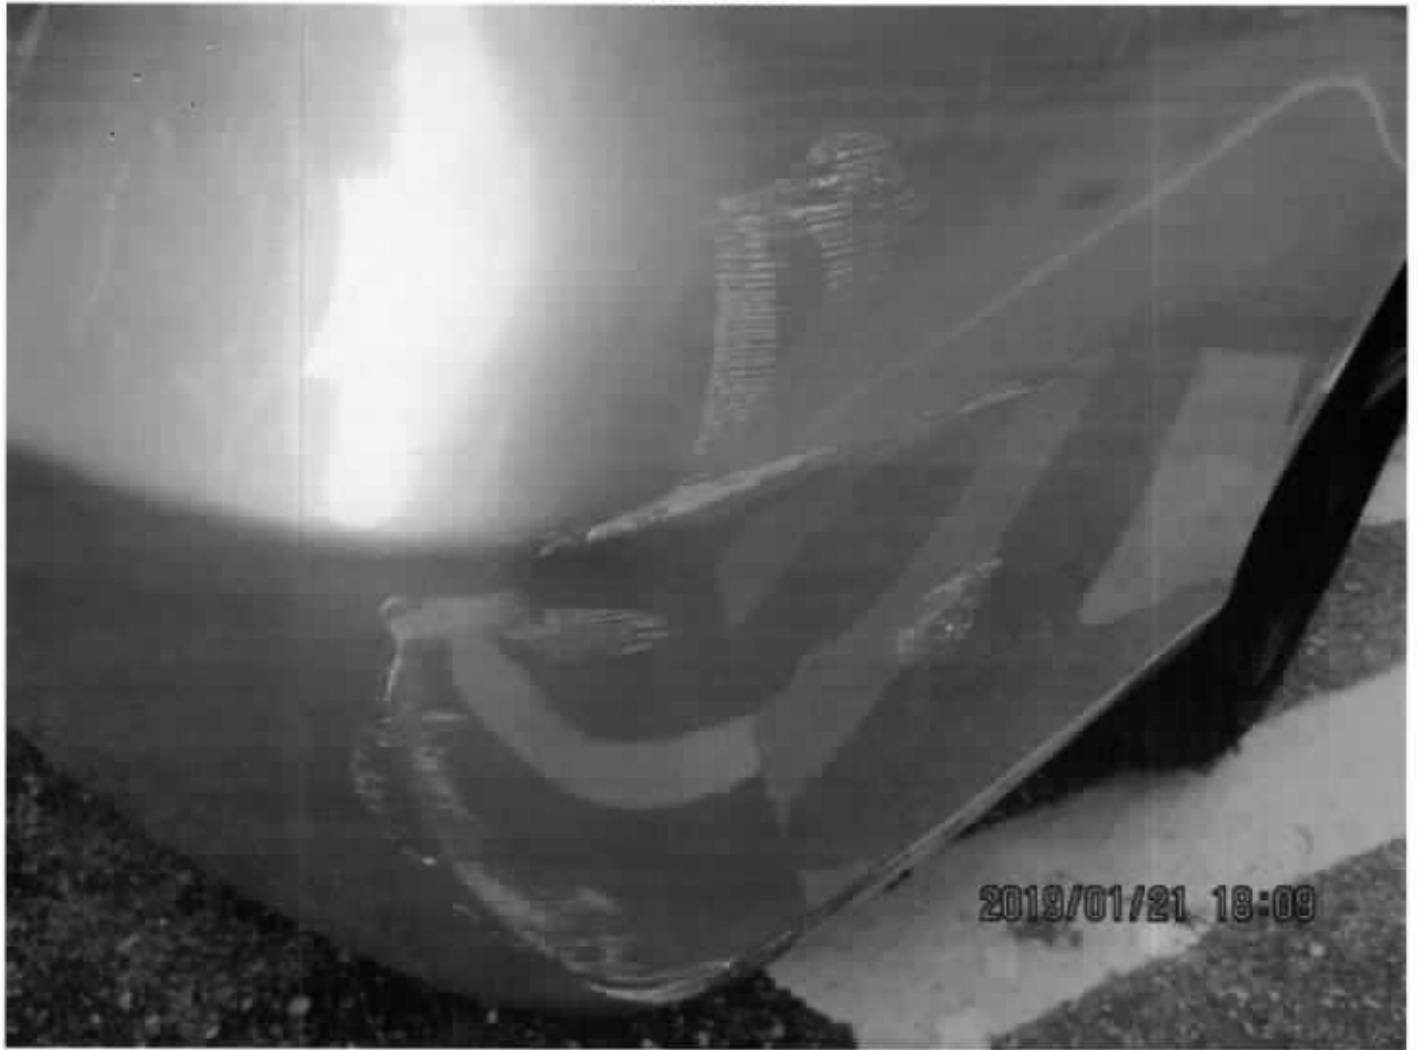
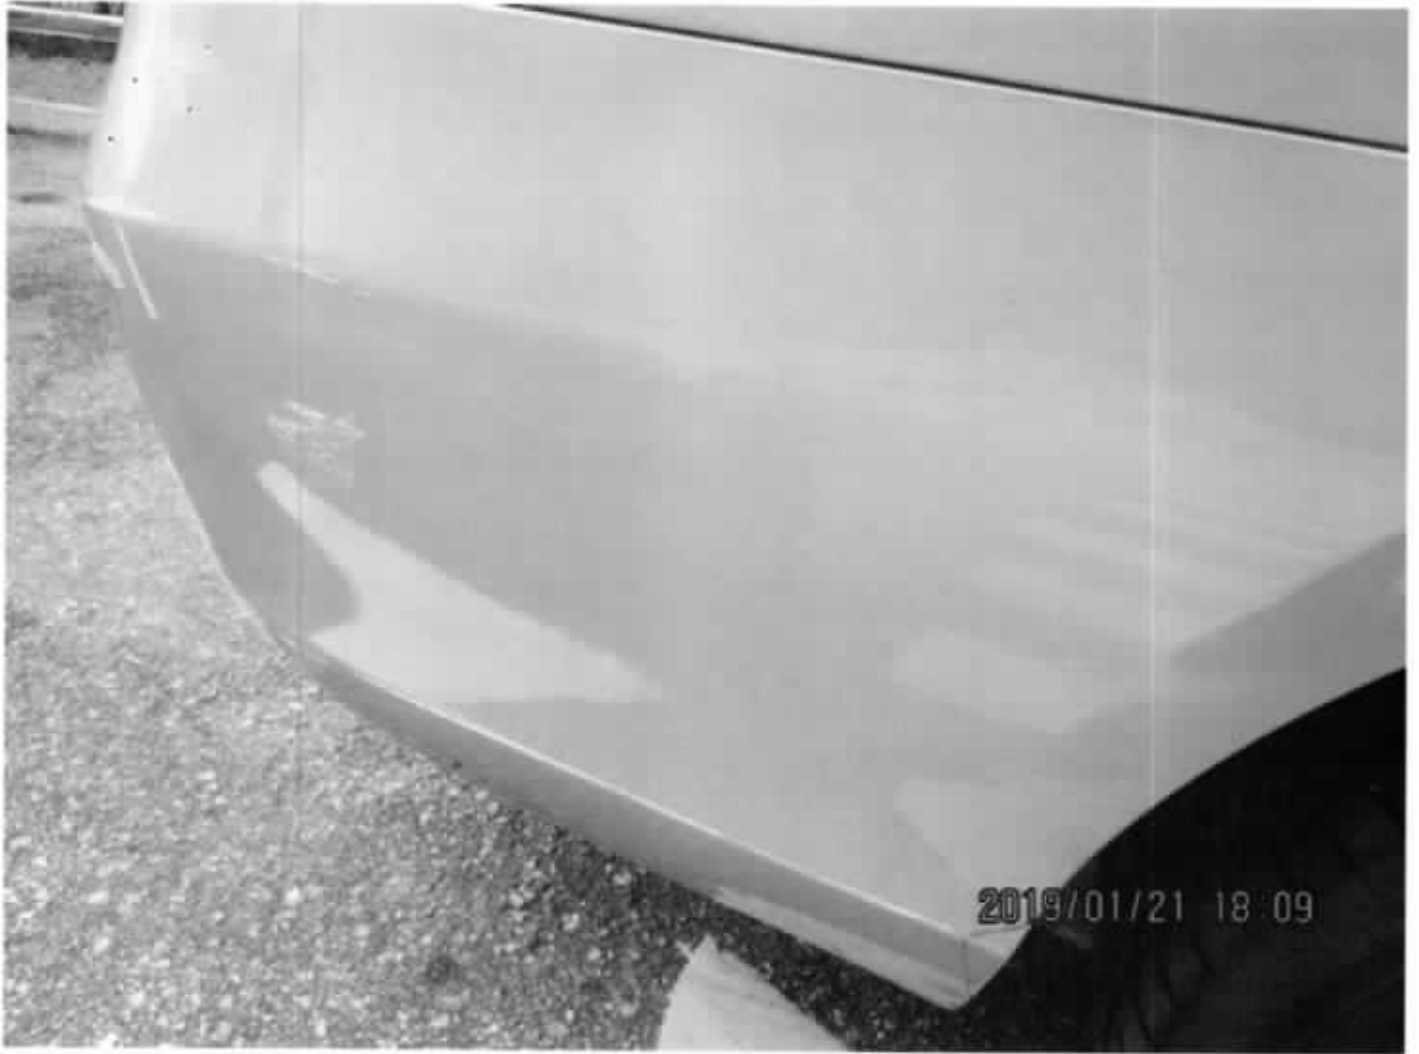
Accident Photo

The vehicle sustained damages at rear right hand portion.
(For information of damages please refer to Parts/Labour/Photographs attached)

On the same day at about 7.55pm, while I was travelling towards JB customs, due to the jam, my vehicle was in stationary position. Out of a sudden, one vehicle registration plate number SLJ8828G collided onto the rear of my vehicle. My vehicle damage was at the rear portion.

The repairer has agreed to undertake the repair on a lump sum basis of \$3,450.00, with a repair period of 5 working days.

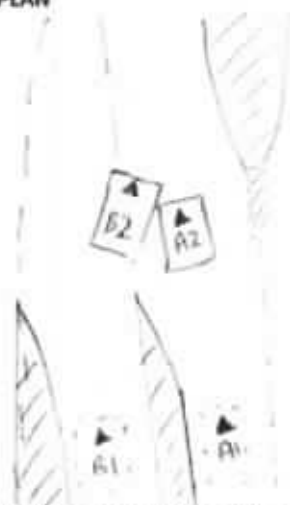
SKETCH PLAN

before Jalan custom to Singapore

Vehicle A: SLJ 8828 G
